Existing Conditions and Facility Evaluations - Berlin

POWDER MILL FISH HATCHERY FEASIBILITY
STUDY

New Hampshire Fish and Game Department

May 25, 2023

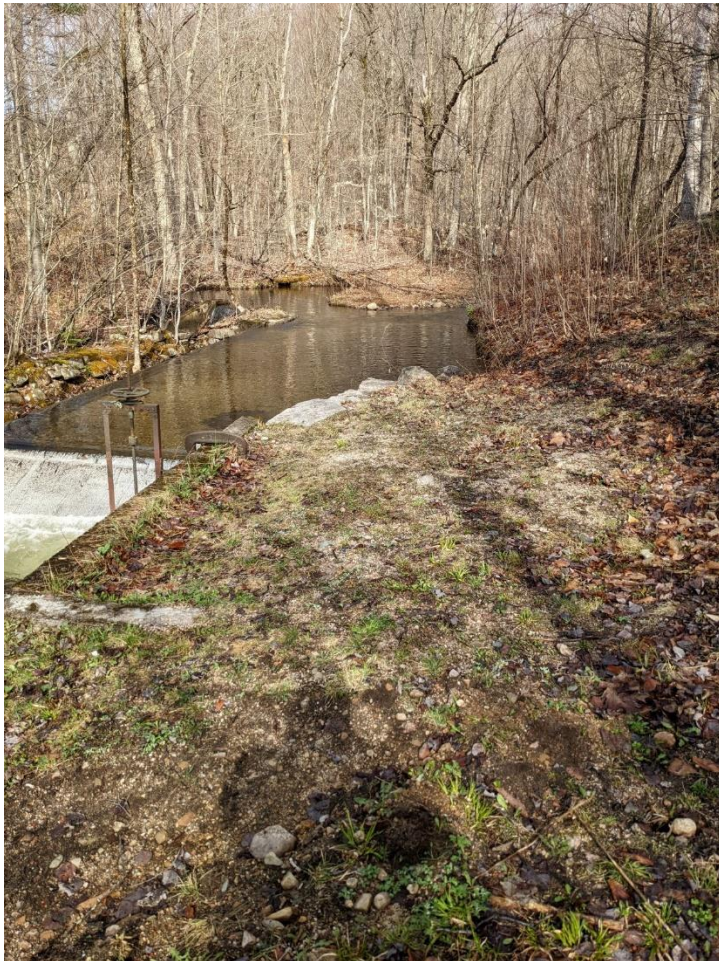
Figure 4-1: Cold Brook Diversion Dam

Cold Brook Diversion Dam has two cast iron slide gates. One controls flow into a 12" diameter AC pipe that discharges to the CB Distribution Box. The second is considered obsolete, as 1978 drawings indicate no piping is served by the second gate. Cold Brook Water is not used in winter since it is too cold. No freezing problems have occurred when not in use.

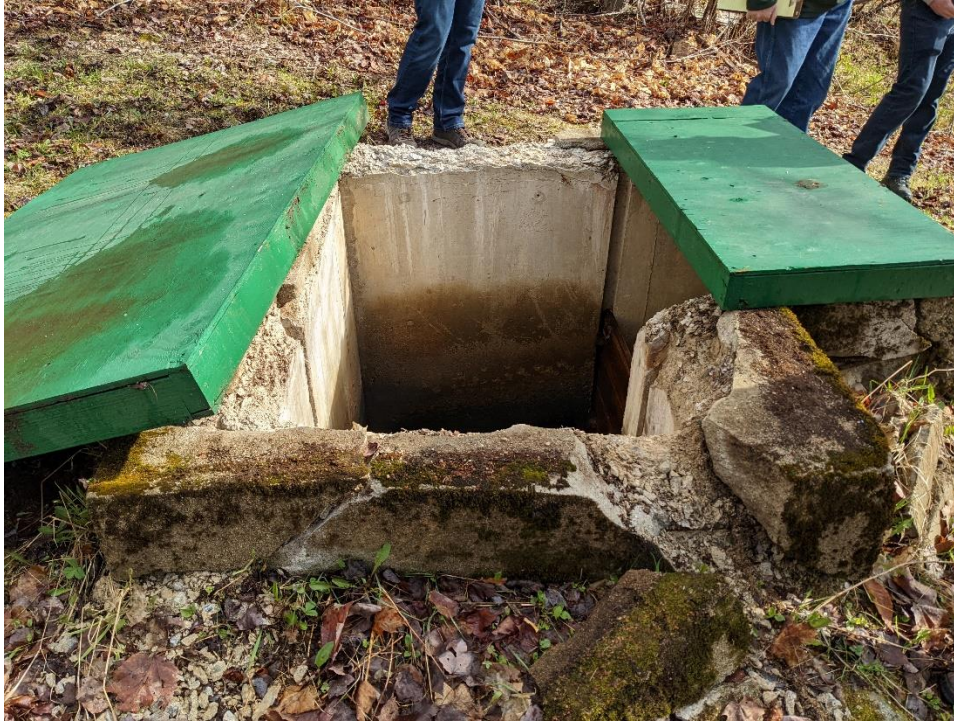
Figure 4-2: CB Distribution Box

The CB Distribution Box needs rehabilitation. The walls of the concrete box extend above the surrounding grade by about a foot, with a two-piece wooden cover on top of the walls. The walls are heavily spalled, cracked and deteriorated above the level of the surrounding grade (Figure 4-2).

Additionally, given this site is open to the public, increased safety measures such as grating, or a solid aluminum hatch should be installed. The Distribution Box has two outflow pipes; one goes to a Blending Tank with Lime Mill and the other to Salmon Pond. A 2" high slot under stop logs feeds the pipe to Salmon Pond.

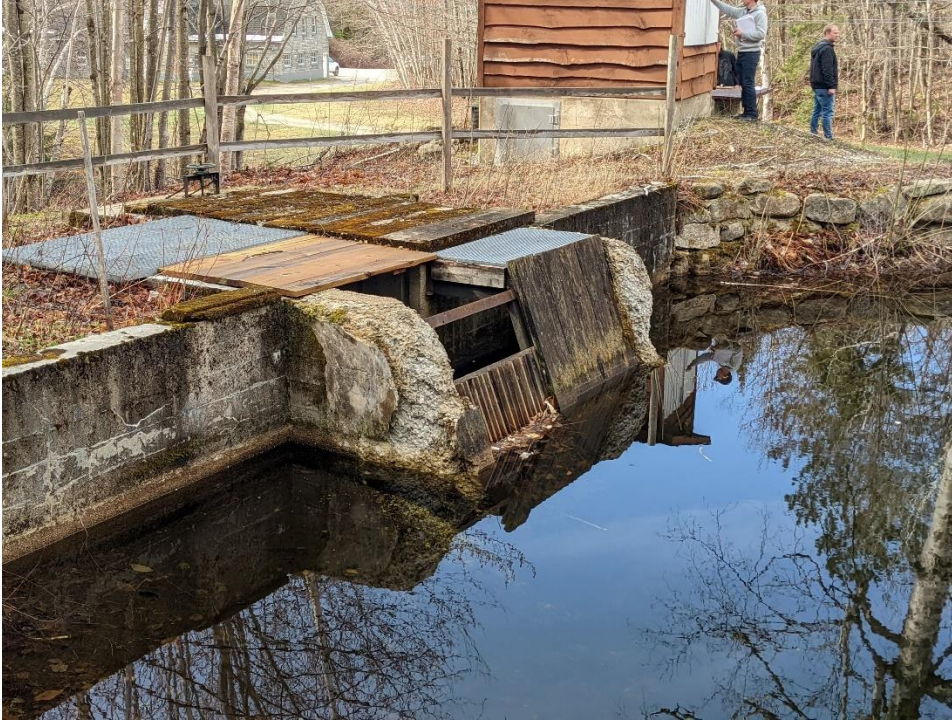
Figure 4-3: Salmon Pond Outlet and Distribution Box

Salmon Pond (Figure 4-3) is formed by a concrete impoundment wall with stone walls extending on either side of it. A concrete outlet box with a metal trash rack on its inlet is present near the center of the concrete impoundment. The concrete of the impoundment wall is in fair condition. The concrete of the outlet box is very deteriorated and spalled and needs to be rehabilitated. Timber boards have been used to replace missing metal gratings. For safety purposes for both staff and the public, these should be replaced with gratings. The screened outlet structure contains one discharge pipe arriving at a slide gate in the Blending Tank at Lime Mill. The distribution box houses a slide gate controlling flow to a discharge pipe to the lower part of Cold Brook as well as a second pipe feeding the Hatchery Building. Salmon Pond is allowed to spill into an un-named, un-numbered pond directly adjacent.

- Salmon Pond:
 - Rehabilitate concrete at the outlet box including new metal gratings for increased staff and public safety.
 - Replace slide gate.
- Blend Tank and Lime Mill:

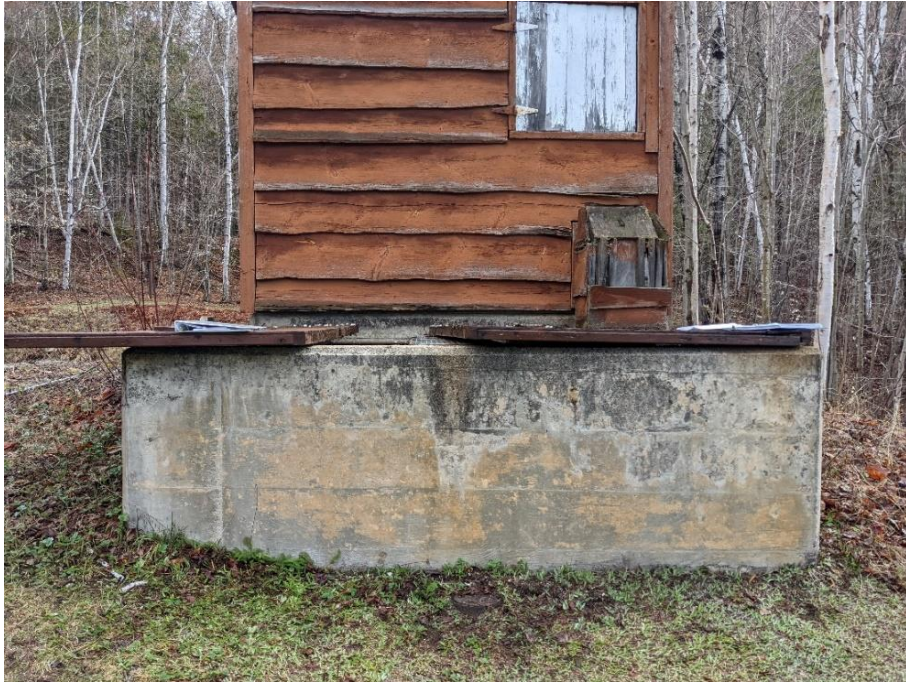
Figure 4-4: Blending Tank at Lime Mill

The Blend Tank at Lime Mill is a concrete distribution box in front of Lime Mill that has a two-piece plywood/lumber cover, see Figure 4-4. The concrete of the Blend Tank is in good condition. Lime Mill itself is a concrete valve enclosure topped by a timber/lumber shed-type structure. The concrete of Lime Mill is in fair condition.

The Blending Tank at Lime Mill can receive water from Salmon Pond, a pipeline from the two pumped production wells, and a pipeline from Cold Brook. Leaving the Blending Tank is a valved 6" pipe to the Hatchery and 12" pipe to Young's Raceways. The valve on the 6' pipe is seized open and needs to be replaced.

- Replace plywood cover with grating or solid metal hatch for increased public safety.
 - Replace all gates and valves within this structure.
 - Remove all associated lime mill equipment and demolish timber structure.

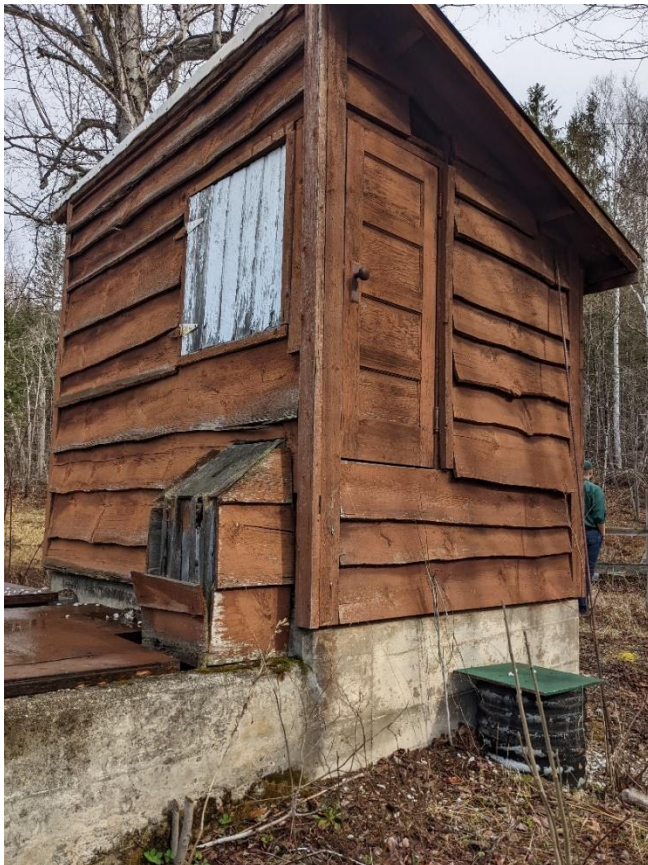
Figure 4-5: Lime Mill Structure

Cold Brook water has low pH 6.0 to 6.3. Inside and atop the Blending Tank is a limestone mill that was historically used to raise pH; but the mill has deteriorated and is no longer in use. The timber of the Lime Mill structure is weathered and in need of maintenance or demolition, see Figure 4-5.

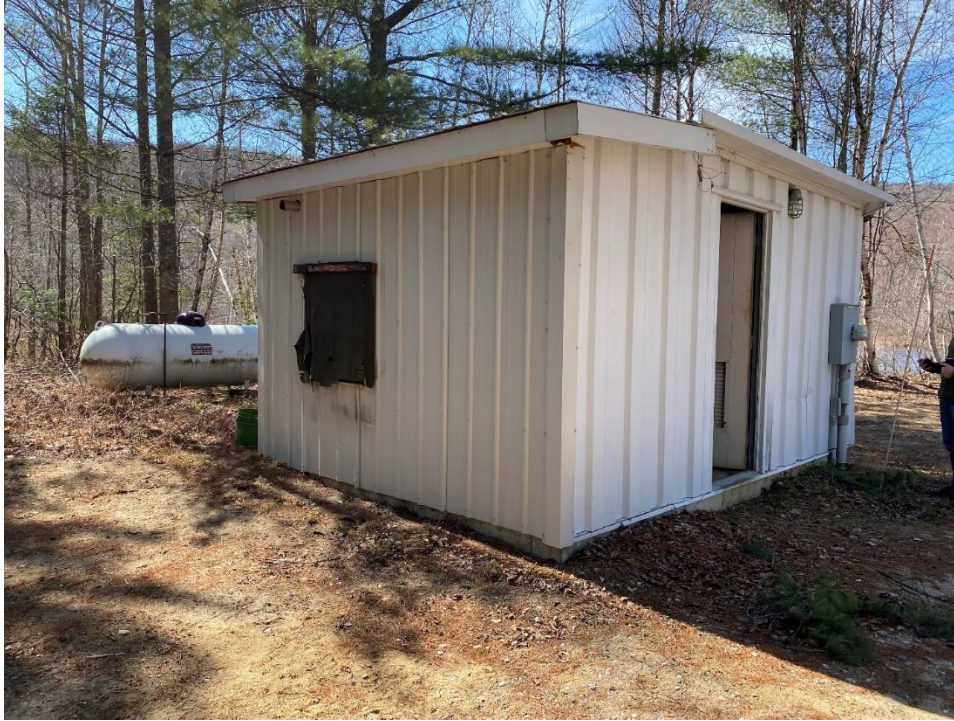
Figure 4-6: Well House #1

The well pump, generator, and controls for both wells are housed within Well House #1. This structure consists of a concrete foundation slab and metal panel walls and roof (Figure 4-6). The walls are comprised of a combination of structural metal panels and a section of metal stud framing where the structure was expanded. The roof is a standing seam metal roof with a very low slope. The walls and roof appear to be in fair condition other than a damaged section of the metal wall panel at the entrance door. Well House #1 is not insulated, barring a few pieces of rigid insulation around the generator exhaust louver, and has no windows.

Well #1 has an on/off combination starter with pump fail alarm. The alarm notifies the dialer at the Hatchery Building. The main panel is in good condition. The sub-panel "P2" and auxiliary power transformer are in poor condition due to age.

A 100kW backup generator is located in the well house. The generator is connected to an automatic transfer switch that provides emergency power to both Well Pump #1 and Well Pump #2 up the road. Staff noted that the generator is more than 20 years old, and it is difficult to maintain and get replacement parts for it. There are intake and exhaust louvers (with backdraft deterrence) in the building for cooling ventilation for the generator engine. These louvers are in poor condition and require replacement. The building has a floor standing portable electric space heater. A 500-gallon propane tank fuels the generator engine.

- Well #1
 - Replace sub-panel P2 and auxiliary power transformer.
 - Replace backup generator.
 - Replace louvers.
- Well #2
 - Replace roof.
 - Replace electrical equipment in poor condition.

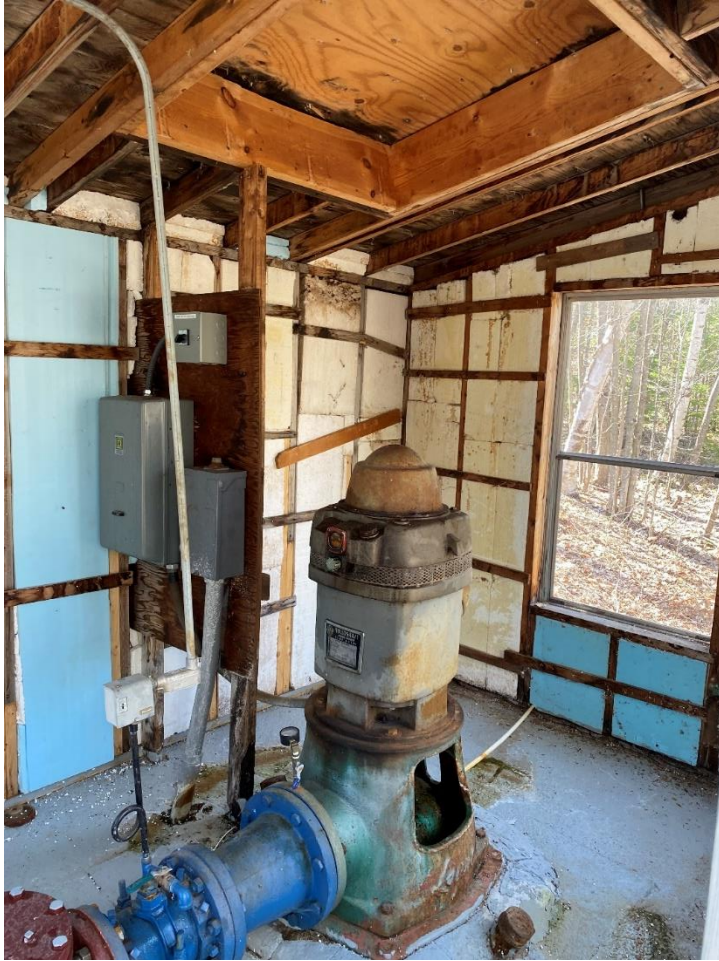
Figure 4-7: Well House #2 Interior

The pump for well #2 is housed within Well House #2, which is constructed of a concrete foundation slab, wood framed walls and roof structure (Figure 4-7). The exterior of the walls are painted wood boards. The roof is a low slope asphalt shingle roof with an access hatch in the middle. The wood framing was observed to be rotted and have noticeable water staining throughout the structure, and the sill plate was rotted and in poor condition. The plywood roof sheathing was observed to be water stained and rotting, with water staining visible on most of the roof rafters. The foundation and building was extended 2 years ago in order to fit a new valve. The walls of this structure are insulated, but no heat or ventilation is present.

Electricity is sub-fed to Well #2 from the utility service at Well #1. Well #2 has an on/off combination starter with pump fail alarm. The electrical equipment is in adequate to poor condition. The pump is connected to the backup generator at Well #1. The well pump has a pump fail alarm that notifies the alarm dialer at the Hatchery Building.

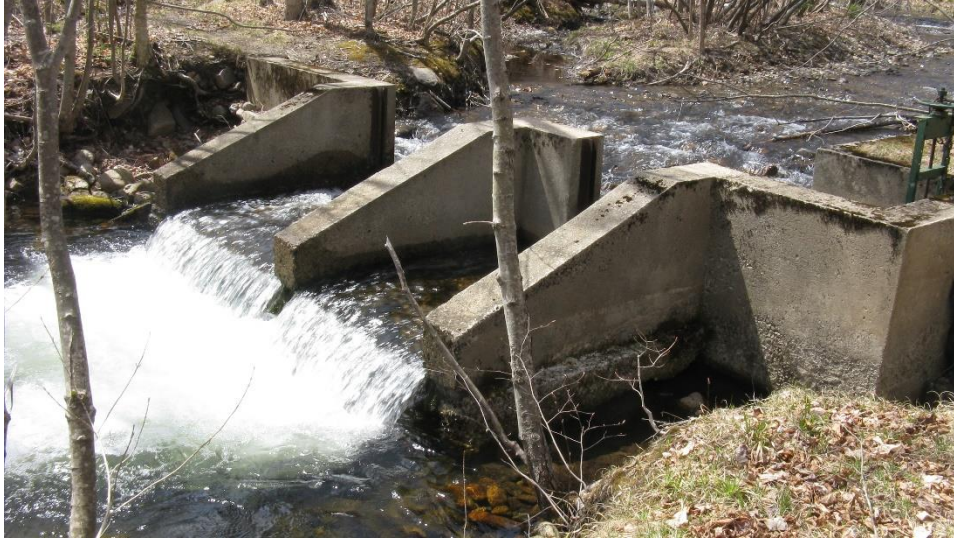
Figure 4-8: Third Brook Diversion and Intake Structure

Access to Third Brook Intake Structure is poor and the valve on the pipe inlet there is in poor condition. The concrete of the diversion/intake is in fair to good condition, with moderate bank erosion downstream of the intake box.

- Third Brook Intake Structure
 - Replace valve on inlet pipe and install stone riprap downstream of intake box.
- West Branch Diversion Dam
 - Improve access to dam pool for sediment removal.

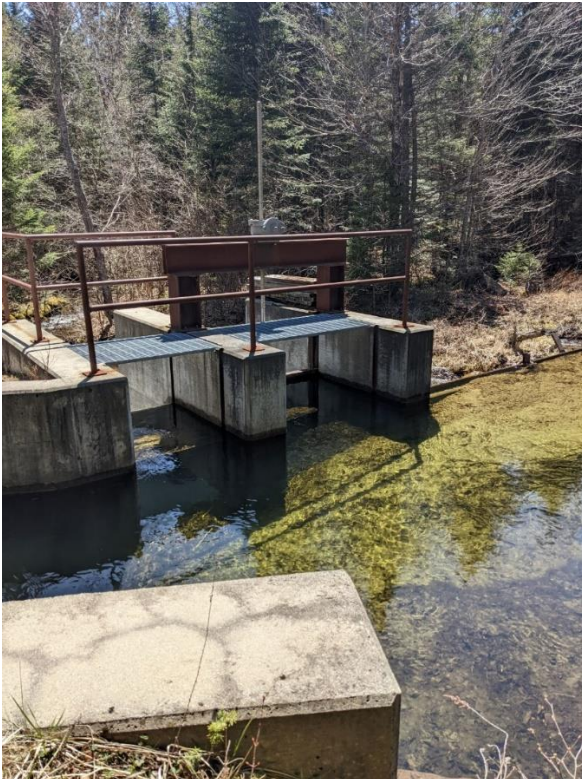
Figure 4-9: Double-Box Concrete Spillway (intake box is to the left of image (river left side))

The Double-Box concrete spillway portion of the West Branch Diversion Dam intake structure was replaced, including dam boards and two slide gates, in 2003 (see Figure 4-9). This structure is a mass concrete wall across the channel, with vertical steel beams cast into the wall that allow timber boards to be slid into them to increase the height of the impoundment. The concrete of the impoundment wall is worn but in fair condition. A portion of the West Branch of the Upper

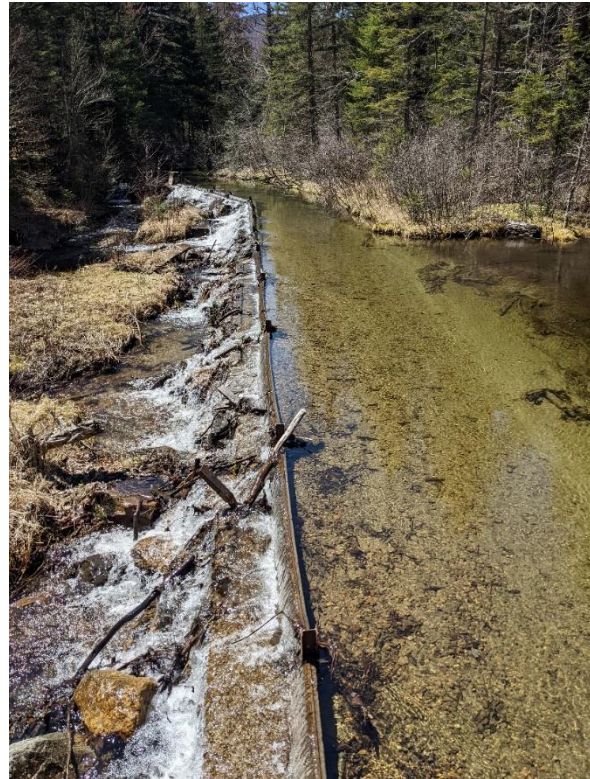
Figure 4-10: West Branch Diversion Dam

Ammonoosuc River (West Branch) is diverted through the recently renovated concrete box intake structure to provide water to Canals A-C. The overflow reenters the West Branch via a channel below the double-box concrete spillway (Figure 4-10). The condition of the concrete diversion structures is good to excellent. There is poor access to the dam pool for sediment removal equipment.

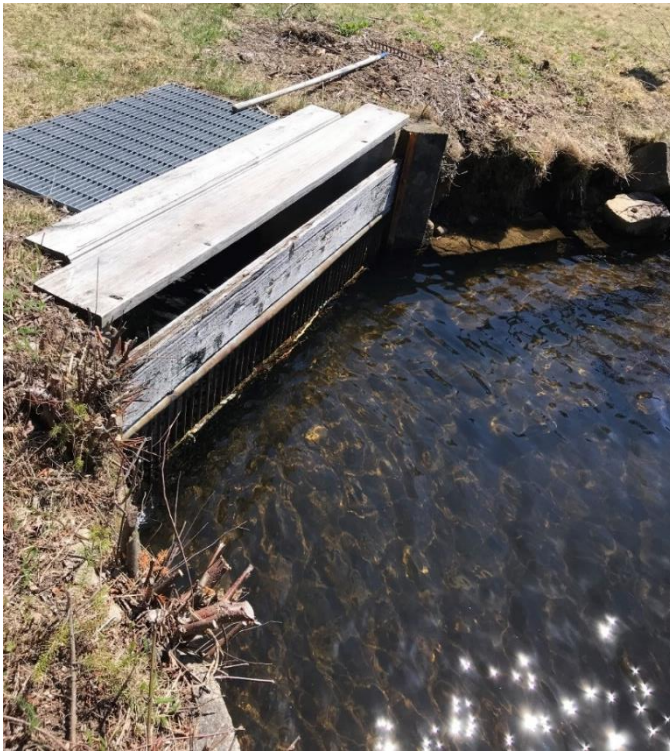
Figure 4-11: Diversion Pond Outlet Structure to Raceways

Diversion Pond is fed by No. 9 Brook and discharges into the West Branch of the Upper Ammonoosuc River. It is a man-made reservoir with an earthen dam that was constructed in 1928 and contains concrete and granite outlets. There is a concrete outlet box that has 20" AC piping to the West Branch Raceways (see Figure 4-11). The structure has a bar screen that must be manually raked clean. The bar screen is accessed by lumber boards placed across the top of the box. The concrete of the box is in fair to good condition. The top and front of the outlet box should be rebuilt to increase safety for staff and the public.

- No. 9 Brook and Diversion Pond
 - Repair Diversion Pond outlet to West Branch Raceway for safety.
 - Repair spillway structure for safety.
 - Replace walkway to West Branch Outlet Box for safety.

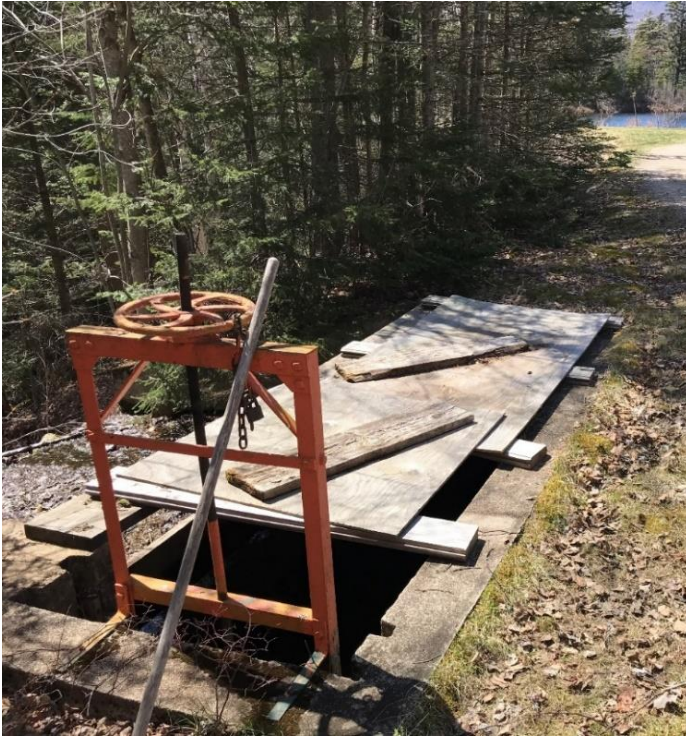
Figure 4-12: Gated Pipeline from Diversion Pond to Raceways

A open concrete box structure on the raceway supply piping approximately 100 feet downstream of the outlet box has a slide gate that can be used to stop or choke flow to the raceways (see Figure 4-12). It has a spillway to the river and is covered with wood planks. The concrete of this structure is in fair condition. The top of this structure should be rebuilt to increase safety for staff and the public.

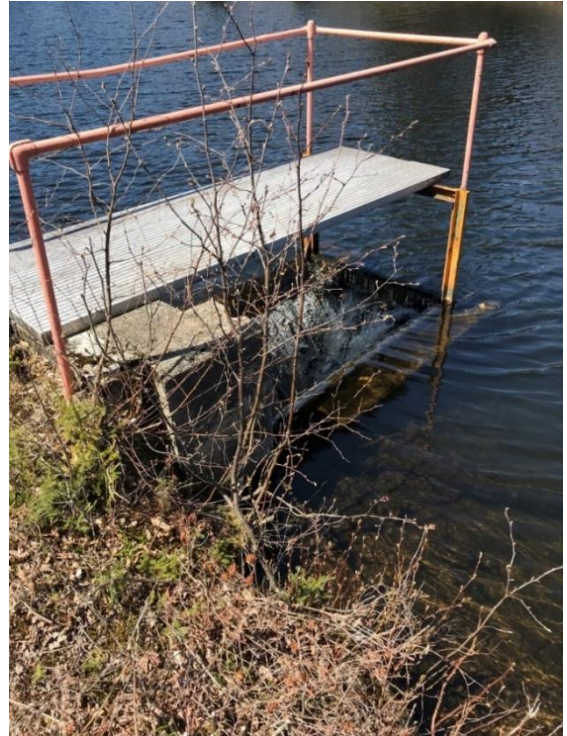
Figure 4-13: Diversion Pond Outlet Structure to River

The second outlet structure in the pond has weir boards and overflows through piping to the river (see Figure 4-13). During some summers there is no overflow to the river. It has an average flow rate of 1,602 gpm with a maximum flow rate of 2,063 gpm and a minimum or low flow of 634 gpm, as per data collection from 2001. The dam failed once and there appeared to be 6 to 8 feet of sediment. The concrete of this outlet box was in fair to good condition, with no need of repairs. The access walkway for personnel should be improved to increase safety for staff and the public.

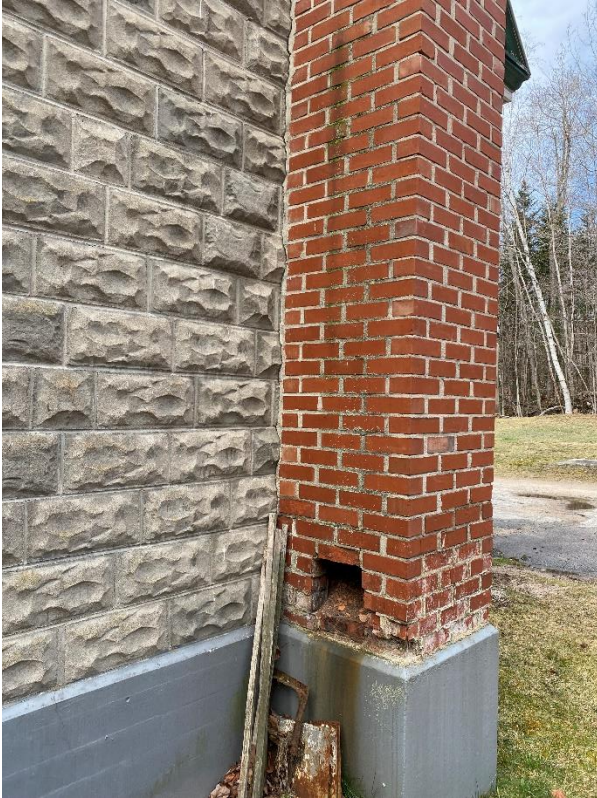
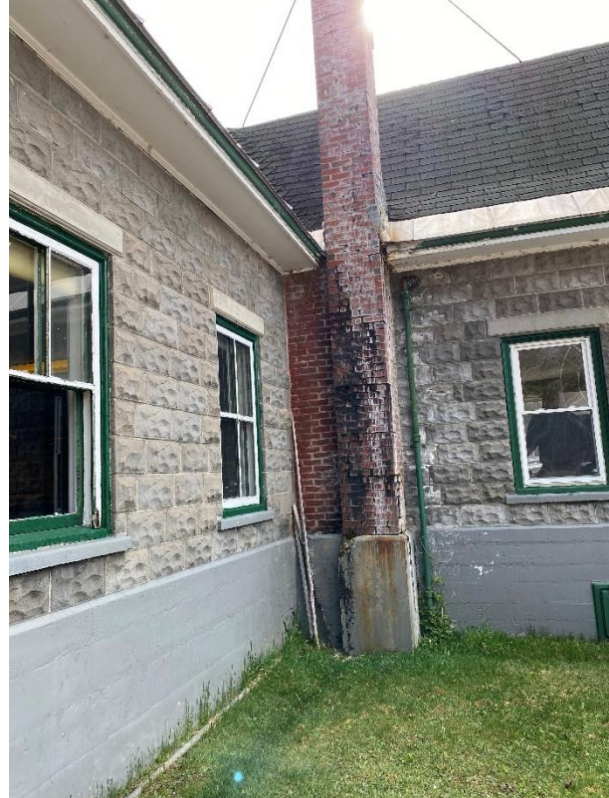
There are two brick chimneys on the building, one on the north side of the boiler room (Figure 5-3) that serves as exhaust from the boiler room equipment, and the other along the west side of the main entrance where the main entrance and hatchery area intersect (Figure 5-4), which serves as exhaust from the mechanical equipment in the basement. Both chimneys were observed to be in poor condition with spalling and missing bricks near the top. The chimney outside the boiler room also appears to be missing a vent or access hatch near the bottom, leaving approximately an 8" by 8" hole and spalling bricks. The chimney along the main entrance was observed to have water stains, missing mortar joints and moss growing from the mortar joints. The flashing around the chimney where it intersects the roof eaves does not appear to direct water away from the chimney and allows rain water and snow melt to run down the faces of the chimney. It was noted that the interior wall finishes around the chimney in the main entrance have had to be replaced due to water damage, and that the water in the basement appears to be coming from the chimney. It is recommended that both chimneys get repointed with localized brick replacement.

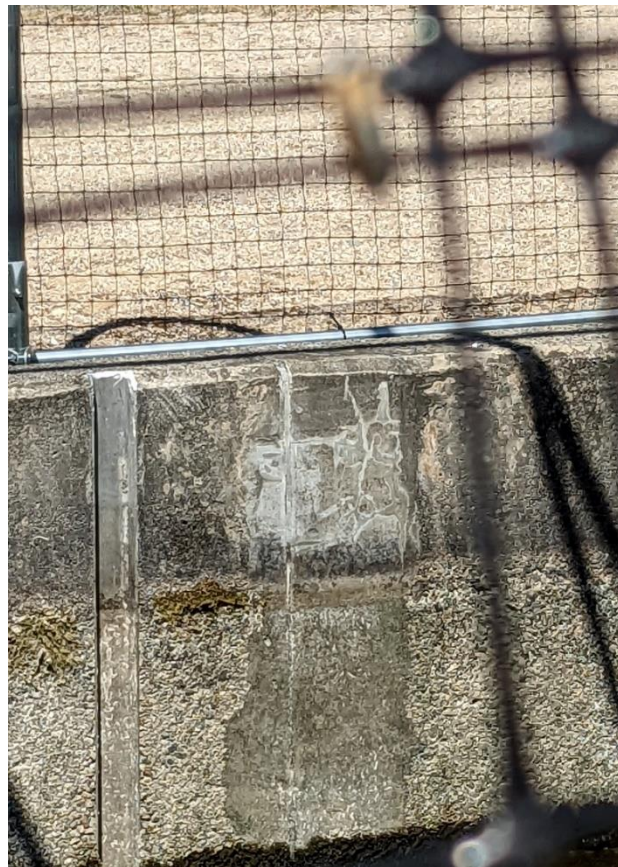
Figure 5-6: Young's Raceway Concrete Condition

The concrete is in fair to good condition, with minor surface cracking of the walls spaced every 10-15 feet. Expansion and contraction joints in the walls have required periodic maintenance to correct spalling and cracking dating from construction (Figure 5-6). Water stops were not used during construction, which have caused leakage and wall lifting. Young's Raceways are protected against predation by metal-framed canopies covered with open netting.

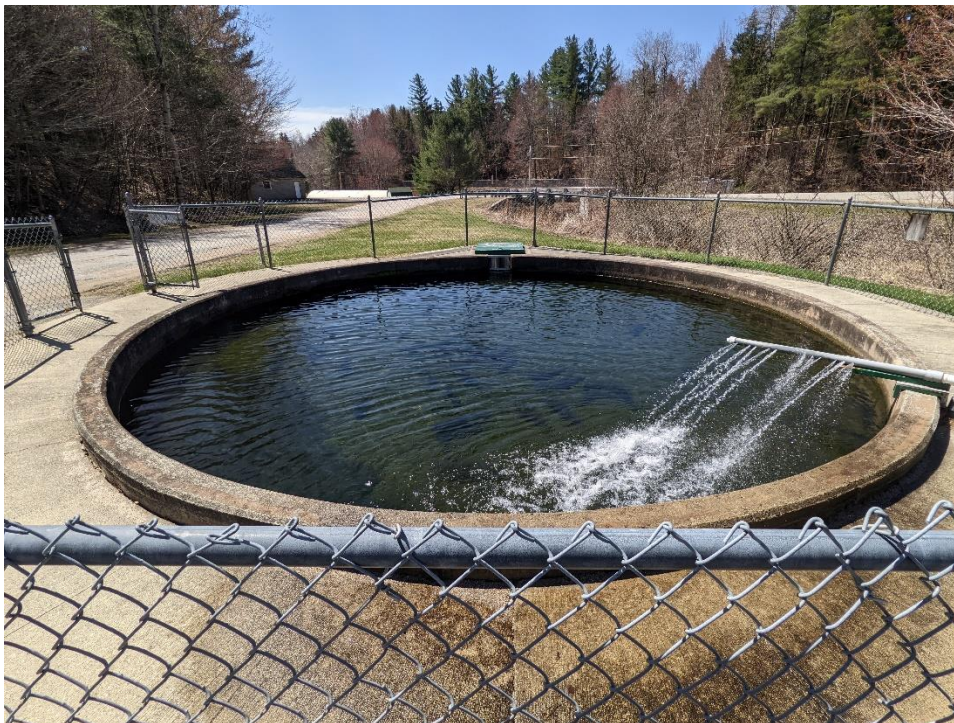
Figure 5-7: Display Pool

The Display Pool is surrounded by a chain-link fence with no overhead protection against predation. This results in the Display Pool experiencing a high magnitude of fish losses due to predation (15-20%), which are difficult to replace. It is recommended that increased predation protection be installed at the Display Pool.

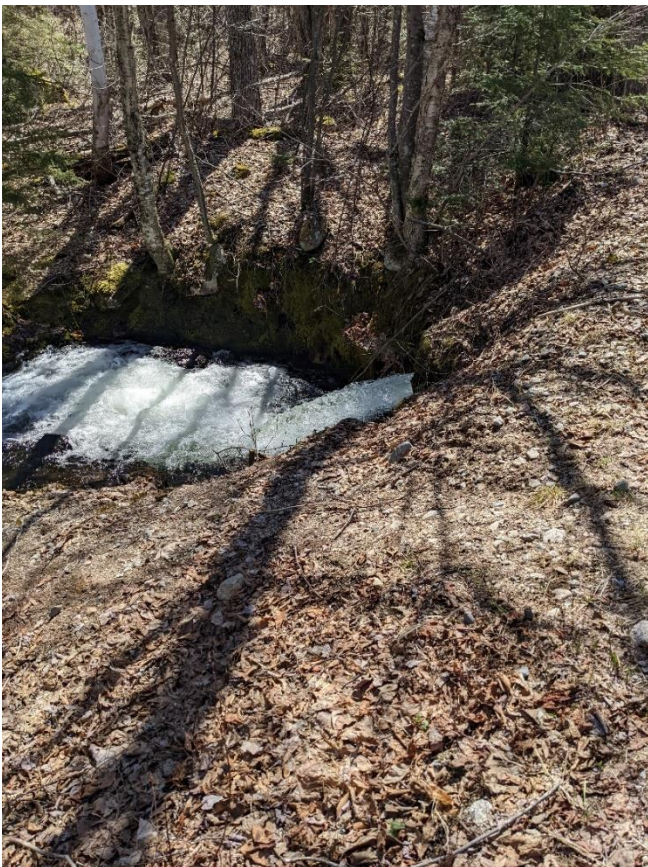
Figure 5-14: Outfall 005 Embankment at End of Canal C

C Canal is like A Canal, with a sandy bottom and stone-sloped embankments. The concrete outlet at the end of Canal C diverts flows to No. 9 Brook and can divert flow to Trap Pond. The outfall pipe to No. 9 Brook is causing erosion that is starting to undermine the adjacent roadway embankment. It is recommended that compacted gravel is installed to fill the eroded embankment and that stone riprap is placed around the toe of slope at the outlet pipe to prevent future erosion (Figure 5-14).

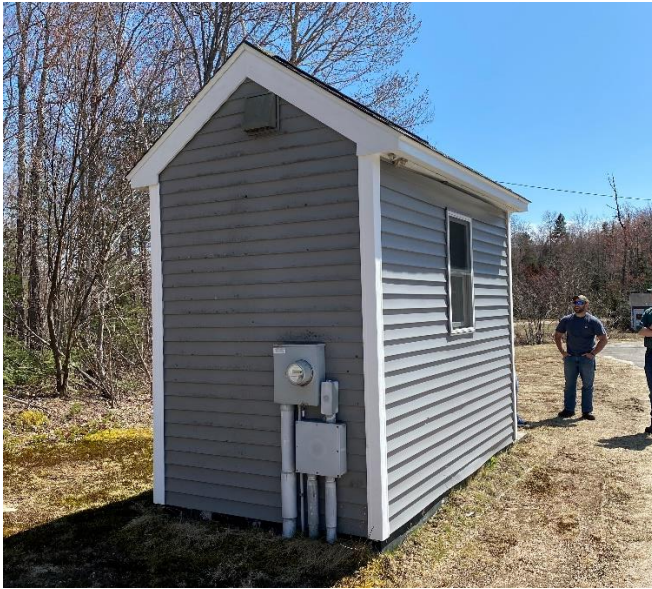
Figure 5-18: West Branch Sampling Shed

West Branch Raceways' effluent main recently had a water flow meter and automatic sampler added in a dry vault covered with a shed (Figure 5-18). This sampling shed appears to be in good condition, other than some minor cracking of the vinyl siding. The shed has a 240/120V, 200A panelboard to provide power to raceway lighting/receptacles, the West Branch Garage, and the Old Salmon Building. The electrical infrastructure is in good condition. The sampling shed is heated by a portable space heater.

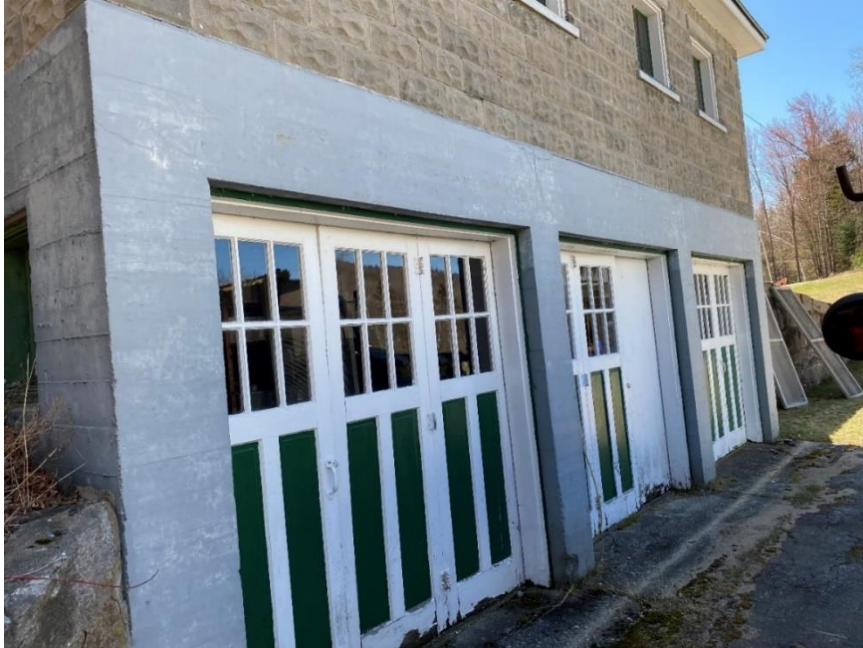
Figure 6-5: Pipe Shop Lower Level Carriage Style Garage Doors

- Some of the glass vision panels are broken;
- One of the door panels has been replaced with a solid wood panel;
- The bottom of the doors are rotting;
- The concrete pad outside the doors is cracking;
- The slider channel is rusted
- The doors are difficult to operate.

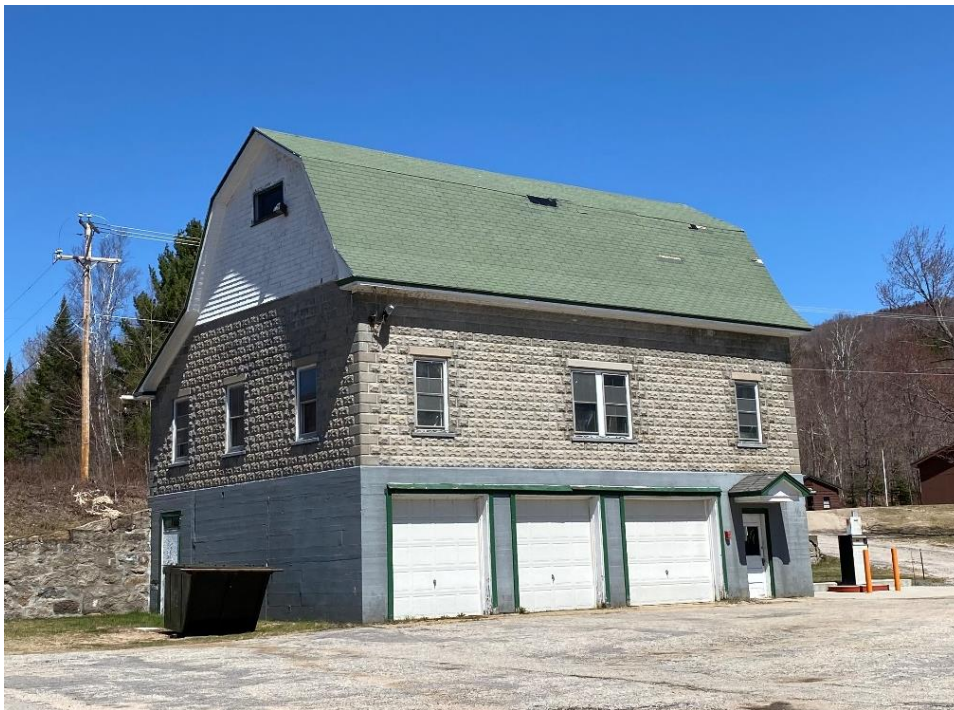
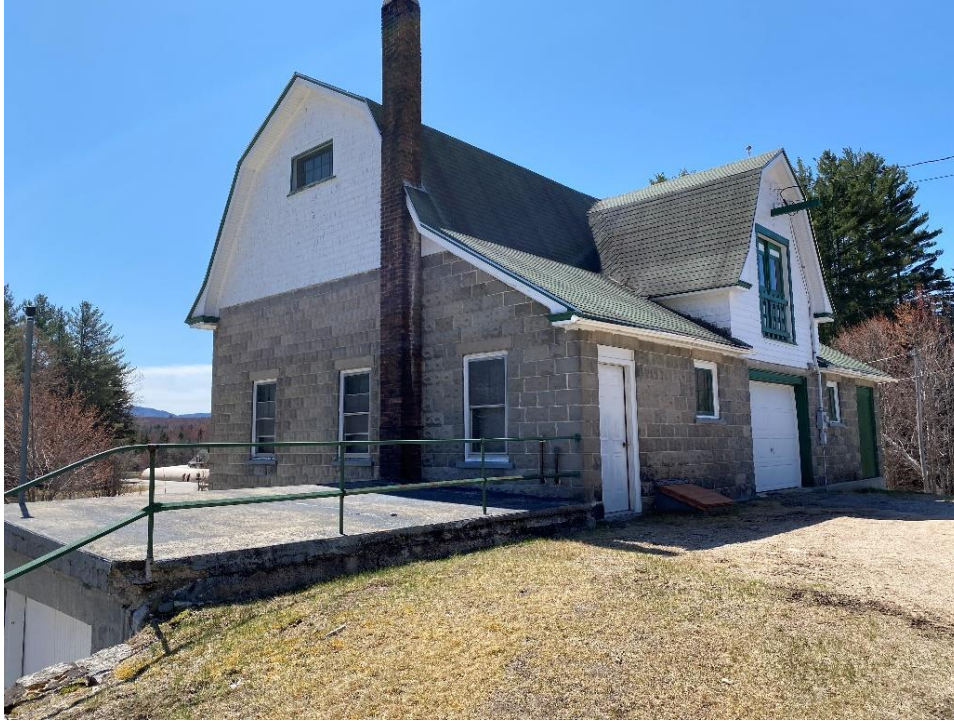
The Carpenter's Shop is constructed with concrete foundation walls at the lower level, concrete second floor, concrete block walls at the second floor, and a wood frame roof and attic floor. The structure appears to be in good condition (Figure 6-10 and Figure 6-11).

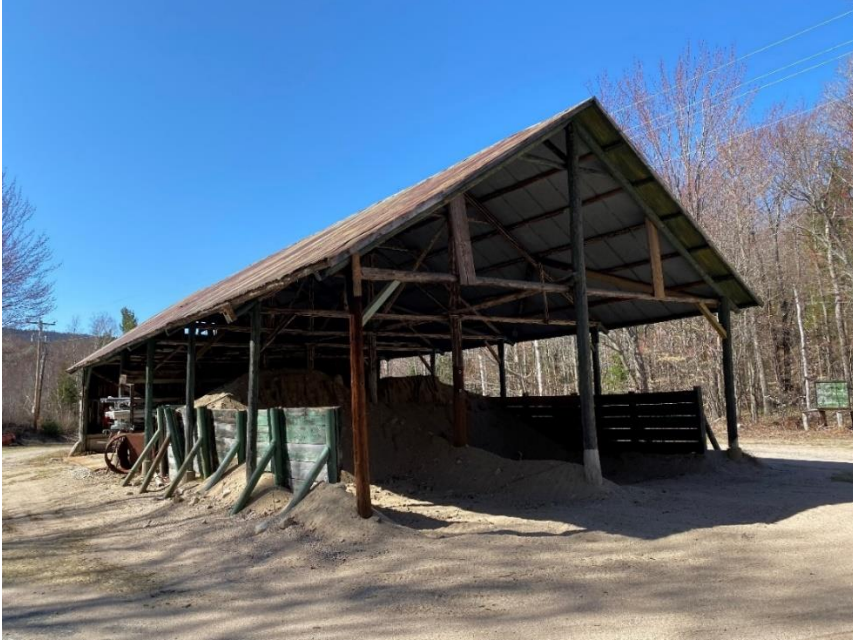
Figure 6-15: Pole Shed

The Pole Shed is a heavy timber structure with a dirt floor, corrugated metal roof, and three open sides that is used for the storage of large pipes, tubes, and sand. Partial height corrals have been set up around the sand storage to keep it from flowing into the rest of the shed. The metal roof is significantly rusted and in poor condition and should be replaced. The heavy timber columns, beams and roof rafters appear to be in good condition. Staff have noted that the open sides allow for water to get into the shed, minimizing what they are able to store in this structure (Figure 6-15).

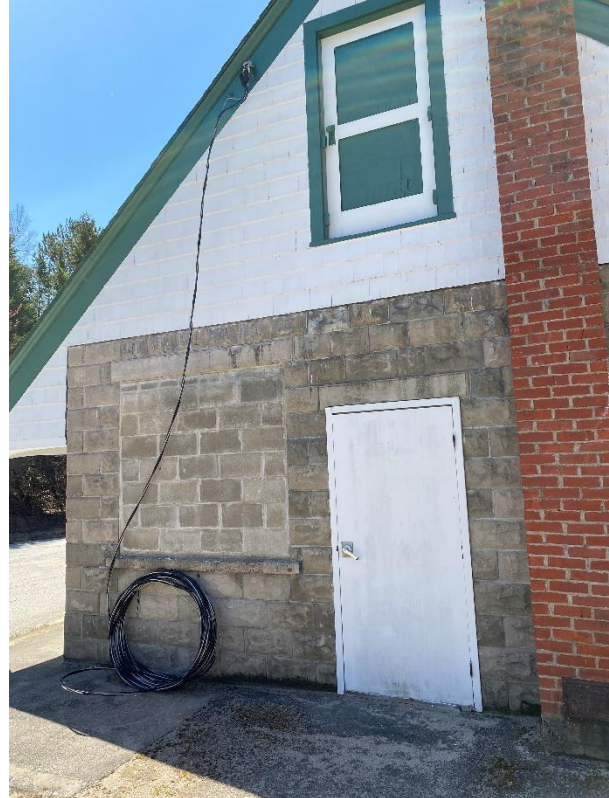
Figure 6-23: Visitor's Center Egress Door and Attic Access

There is an attic space above the visitor's center that has an access door on the north facade. No interior access to the attic was observed, and the attic was not inspected (Figure 6-23).
