Existing Conditions and Facility Evaluations - Milford

POWDER MILL FISH HATCHERY FEASIBILITY
STUDY

New Hampshire Fish and Game Department

May 25, 2023

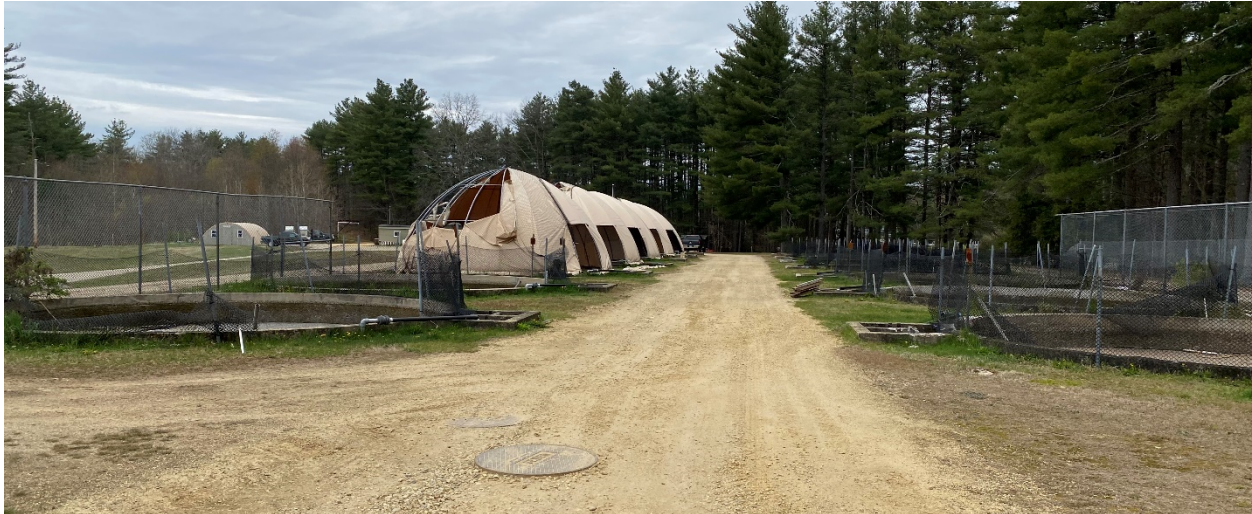
At the upper circular tank area, all but five of the covers have been completely removed, and the covers that remain are in poor condition. The tanks without covers are utilizing netting in the same manner as done in the lower pools. There is an outer chain-link fence around the upper tanks, but this fence does not fully enclose the tanks, so it offers no protection. Upper pools predatory controls are shown in Figure 3-2.

Figure 3-2: Upper Pools Predatory Protection

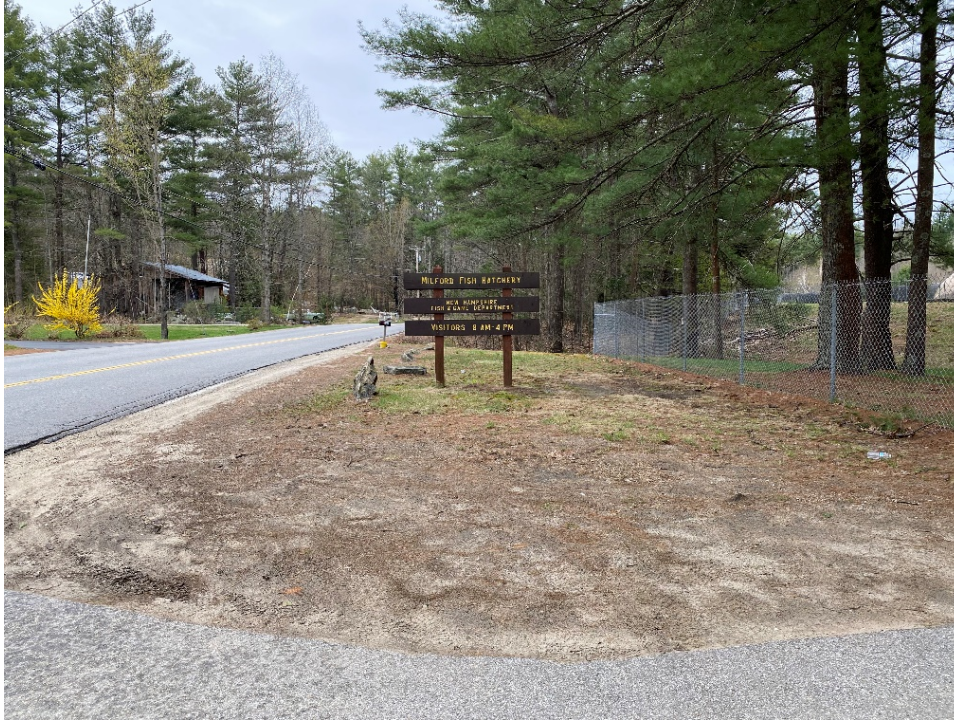
The hatchery does not presently have complete perimeter security fencing, however there is a perimeter fence along River Road (shown in Figure 3-3), with a security gate at the main entrance from River Road. Additionally, each of the entrances leading to the well houses has a security gate. Staff noted that several breaches of the fencing have been made, where holes in the fence were cut.

Figure 3-3: Perimeter Fencing Along River Road

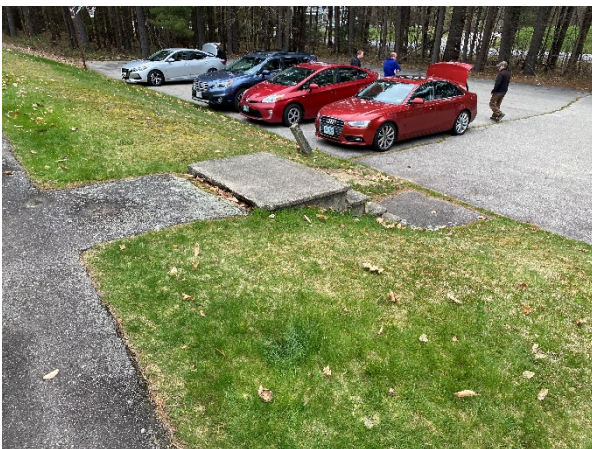
The visitor's parking lot does not have any designated accessible parking spaces, and there are no accessible routes from the visitor parking into the Hatch House where the public spaces are located, as the parking lot is lower than the building, there is only a set of stairs up from the parking lot, but no ramps. Both the main entrance and employee entrance have a step up to get into the building. The concrete stairs between the visitor parking lot and the building appear to be in fair to good condition, but these stairs do not have any handrails, and the transition between the top landing and the asphalt paved walkway is deteriorated and a tripping hazard Figure 3-6. At the main entrance from the visitor's parking, moss was observed to be growing on the walking surfaces along with some minor concrete cracking and spalling, see Figure 3-7. It is recommended to provide ADA compliant access should the building continue to be in service.

Figure 3-6: Stairs from Visitor Parking

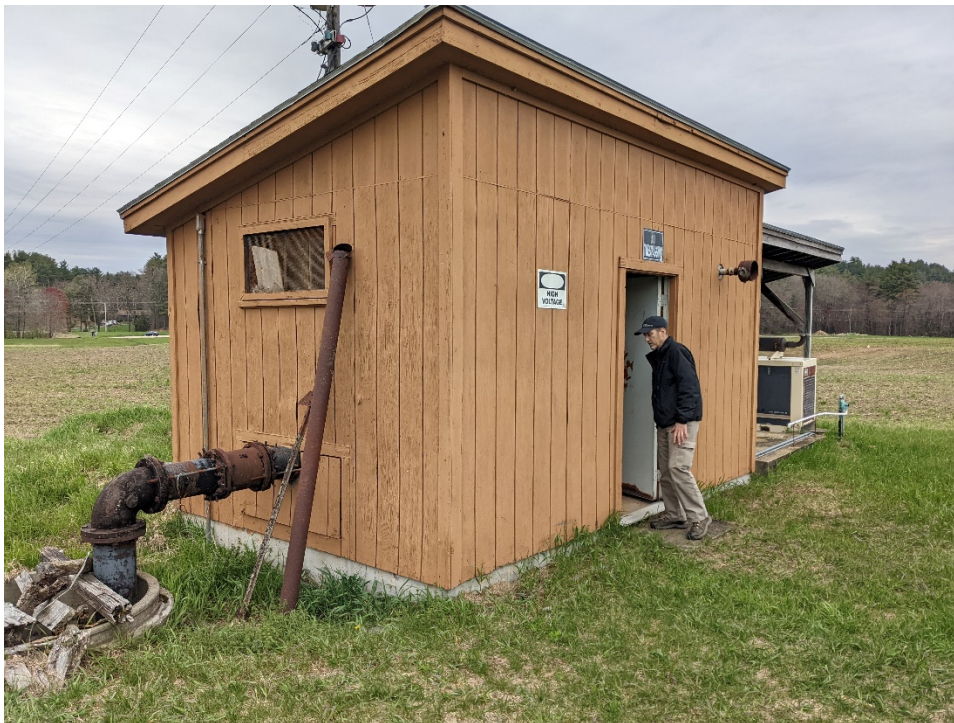
The Field Well (Well No. 5) was replaced in 2020 approximately 30-ft away. Well No. 1's abandoned line-shaft turbine pump and abandoned backup indoor engine drive is in a well house (shown in Figure 4-2) where Field Well controls now reside. Well No. 1 was required to be replaced due to high iron levels and declining output.

Figure 4-2: Old Well (No. 1) Building

- It is recommended that new well locations or new source water supplies be explored to replace this well.
- Backup generator should be replaced in the near future if this well continues to produce an adequate supply of water.
- Remove old and abandoned electrical systems in the well house to improve safety.

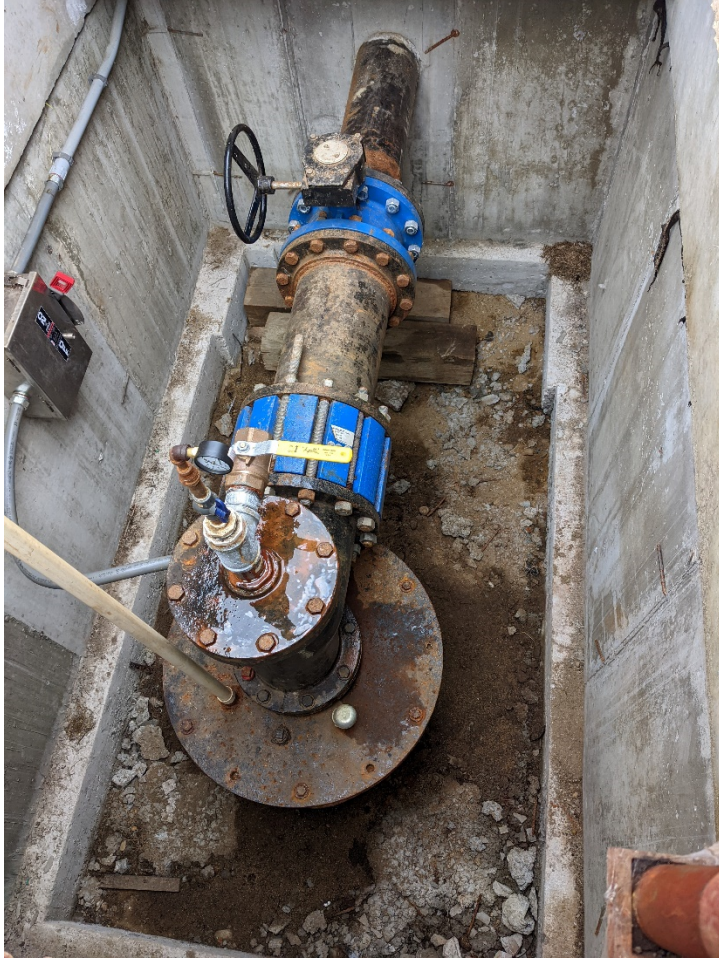
The Field Well pump is a submersible turbine pump. The vaulted discharge piping has a pressure gage, non-slam wafer check valve and butterfly valve, shown in Figure 4-3. Initial capacity was roughly 600 gpm; but has declined to 400 to 550 gpm also due to high levels of iron. It was chemically cleaned in summer of 2022, initially increasing capacity approximately 300 gpm, although its water level dropped from 30 to 40 ft down in three months. It is suspected the increase is not sustainable long term. It is recommended that new well locations or new source water supplies be explored to replace this well.

Figure 4-3: Field Well (No. 5) Inside Concrete Vault (in use)

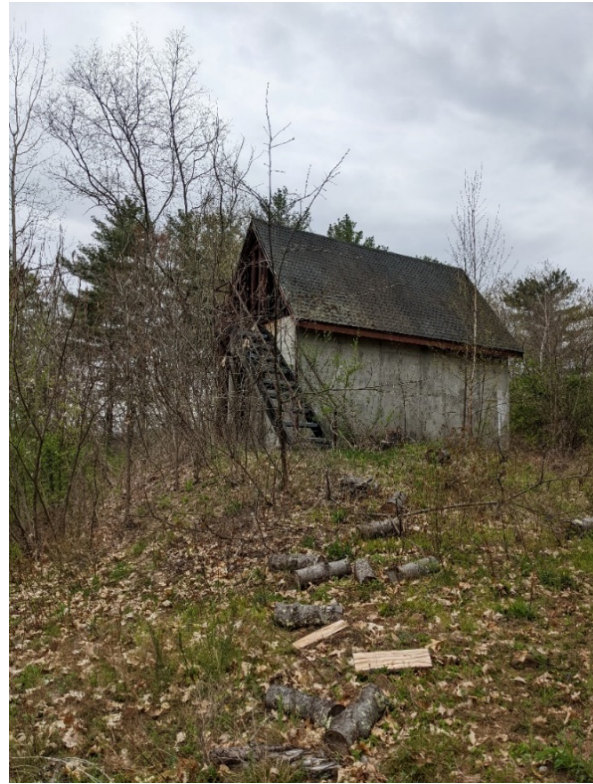
The aeration/degassing headbox replaced an aspiration system on a hill 30 feet to its north. The old aspiration system is no longer in use and has been abandoned in place inside the building it was housed within. The old aspirator building structure appears to still be fair condition, but it is recommended that the equipment and building be removed as part of any renovations, see Figure 4-7.

Figure 4-7: Older Aspiration System Building (no longer in use)

- The old aspirator building structure appears to still be fair condition, but it is recommended that the equipment and building be removed as part of any renovations.
- Fix cracked pipeline that is branched to the truck fill to stop slow leak under regular maintenance activities.
- Additional lighting is needed in this area.

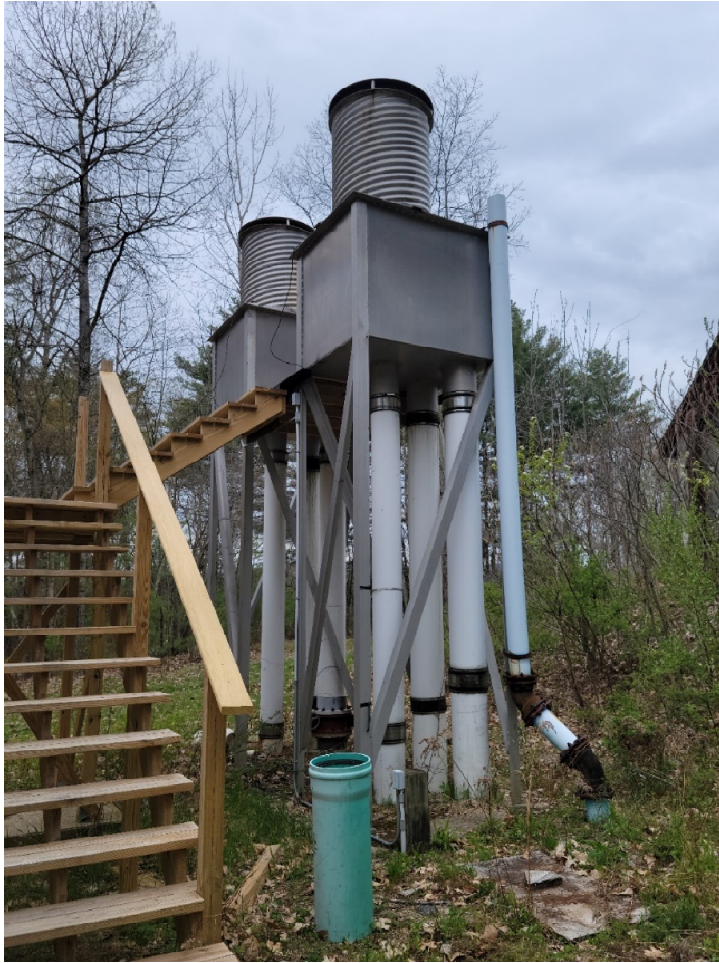
Field Well water is higher in iron. The Field Well column packing gets orange faster than the River Well column packing. Because of the minerals, both packed columns are cleaned every year or two. Also, when feasible, when the well pumps are restarted after having been off, such as for well cleaning, the piping is flushed to deter surging depositional material from the wells or their force-mains into the columns.

Figure 4-8: Aeration/Degassing Headbox

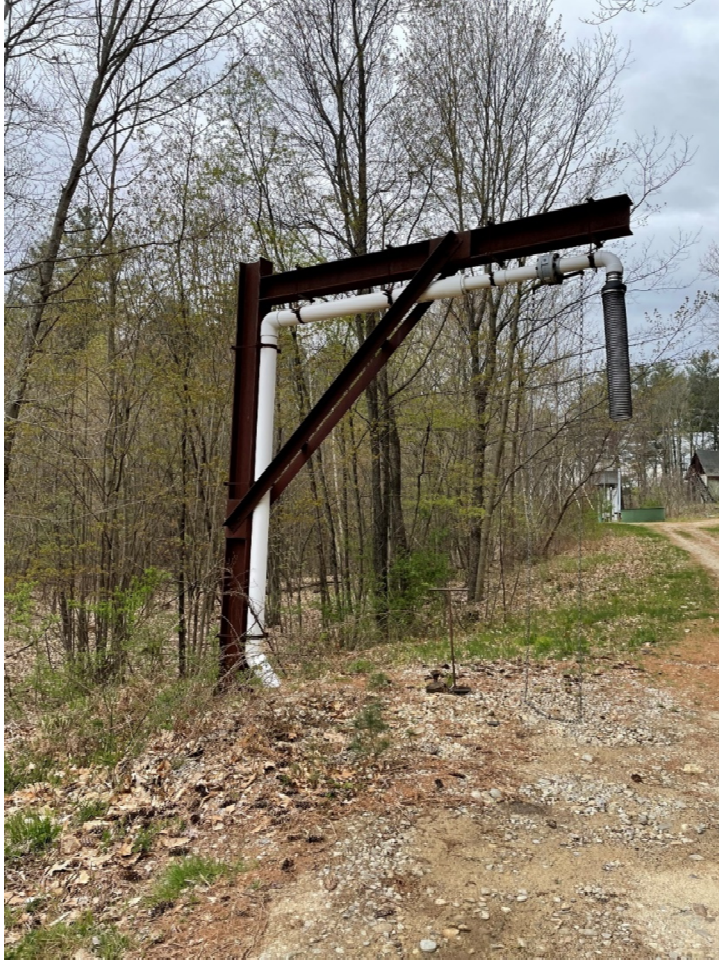
The headtanks have water level alarms. Water leaves the two headtanks and mixes into one PVC pipeline installed in 2011 to the Hatch House and outdoor round tanks. On the way, the pipeline is branched to a truck fill (Figure 4-9), which has a cracked pipe that slowly leaks. It is recommended that this be fixed during regular maintenance activities.

Figure 4-9: Truck Fill with Slow Exposed Leak

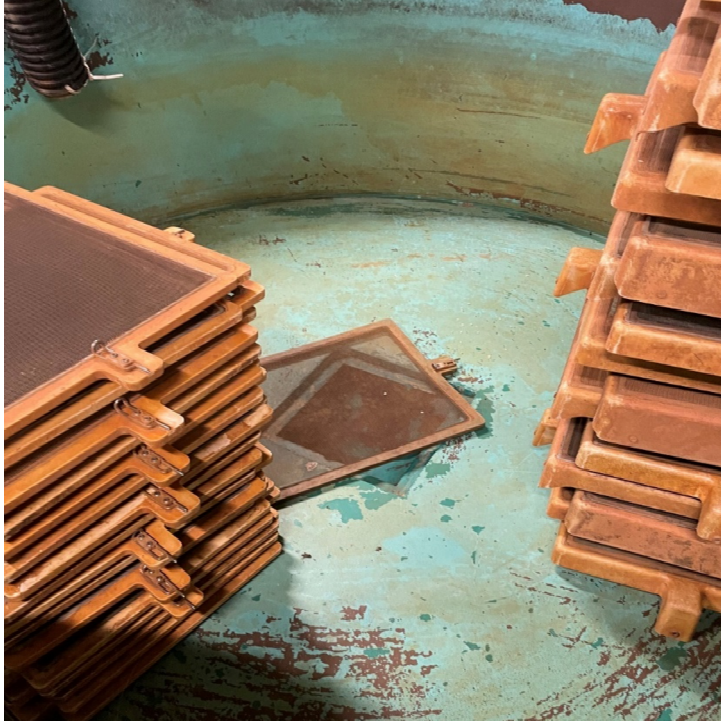
The Tank Room also has one oval fiberglass tank approximately 4-ft x 8-ft and four 6-ft-dia. operated with 2-ft water depth. For the earliest rearing, each round tank flows from 1 to 6 gpm and later flow is increased to 20 gpm. These tanks have packed columns and oxygen like the linear tanks. The indoor linear and indoor round tanks were painted brown in the 1980's. The paint is in poor condition, worse on the tank interiors than exteriors. The interior of one of the round tanks is shown in Figure 5-3. It is recommended that these be recoated with epoxy.

Figure 5-3: Once-brown Round Tank Bottom and Incubator Parts Water-stained Orange

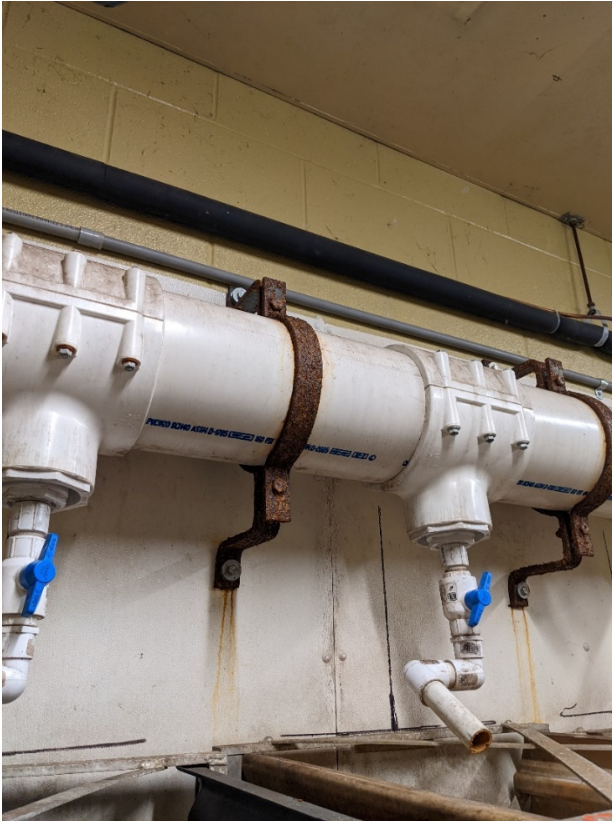
The Hatch House is a one-story masonry block building with interior masonry-block partition walls and a flat roof made of galvanized roof decking supported by steel roof trusses. The roof is prone to leaking, with known leaks in the lounge area and in the furnace/mechanical room. The hatchery area is largely open. No significant deterioration of the building foundation, walls or roof support system was noted. Due to lack of working HVAC systems, in the summer months the Hatch House experiences high temperatures and humidity, resulting in mold. The incubation room is particularly prone and shows significant rusting of the steel hangers supporting incubator piping. Hatchery

Figure 5-5: Rusting Hangers in Incubation Room

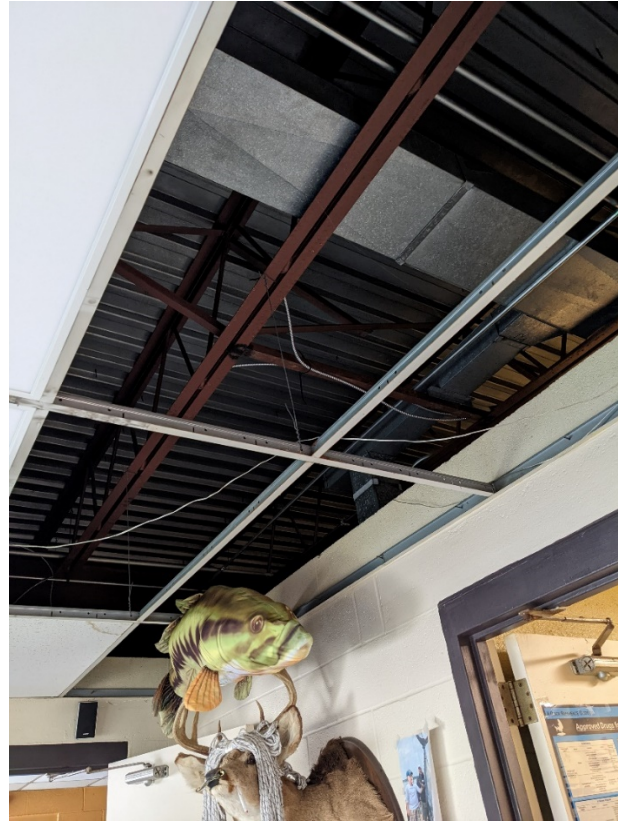
personnel noted that mold is also an issue in the open hatchery area, due to inadequate ventilation. An area of the suspended ceiling in the lounge area near the front of the building had been removed due to roof leakage and resulting mold. The concrete of the rectangular rearing tanks is in good condition.

Figure 5-6: Area of Roof Leak in Lounge Area, with Removal of Suspended Ceiling

The Hatch House has a flat membrane roof on metal decking supported by steel roof trusses. The roof overhangs the exterior wall approximately 2 feet, which is supported on a series of pilasters extruding from the walls. The edges of the roof are closed off by a shallow parapet. The exact age of the roof is unknown, but staff believe the roof to be over 30 years old, which is well past the life expectancy for a membrane flat roof. Based on the extent of roof leakage observed and noted by staff, it is recommended that the roof be completely replaced.

It is recommended that a full inspection and survey of the roof be performed in order to provide a complete design for the roof replacement.

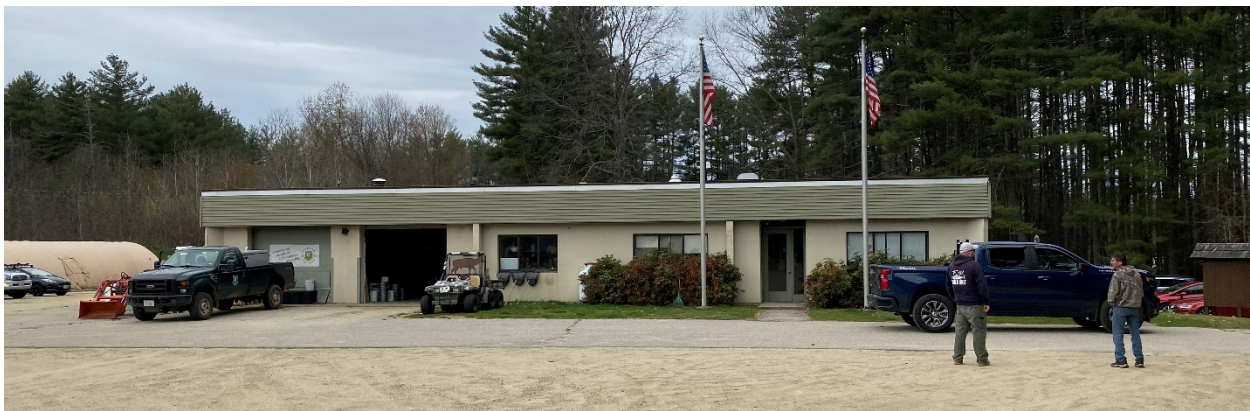
The exterior walls consist of concrete masonry units (CMU) with an exterior stucco finish. The CMU and stucco appear to be in good condition see Figure 5-7. There are no details on the existing building construction, so it is unknown if the exterior stucco system has insulating properties. However, based on the amount of moisture that builds up on the interior face of the exterior walls, especially in the tank room, it is likely that the exterior stucco does not provide adequate insulation for the exterior walls. It is recommended that the exterior finish be removed and replaced with a better insulating finish system.

Figure 5-7: East Facade of Hatchery Building

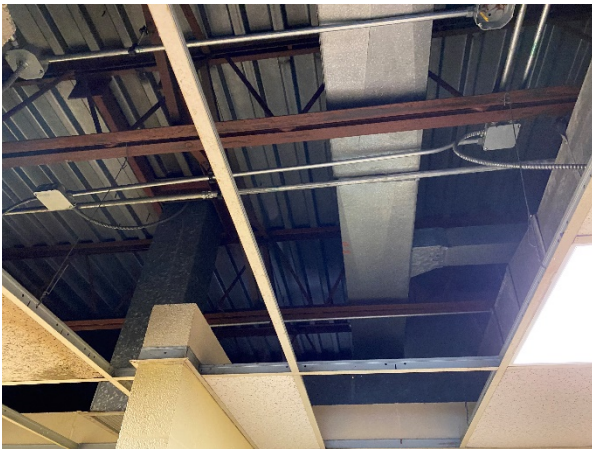
The interior finishes consist typically of vinyl tile flooring in the public and staff areas; painted concrete floors in the maintenance, hatchery and back of house rooms; painted CMU walls; and acoustic drop ceilings or exposed roof deck. The floors and walls appear to be in good condition. The ceiling was in fair to poor condition, with missing tiles where they had been removed due to water damage from the leaking roof, and other with holes in them where old lights or fire alarm equipment had been removed, see Figure 5-10 and Figure 5-11.

Figure 5-10: Missing Ceiling Tiles in Crew Area

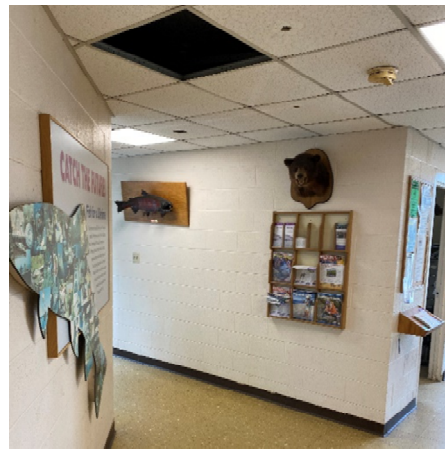
Figure 5-11: Missing Ceiling Tiles and Holes in Public Areas

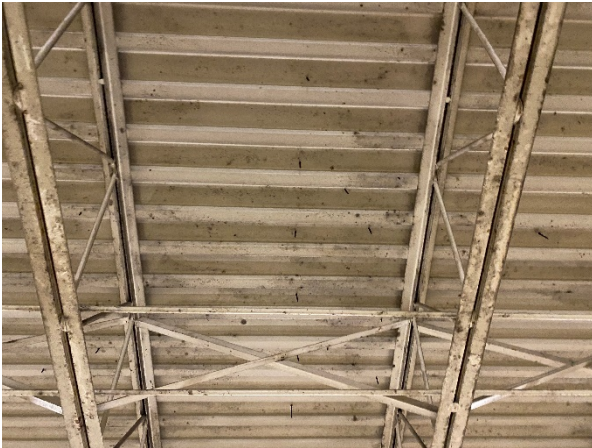
In the tank room, staff noted that black mold has been an on-going issue on both the ceiling and on the walls, due to improper air circulation and insulation, see Figure 5-12 and Figure 5-13. Due to the issues with black mold, it is recommended that all “soft” interior finishes, such as drywall and acoustic ceiling tiles be removed and the spaces be “gutted” back to structural or “hard” surfaces such as CMU walls and the underside of the roof deck, so that proper cleaning of the surfaces can be performed. New interior finishes can be installed after the black mold remediation, roof replacement, insulation, and HVAC upgrades.

Figure 5-12: Black Mold Spots on ceiling in tank room

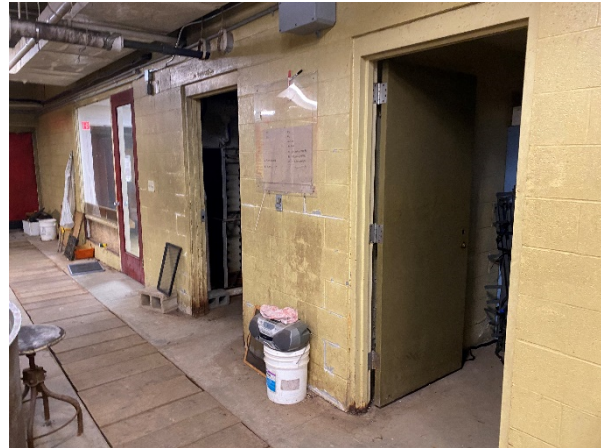
Figure 5-13: Black Mold Stains on walls in tank room

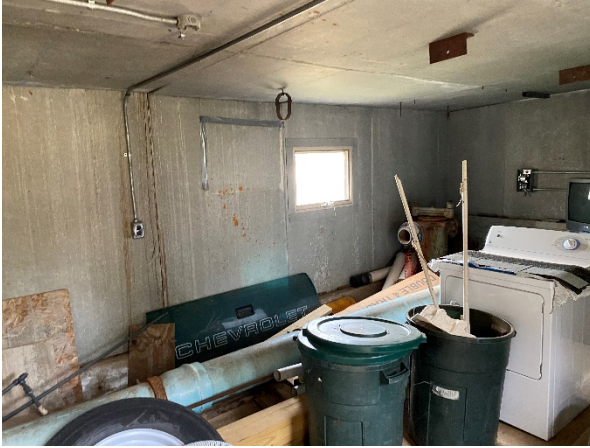
is a low slope shed style roof. The exterior siding appears to be in good condition. The interior asbestos panels have water stains from roof leaks, and various support angles and hangers that are no longer used are rusted (Figure 5-19). The roof was not visible during the site visit, but based on the extent of water damage inside, the roof is believed to be in poor condition. The exterior door to the addition is wood, and the bottom half is rotted (Figure 5-20).

Figure 5-19: Interior of Addition showing water stains and rusted hangers

It is recommended that the roof of the addition be replaced along with the roof over the main building. Due to the extent of water damage to the asbestos panels, it is recommended that they be abated, and replaced with gypsum wall board, and additional wall insulation should be installed.

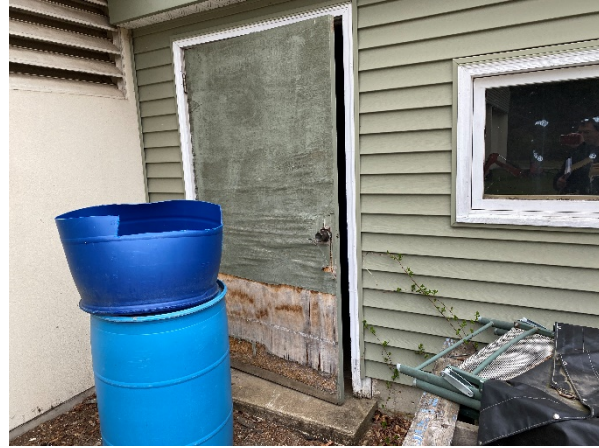
Figure 5-20: Rotted door to addition

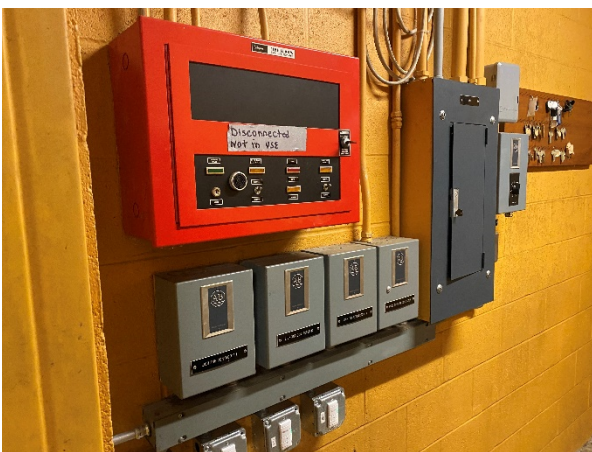
The electrical room has several electrical or control systems (Figure 5-23 and Figure 5-24) that have been abandoned and no longer in use. Such equipment may include a fire alarm panel, a power failure alarm system, an intercom control system, and emergency power system including generator, transfer switch, and load panel, a lighting control time clock, and a high-water temperature alarm system. Similarly, the building addition has an old panelboard and several lighting contactors. The abandoned systems should be removed to improve clarity on system operation/functionality, and to allow for efficient future modernization.

Figure 5-23: Electrical Room North Wall with Disconnected Fire Alarm Panel

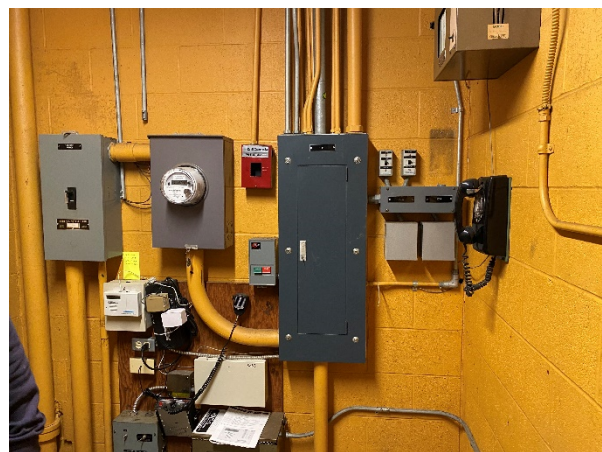
Figure 5-24: Electrical Room East Wall

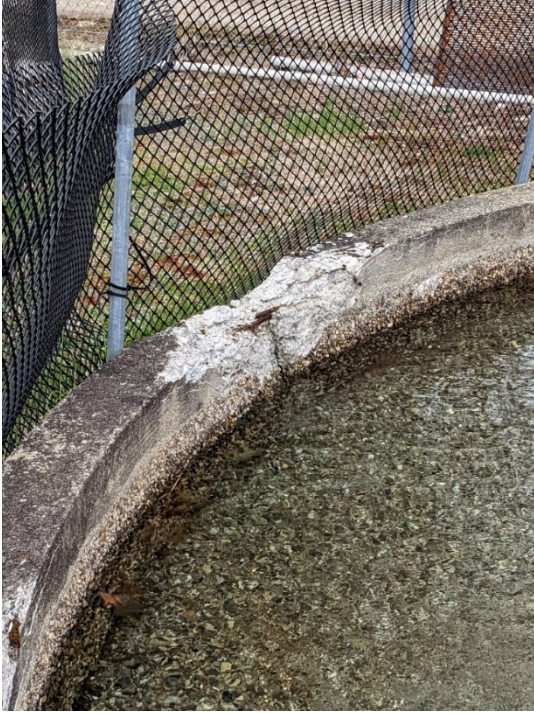
The concrete of the circular tanks is in fair to poor condition, with spalls and exposed reinforcing at the top of the walls and significant loss of mortar with exposed aggregate below the water line of the walls and slabs, see Figure 5-30. The outfall boxes are also deteriorated with efflorescence, spalling and cracking resulting in exposed rebar. The circular tanks and outfall boxes in the worst condition have concrete repairs done by staff each year, see Figure 5-31 and Figure 5-32, but ongoing deterioration makes it difficult for staff to keep all of the tanks in usable condition. The circular tanks in the upper area are generally in the worst condition, with mortar loss on the walls and slabs up to ½" deep on many of the tanks.

Figure 5-30: Typical Concrete Deterioration Upper Area

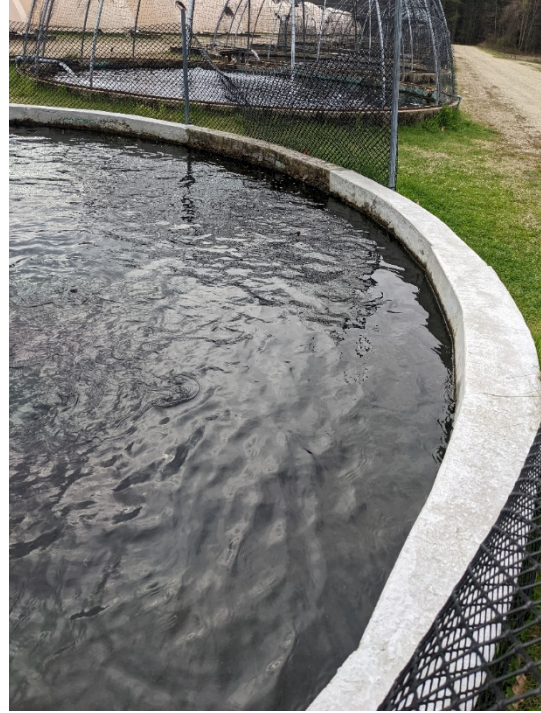
Figure 5-31: Previous Concrete Repair at Lower Area Tank Walls (Show Tank)

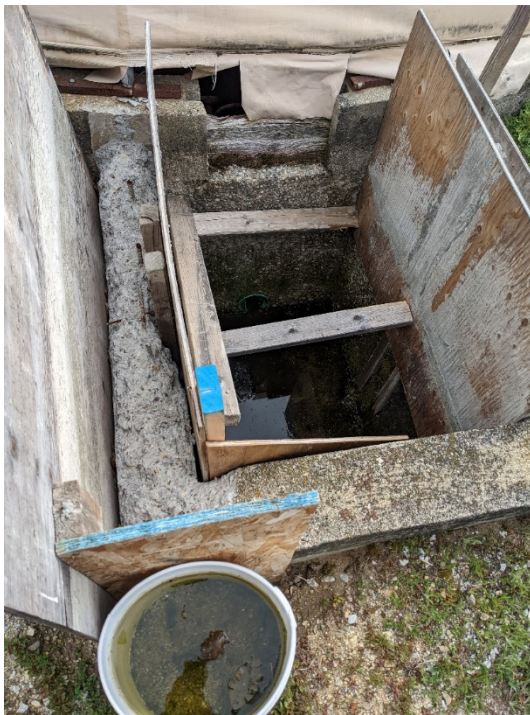
Figure 5-32: In-Process Concrete Repairs of Circular Tank Outlet Box

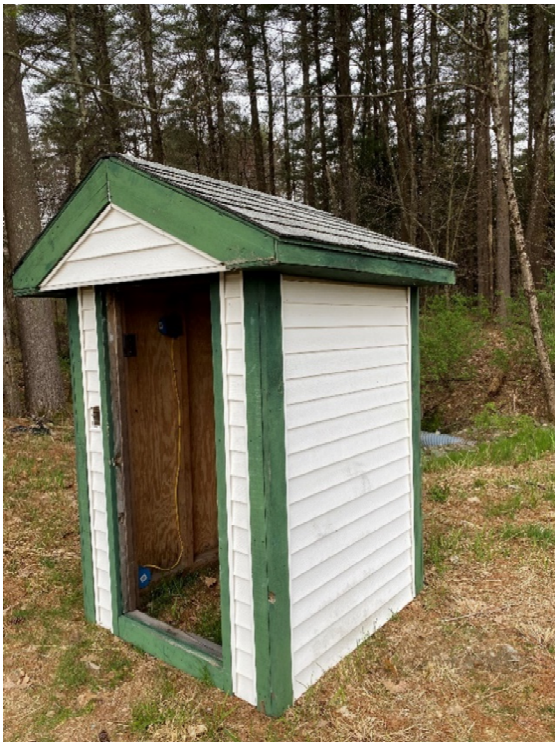
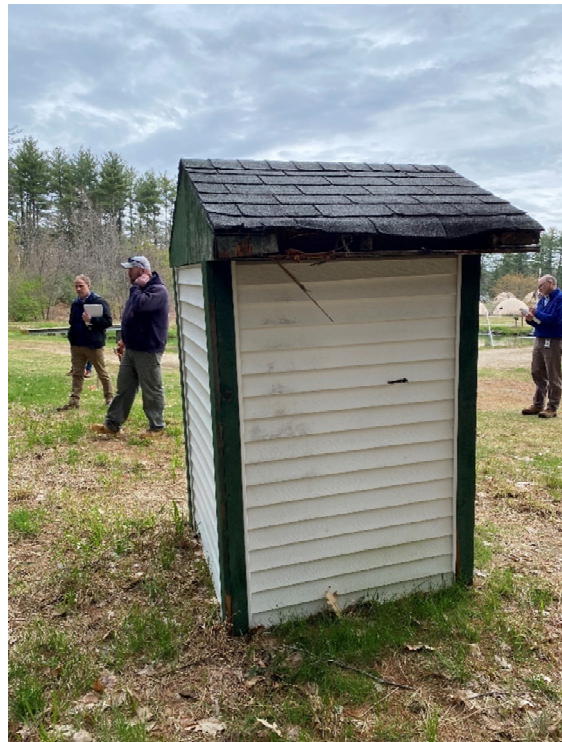
The facility has one permitted outfall located just southwest of the earthen ponds. A mobile composite sampler and prefabricated protective shed was added in summer of 2022. At the time of the site visit in May 2022, the shed was missing the door, and the left side roof fascia was rotted and fallen off (Figure 5-35 and Figure 5-36). A door and light were added to the shed after the condition assessment site visit occurred. It is recommended that the roof fascia be fixed.

Figure 5-35: Sampling Shed -Front/Right (May 2022) **Figure 5-36: Sampling Shed - Rear / Left (May 2022)**
