Existing Conditions and Facility Evaluations – New Hampton

POWDER MILL FISH HATCHERY FEASIBILITY
STUDY

New Hampshire Fish and Game Department

May 25, 2023

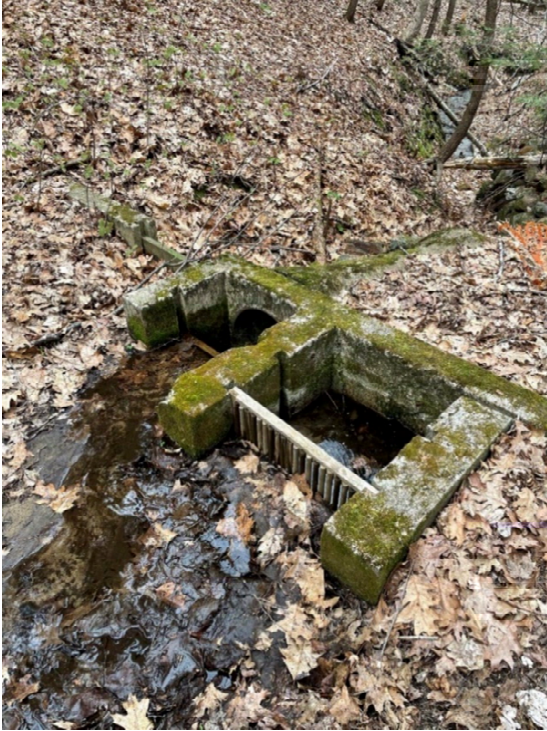
Figure 4-1: Major Springs' Typical Stoplog Structure

A couple of concrete structures in the ravine have slots for bar screens or stoplogs and pipe connections. A typical structure is shown in Figure 4-1. No drawings of these springs, structures, or pipes have been found. The concrete condition of these structures is fair, with minor cracking and spalling and some vegetation growth. One of the structure's pipe connections appears to be cast iron. The other structure's pipe connection appears to be 16-inch asbestos-cement (AC). At least one of the pipes leads to Raceway A-4; but this line is assumed to be abandoned.

It is recommended that the concrete structures in the ravine be cleaned free of moss and resurfaced to maintain the concrete for as long as possible. Bar screens, stoplogs, pipe connections, and valves should be replaced if defective. It is recommended that the pipes that carry source water be inspected. It is recommended that the Spring Pool be cleared of sediment on a yearly basis, as this buildup of sediment and leaves can contribute to maintenance issues downstream if not properly maintained.

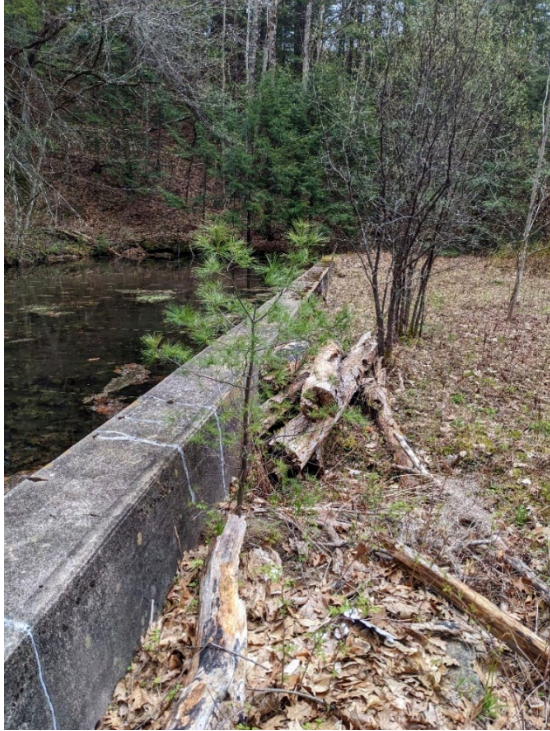
Figure 4-3: Sealed Surface Cracks in Spring Pool

The concrete dam is in fair to good condition. There are surface cracks spaced at approximately 2- to 3-feet along its length (Figure 4-3). Most of the cracks have been sealed. There were no significant areas of spalling or loss of concrete along the length of the dam. The dam impounds a relatively shallow (2- to 3-foot max depth) area of water from the creek above. There is some leakage underneath the dam, but it appears to be minimal and does not pose a threat to the dam integrity.

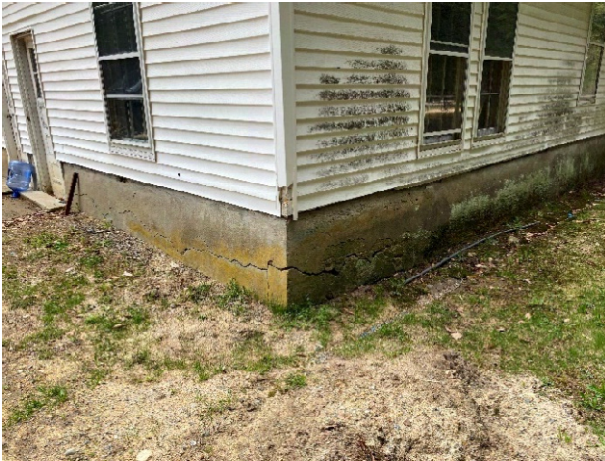
Figure 5-6: SE Corner Foundation Cracks Hatch House Main Production Rearing Area

The Hatchery Building consists of a concrete foundation and slab-on-grade, with a wood-framed first floor, attic, and roof structure. The exterior foundation walls of the hatchery building have cracks and periodically get water leakage from outside during heavy rains or high groundwater conditions. The attic is supported by a series of three round steel columns located between each set of concrete tanks, supporting wood beams running the length of the hatchery building. The columns and wood framing appears to be in good condition (Figure 5-6 and Figure 5-7).

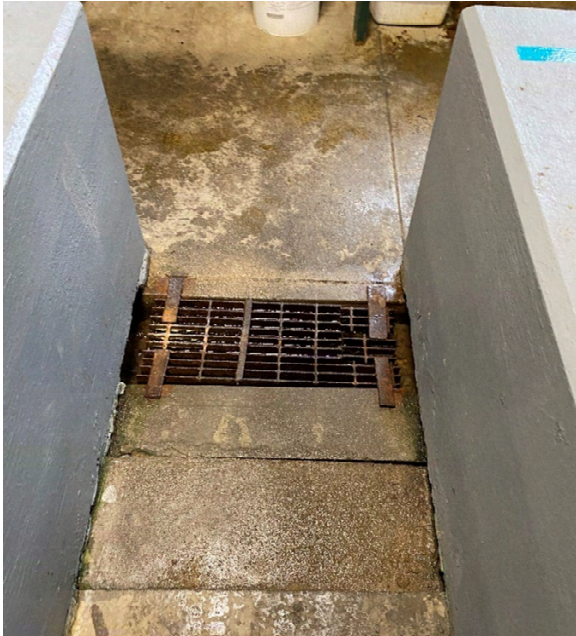
Figure 5-8: Drainage Channels

The concrete of the rearing tanks and concrete floor slab appear to be in good condition. The concrete tanks drain into a series of 12-inch wide by 5-inch deep drainage channels that are cut into the floor slab. This cleaning channels are covered by steel grating (Figure 5-8). Directly adjacent is an overflow channel which is covered with a concrete cover. Staff noted that when they drain the water from the tanks into this concrete covered channel, water spills out of the drainage channels and sometimes can be seen coming up out of the joint between the floor slab and the foundation walls. A demonstration was given, where a few stoppers were removed. Water was seen coming up out of the overflow channel at the gaps between the concrete cap and the tanks, but no water was seen coming up from the joints at the walls during this site visit.

Due to the concrete caps, the condition of the overflow channels could not be inspected but based on the information provided and what was visually observed, it is likely that water from the drains is leaking into the soil below the slab. It is recommended that concrete cores through the floor slab are taken to inspect, sample and evaluate the underlying subgrade for erosion due to water leakage and infiltration.

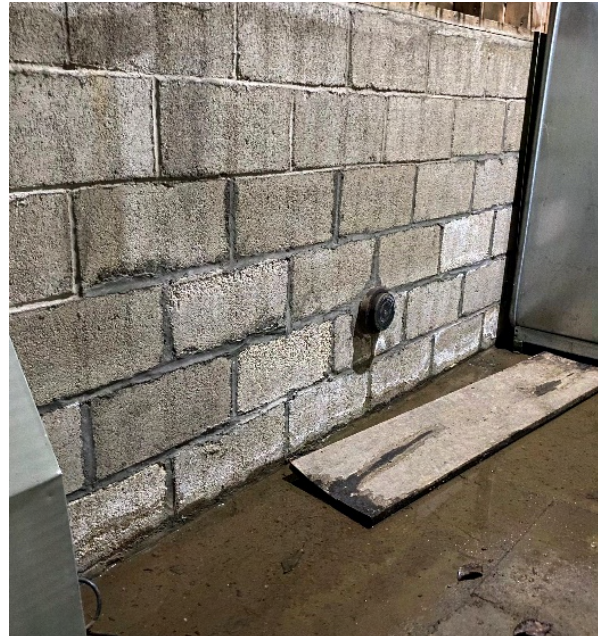
Figure 5-9: Mechanical Room Floor and CMU Wall

The mechanical room floor slab, which is approximately 2-feet below the main floor level, was observed to be wet and the bottom joints of the CMU foundation wall on the south side of the mechanical room appear to have been recently repointed (Figure 5-9). Staff noted that there is typically water on this floor. This indicates there is likely hydrostatic pressure on the floor slab and foundation walls, pushing water through into the building.

The water table at this location is unknown, however, based on the location of the Hatchery Building to the creek, it is expected that the water table is close the foundation, and rises during periods of high rain which leads to water being pushed up through the joints in the slab. At the time of the site visit, the weather had been dry for a few days, which likely impacted the demonstration and what was observed. It is recommended a core boring be performed to verify the condition of the floor slab, soil beneath the slab, and water table elevation to ensure there are no underlying conditions that could not be visually observed.

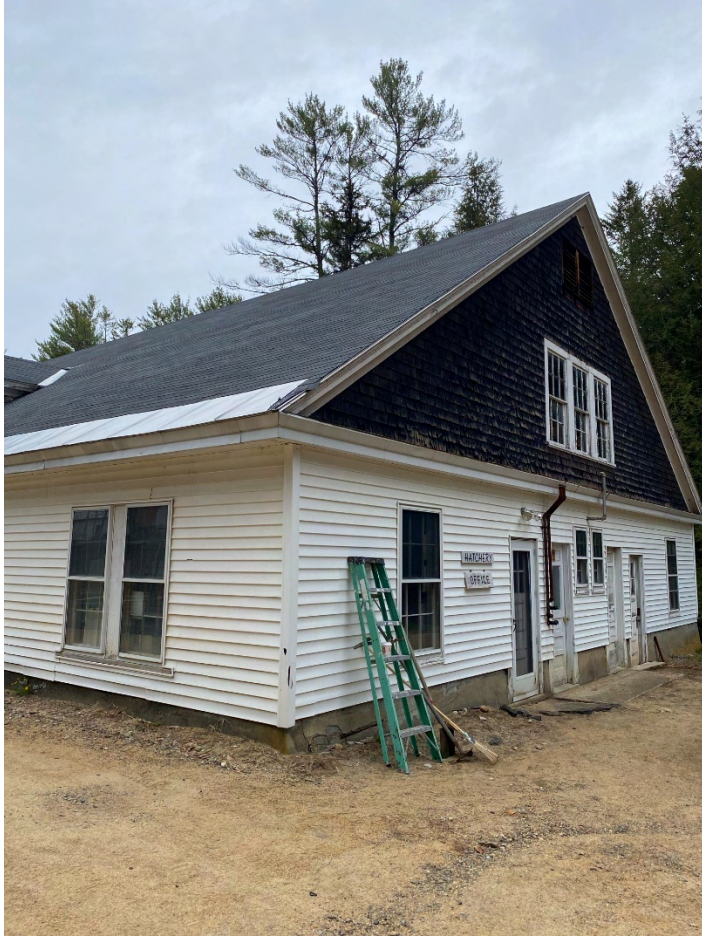
Figure 5-10: Hatch House - South (Front) Elevation

The Hatchery Building exterior consists of a concrete foundation, vinyl siding at the first floor, and cedar shingle siding at the attic level and gable roof with asphalt shingles and a metal edge at the eaves (Figure 5-10). The cedar shingles appear to be in poor condition, as they are visually weathered, warping and broken and should be replaced. The roof appears to be in good condition, and no visual signs of water infiltration were observed in the attic. The vinyl siding appears to be in fairly good condition, except at the corners, where the corner trim is cracked and broken. On the east side of the building, moss is growing on the concrete base, and black staining was observed on the vinyl siding.

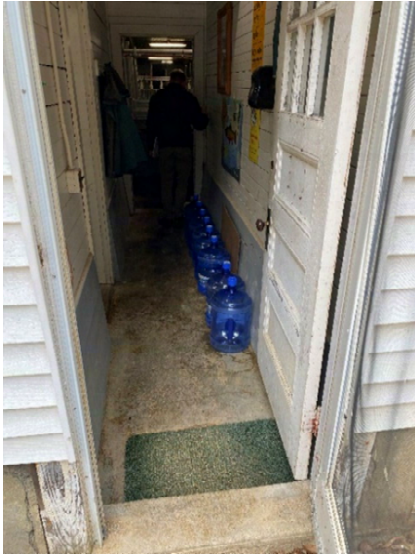
Figure 5-11: Main Entrance

There are eight (8) exterior doors on the Hatchery Building. All the doors are original solid wood doors with vision panels. The exterior doors were observed to be operable condition (Figure 5-11 and Figure 5-12). All of the doors were observed to have faded or peeling paint, and with the exception of the two doors on the north addition, the bottom of the doors were observed to show signs of rotting, with noticeable gaps between the bottom of the doors and the sill. No weather stripping was observed on any of the doors. The vision panels appear to be single pane glass. At the storage room, the base of the door is below grade with a concrete block in front of the door, trapping any water between the door and the concrete block. At the main entrance on the south façade, there is a similar condition, however an aluminum screen door has been installed on the outside of the wood door to prevent water penetrating the door. It is recommended that doors be repaired or replaced and weather hardening be conducted on exterior doors.

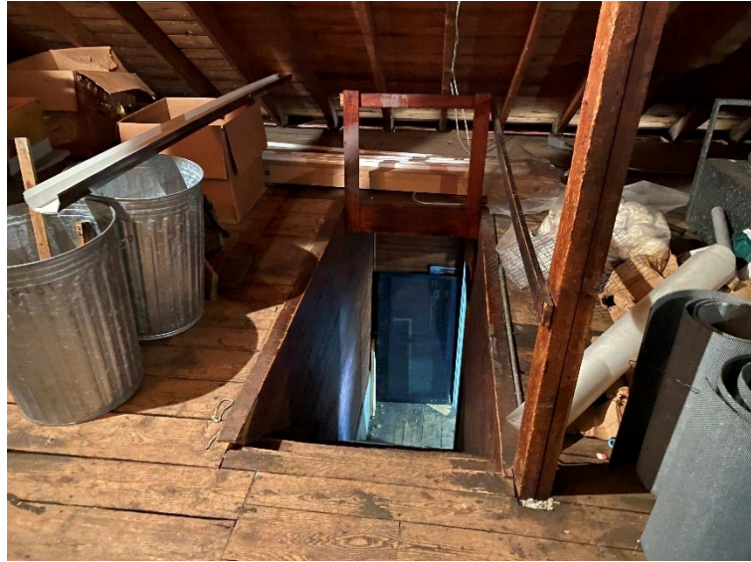
Figure 5-23: Attic Stairs with missing railing and no handrails

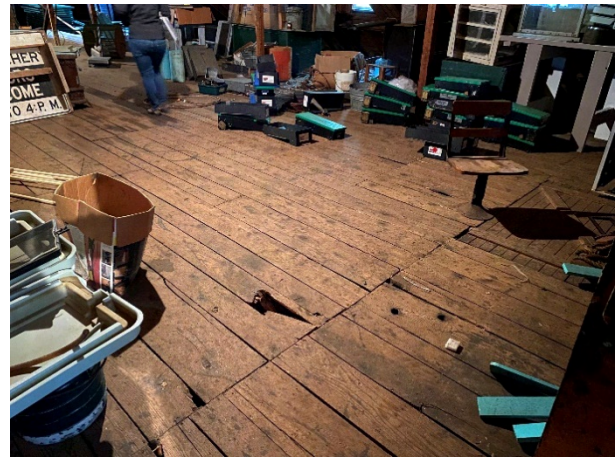
Figure 5-25: Attic broken floor boards

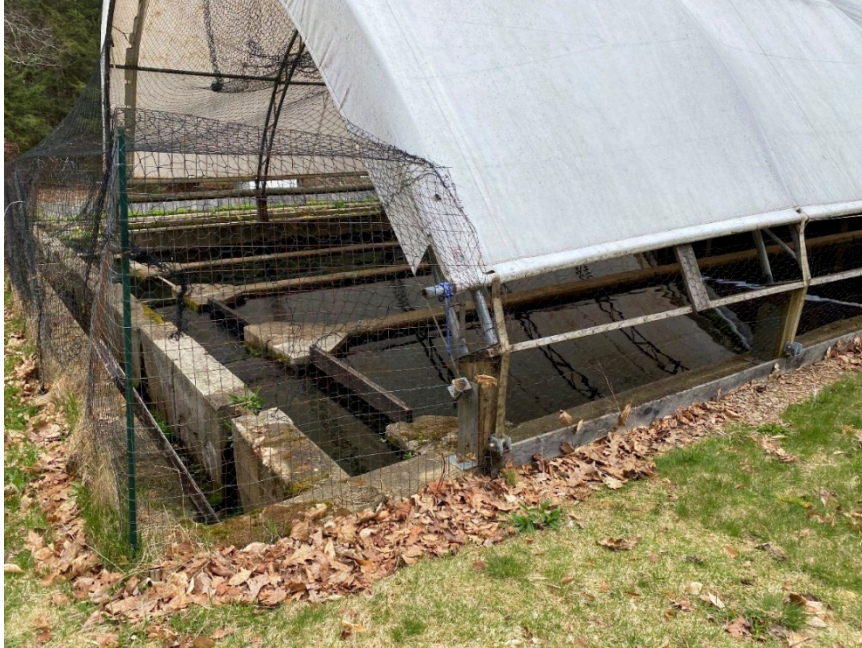
Figure 5-33: Raceway A-3 Broodstock Covering

The cover structure consists of curved steel trusses set on wood blocking at the base with horizontal bracing connecting the trusses (Figure 5-33). The wood blocking bases are attached to concrete curbs with metal angle brackets. The cover and structure appear to be in generally good condition, however most of the anchor bolts that connect the brackets to the concrete are beginning to rust.

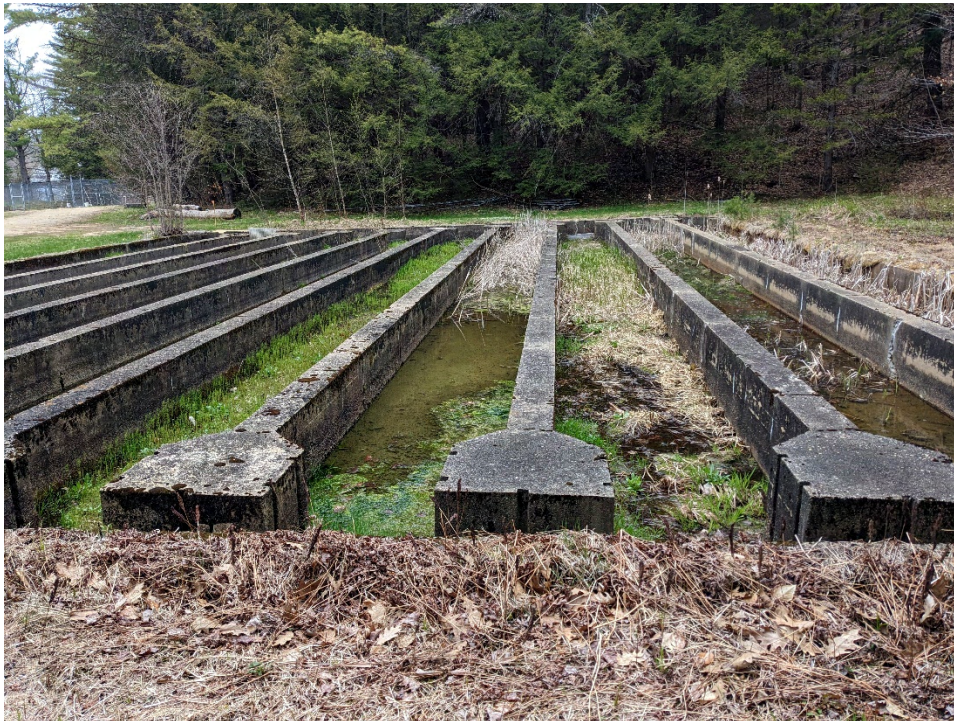
Figure 5-36: Abandoned Raceways A-4

Raceway A-4 consists of ten concrete raceways, each approximately 5-feet by 70-feet, that have been abandoned for over 30 years (Figure 5-36). These raceways were supplied water from the upper main springs by a buried 15- or 16-inch AC pipe; but it is abandoned. The ten raceways are in parallel. It appears that spring water flowed into the most northeastern one and then flowed serially through the others in a serpentine pattern. Their effluent goes to Raceway A-5 in buried pipe. The concrete of Raceway A-4 is in poor condition, with cracking, efflorescence and spalling. Hatchery personnel indicated that removing or filling over Raceway A-4 and replacing it with circular tanks is preferable to repair.

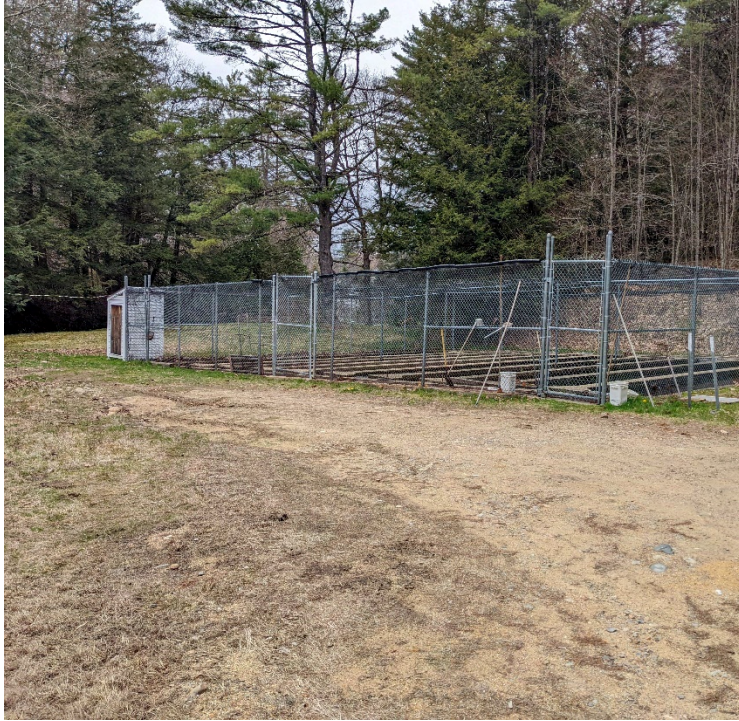
Figure 5-37: Raceway A-5

The concrete of Raceway A-5 is fair to poor, with deep vertical cracking of the raceway walls that allows leakage to and from area groundwater and between raceways. There is minor surface erosion of concrete wall vertical surfaces. If Raceway A-5 is to be used for future rearing or growth operations, there should be a rehabilitation of the concrete to inject sealer into cracks and to re-line exposed concrete surfaces with cementitious epoxy concrete or similar.

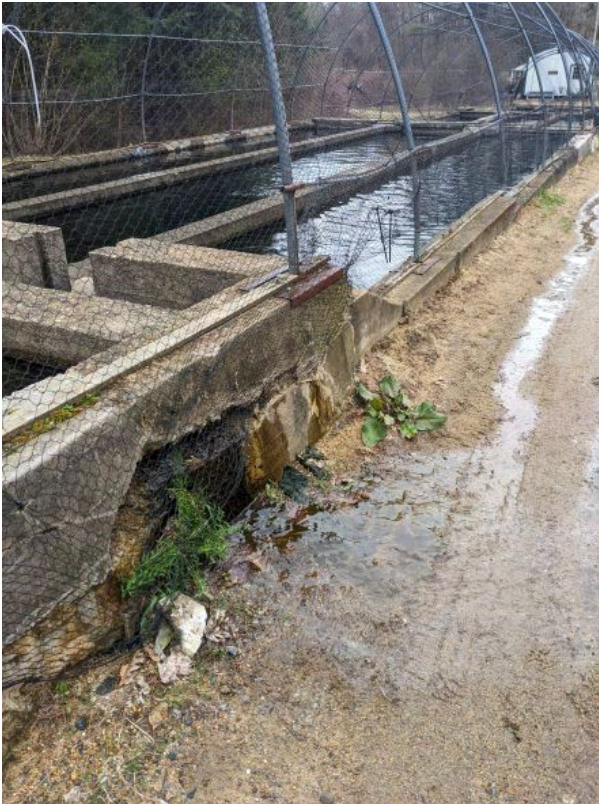
Figure 5-39: Severe leaking from north outside wall at B-Series

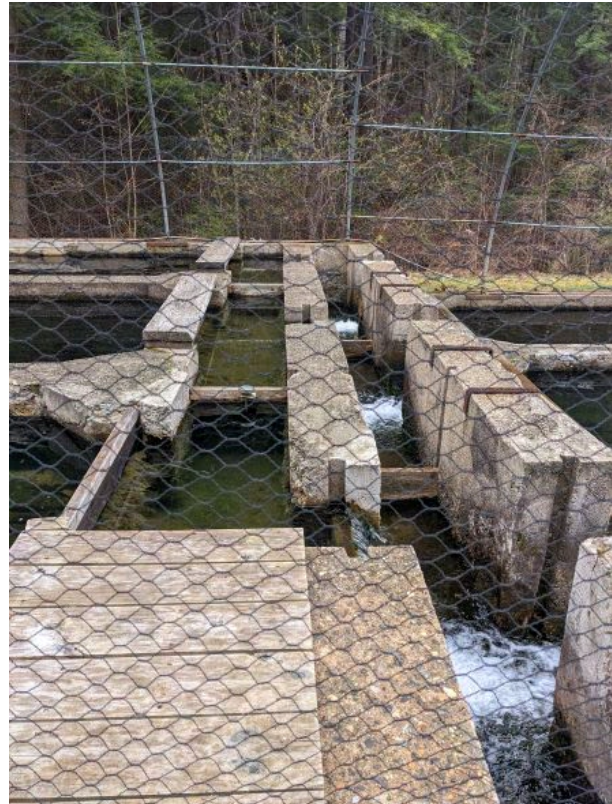
Figure 5-40: Concrete spalls, cracking and deterioration at B-Series baffles

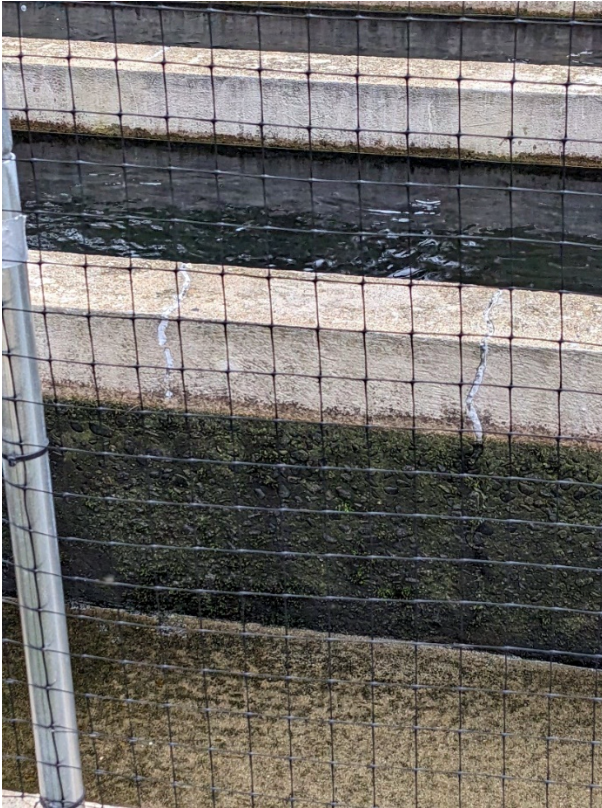
The condition of the C-Series concrete is fair to poor. Facility personnel indicated that there was a significant rehabilitation of the top of the concrete walls at the upper two sets of raceways at C-Series approximately 20 years ago (Figure 5- to Figure 5-45). That rehabilitation is beginning to fail, with cracking and spalling exposing the older deteriorated concrete surfaces. The concrete at the lower three sets of raceways is largely original with local repairs and crack sealing only. The concrete walls are cracked and spalled, with cracks across the entire width and full height of the walls spaced approximately every 2- to 3-feet. There are spalls up to 2- to 3-inches wide over approximately 10-inches of top of wall surfaces in areas that have not been previously repaired. There is significant erosion of vertical concrete surfaces below normal water line in all the raceways, to an average depth of 3/4-inches, with exposed aggregate.

Figure 5-44: Previously repaired concrete surfaces at C-Series upper raceways

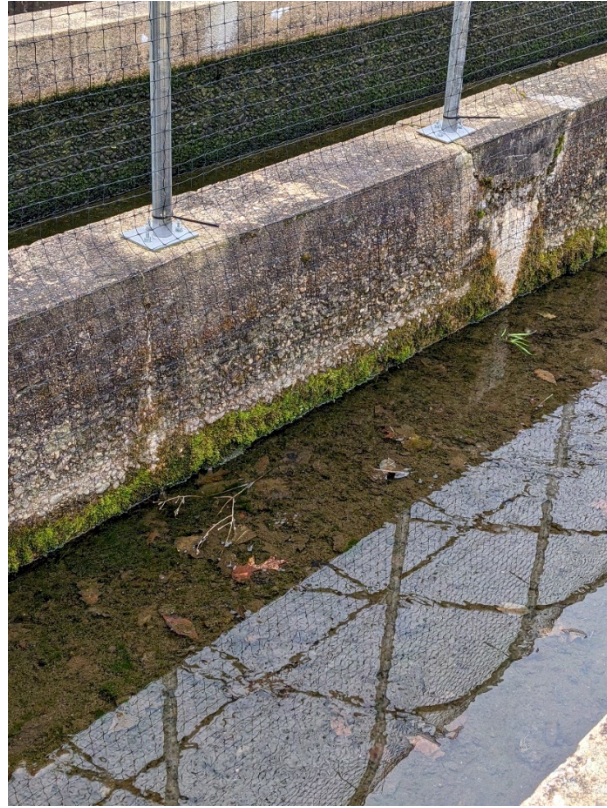
Figure 5-45: Original, unrepaired concrete surfaces at C-Series

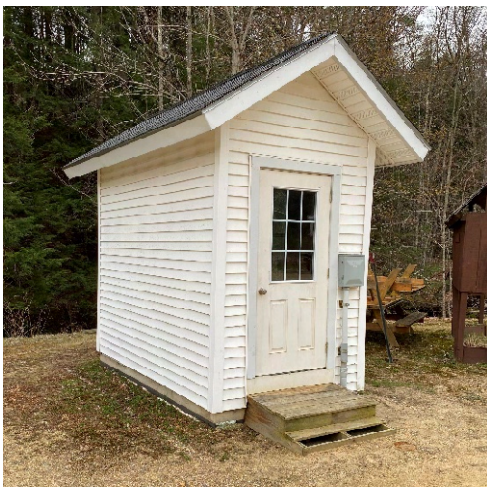
Figure 6-3: Sampling Shed at C-Series

There is a third sampling shed at the north end of C-Series (Figure 6-3). It is on Outfall 004 which is discharge from C-Series. This shed appears to be relatively new and in good condition.

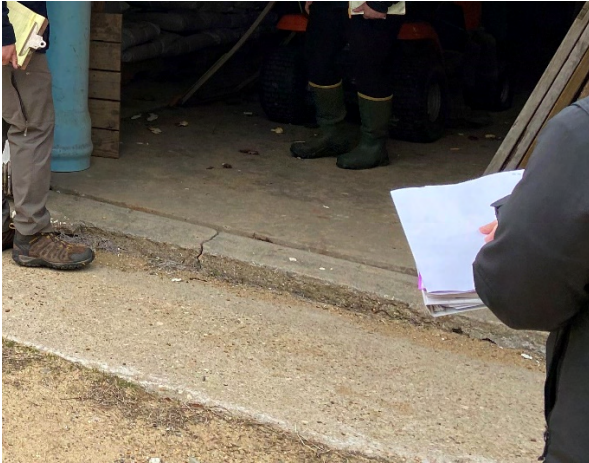
The Upper Garage consists of a concrete curb foundation with wood frame walls, roof and attic, and a concrete slab-on-grade floor inside the concrete curb (Figure 7-2 and Figure 7-3). The structure appears to be in good to fair condition, with some minor cracking of the concrete foundation curb at the entrance doors. The interior slab-on-grade has three sections, and there is a slight difference in height between the sections, indicating some differential settlement of the various slab segments.

Figure 7-2: Example of cracking at foundation curb

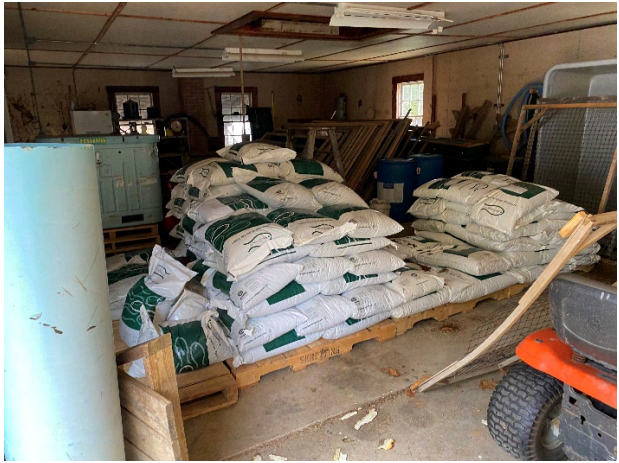
Figure 7-3: Interior view showing feed storage and slab height difference

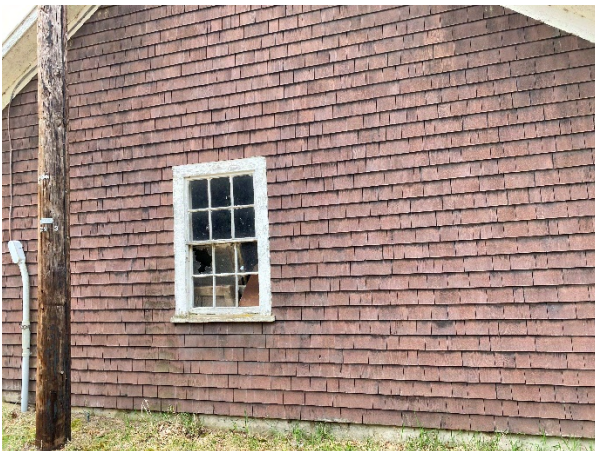
The exterior of the garage is finished with cedar shingle siding which appears to generally be in good condition, except at the southeast corner, where the shingle siding comes in contact with grade. The roof is a gable style roof with asphalt shingles, and appears to be in good condition, other than some moss growing on the north side. There is a gutter on the south side of the roof over the barn doors. The gutter appears to be pulling off the roof in places and sagging, and it does not have any downspouts. The windows appear to be the original single pane wood window and were observed to be in fair to poor condition with some broken and missing panes (Figure 7-4 and Figure 7-5).

Figure 7-4: Broken windowpanes at east elevation

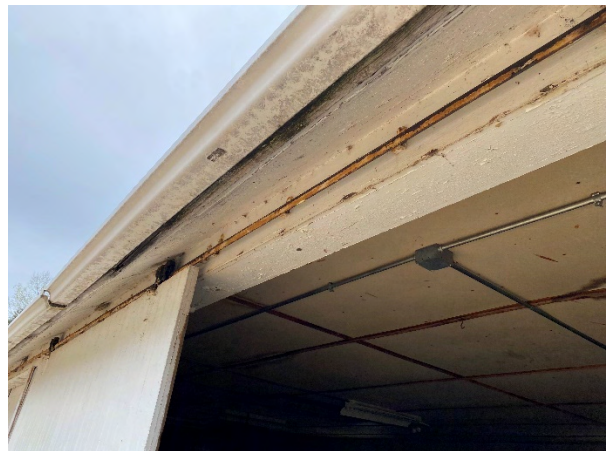
Figure 7-5: Rusted door slide rail and damaged gutter

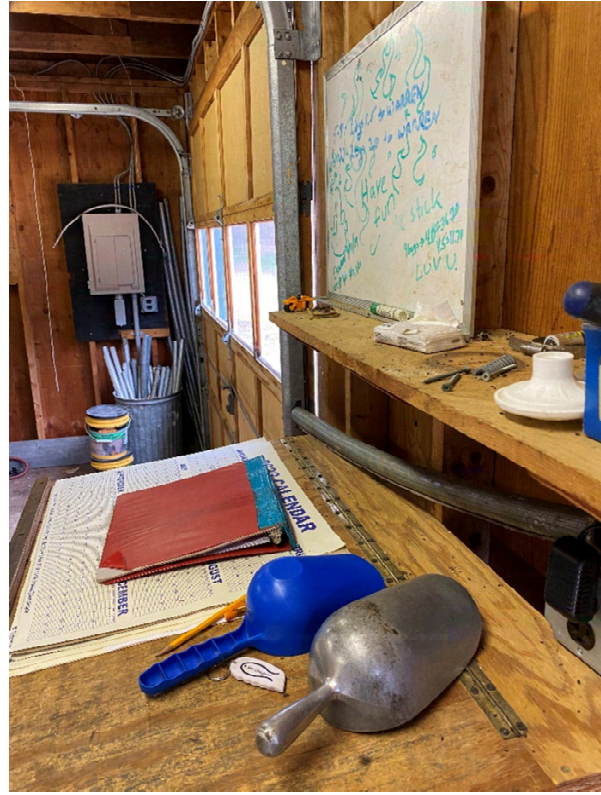
The Feed Shop is accessed via a man door with wood stairs on the east façade and an overhead garage door on the north façade. The doors are operable, however neither seals fully. The man door is rusted at the bottom and leaves gaps for weather and rodents, while the overhead door is not tight to the frame, leaving gaps between the door and wall. Due to rodent access and the inability to maintain consistent temperatures, similar to the Upper Garage, the Feed Shop does not function as an efficient feed storage structure (Figure 7-7 and Figure 7-8).

Figure 7-8: View of gaps in overhead door

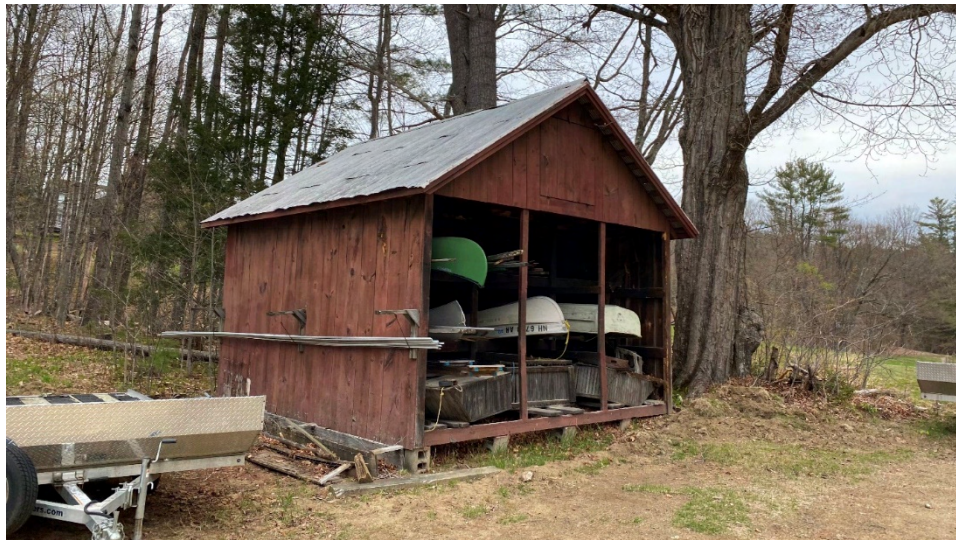
Figure 7-9: Boat Shed

The boat shed is a partially enclosed wood structure that is used for the storage of boats and other miscellaneous equipment that does not require complete protection from the elements, located at the eastern edge of C-Series (Figure 7-9). The south side of the structure is open to allow for loading and unloading. The wood structure is supported by loosely laid CMU blocks sitting on the ground, many of which appear to have shifted and do not appear stable. The CMU blocks do not appear to be secured to the ground, and the wood structure appears to be sitting on the blocks with no visible means of attachment. This structure appears to serve the function of its intended use but appears to be in overall poor condition.

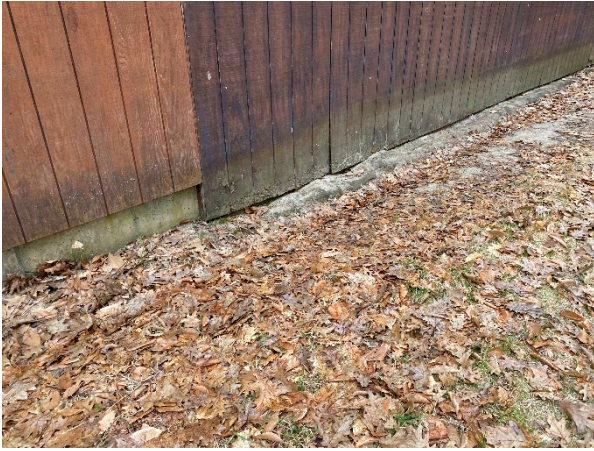
There is a large multi-bay garage building that houses a boat bay with a workshop, wildlife bay, storage bay, feed storage bay, marine biology bay, state police bay, and an open covered area for a cold storage freezer (Figure 7-10). The Garage is constructed of a concrete slab foundation with wood framed walls and roof, which appear to be in good condition. The exterior is finished with vertical wood paneling, and the roof is a gable style metal roof. The roof appears to be in good condition; however, the roof soffit along the north side of the garage consists of screening material, which has been damaged, leaving openings for animals and insects to get into the garage. The vertical wood paneling is in good condition, except in some locations at the bottom of the of the paneling where it comes in contract with the ground. These locations show signs of the paneling rotting or warping and pulling away from the structure. This building is uninsulated and is not heated or cooled (Figure 7-11 and Figure 7-12).

Figure 7-11: Damaged Wood Paneling Base

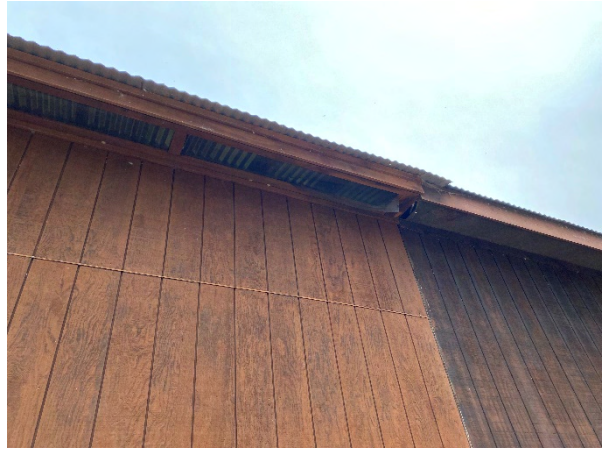
Figure 7-12: Damaged Soffit Screening
