Existing Conditions and Facility Evaluations

POWDER MILL FISH HATCHERY FEASIBILITY
STUDY

New Hampshire Fish and Game Department

August 24, 2022

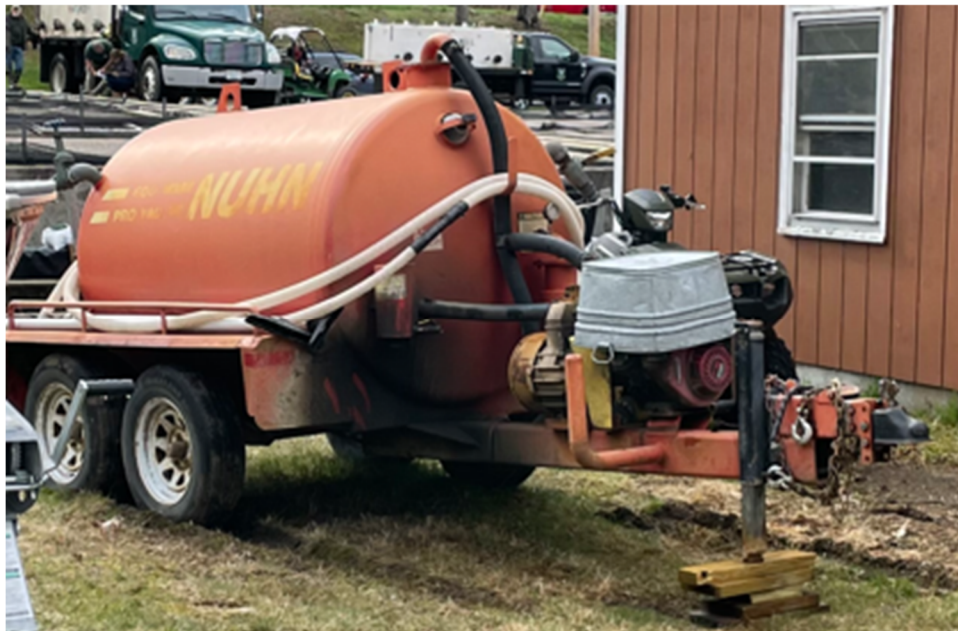
Figure 1-4: Portable Vacuum

In recent years the quiescent zones in the raceways have been vacuumed clean, generally weekly by a portable vacuum (see Figure 1-4), as are all the raceways used for clarification and 25-ft circular tanks that are utilized for production. This procedure was implemented to reduce the amount of phosphorous in the hatchery effluent. The contents of the portable tank containing the vacuumed solids is emptied into either Tank 1 or Tank 3 of the temporary wastewater treatment system (discussed later in the report) which function as a primary clarifier. Sometimes the vacuumed solids are also directly land applied to nearby farmland.

The process of manual vacuuming is very labor intensive and physically demanding on hatchery staff. Given the extremely low level of phosphorus allowed in the effluent, solids should ideally be collected and extracted from the tank as quickly as possible using an automated process. Quick removal of the solids should help reduce the possibility of phosphorus in solid form from becoming soluble, and therefore harder to remove from the effluent.

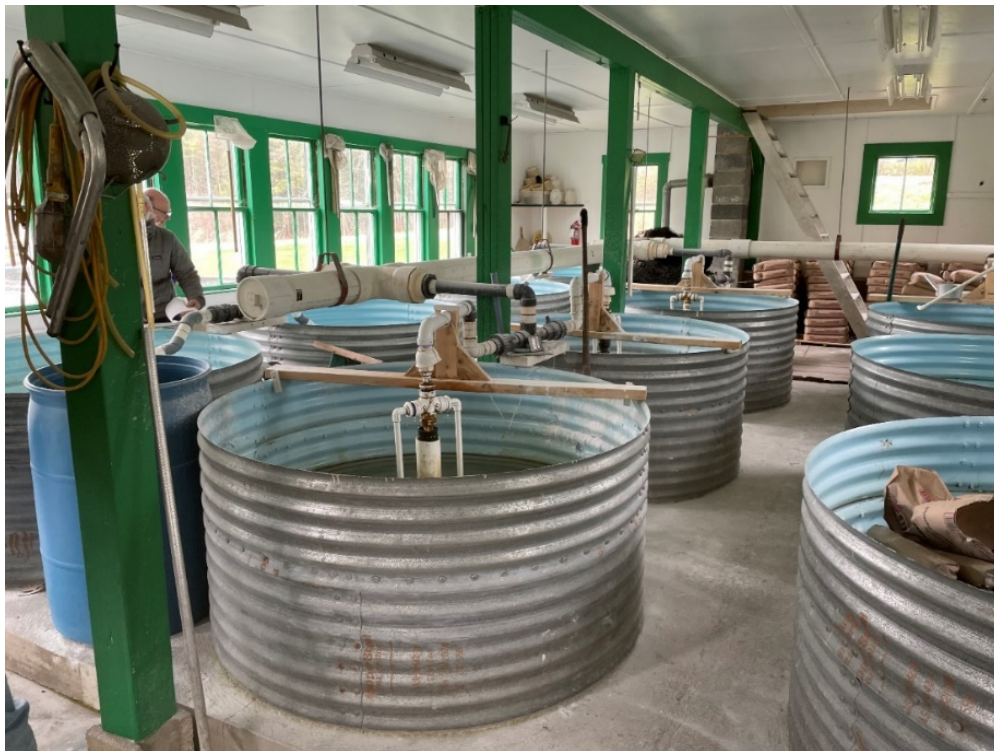
Figure 1-5: Hatch House

Lime addition in the Hatch House was implemented as part of the facilities 2021 NPDES permit. The permit contained a new requirement that limited the reduction in pH through the facility to 0.5 S.U. While the east side of the hatchery can meet this requirement without lime addition, the west side of the hatchery requires it. The existing circular rearing tanks and associated equipment in the Hatch House designed for rearing fish were repurposed by hatchery staff to dissolve bulk lime for addition to the facility. This existing equipment is less than ideal for this purpose.

- Floors: The floor is a concrete slab with a raised concrete pad under the rearing units. Both the concrete floor and pad appear to be in good condition. There is a narrow 21" wide walkway between the south wall and the raised slab.

- Walls: The walls consist of a 30" high CMU base with wood framed walls sitting on the CMU base. The interior finish of the walls appears to be asbestos paneling. The exterior of the walls are finished with wood siding. The walls appear to be in good condition. None of the walls appear to be insulated.

- Windows: The windows are wood frame single pane windows, consisting of a mix of double hung and fixed. The windows appear to be the original windows, with aluminum storm windows added to the outside of the double hung windows. No issues regarding the operation of the windows were reported, but the lack of insulation was noted as an issue during the winter. However, the temperature requirements of the fish are currently met.

- Ceiling: The ceiling is approximately 8'-9" above the finished floor and is comprised of asbestos panels with wood trim mounted to the underside of the wood floor joists for the attic. There is a wood access hatch near the northwest corner to provide access to the attic. The ceiling panels appear to be in generally good condition.

- Doors: The Hatch House has two access doors. The primary access door is located near the southern end of the east wall. The secondary access door is located near the west end of the north wall. The doors are approximately 21" above the floor slab and have concrete stairs leading up to the doors. The doors appear to be in fair condition.

- Roof: The roof is a sloped roof with asphalt shingles. The roof appears to be in fair condition. No evidence of leaking was observed, and no leaking was reported.

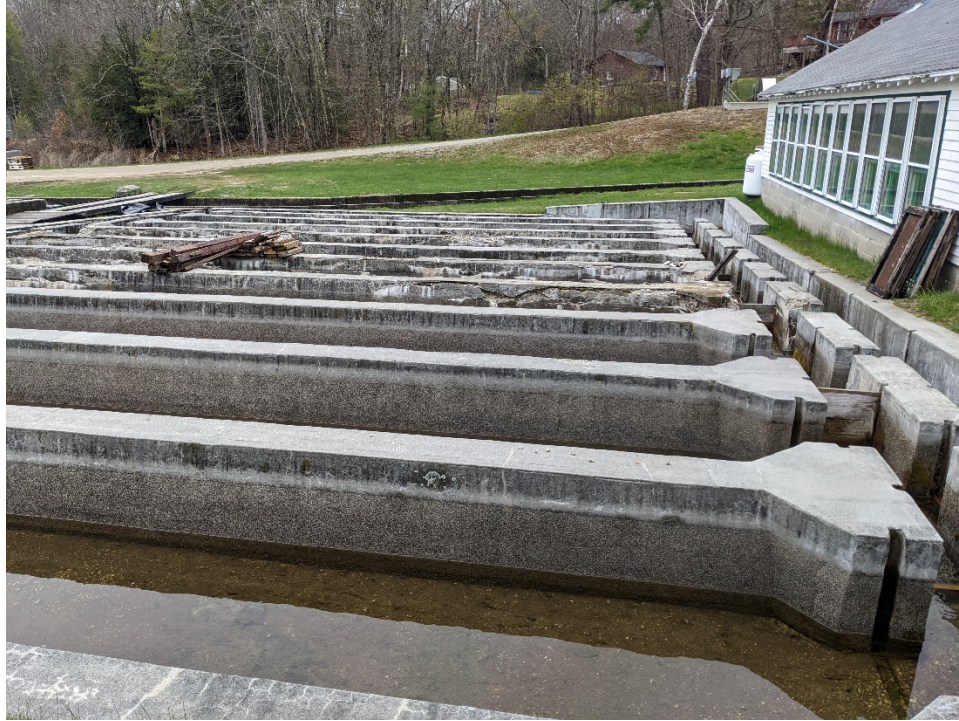
Figure 1-6: Raceway A

Due to the deteriorating structure of these ten raceways (each 5' wide and 35' long, shown in Figure 1-6), only three are used for rearing fish, and only for a few months. Flow is in a serpentine pattern at approximately 150 gpm from the east side raceways' surge box. There are cleanout flumes connected at both ends of the raceways with stop logs in them. These end cleanout flumes and the last A-Raceway discharge into a reuse flume common to B, C and D-Raceways that flows to the Show Ponds. There are slots in the walls for stop logs for individual raceway level control and slots for fish screens.

At the time of inspection, Raceway A was not in service. The concrete walls and floor of the 10 raceways are in serious condition, with heavy spalling, cracking and efflorescence throughout. There is erosion of the walls of the upper four raceways, with exposed aggregate/loss of paste to a depth of up to 1/4". The tops of the walls separating the raceways are cracked and spalled, with deterioration getting worse from east to west. The southerly end walls have been labeled "Keep Off" and painted with yellow warning stripes to keep people from standing on them due to their heavy spalling condition. Repair of the concrete in Raceway A is not likely worth the effort; if Raceway A was to be brought into service again, a complete reconstruction or replacement with more efficient structures would be more prudent. The raceways were built with the east end higher than the west end, so that gravity allows flow to zigzag through the raceways and outlet into a discharge channel at the west end.

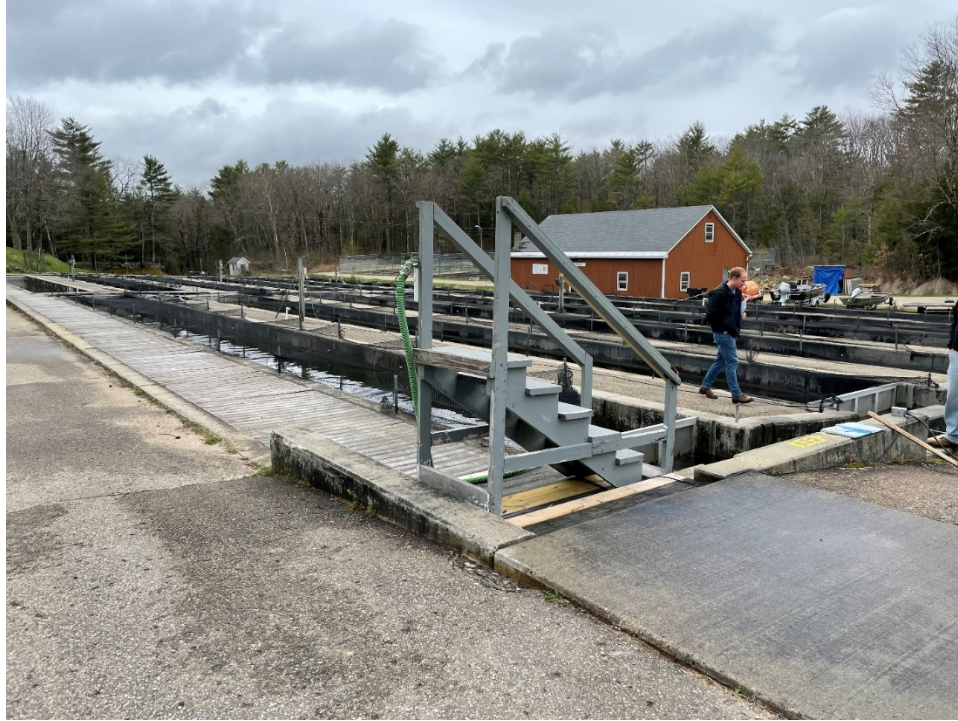
Figure 1-7: Raceway B

Flow is in a serpentine pattern in these 8' wide, 50' long raceways (shown in Figure 1-7) at approximately 800 gpm in B and 600 gpm in C from a common aqueduct fed by the east side raceways' surge box. There are cleanout flumes connected at both ends of the raceways with stop logs with stop plates in them. These end cleanout flumes and the last raceway of each group, discharge into a reuse flume common to B, C and D-Raceways that flows to the Show Ponds. There are slots in the walls for stop logs for individual raceway level control and slots for fish screens. There is also a pipe from each end cleanout flume to a main cleanout flume common to B, C and D raceways that is piped to the river channel. This cleanout system is not used due to recent effluent restrictions and leakage from the adjacent river channel.

These raceways have abandoned aeration piping. This abandoned piping does not detract from the function of the raceways and is not inhibiting any operations. Netting is stretched over the tops of the raceways on knee-high, vertical support pipes.

The concrete is of more recent construction than Raceway A and is in fair condition, with surface cracks in the channel walls and efflorescence every 10 feet or so along their length. The cracks are not full depth, and there is little to no spalling of concrete surfaces. There is moderate surface erosion of the raceway walls below normal water flow levels. The depth of loss is approximately 1/8" on average. There are expansion joints formed into the walls of the raceways near the raceway midpoints. Full depth cracks have formed at several of the expansion joints, but the waterstops cast into the joints appear to be sound.

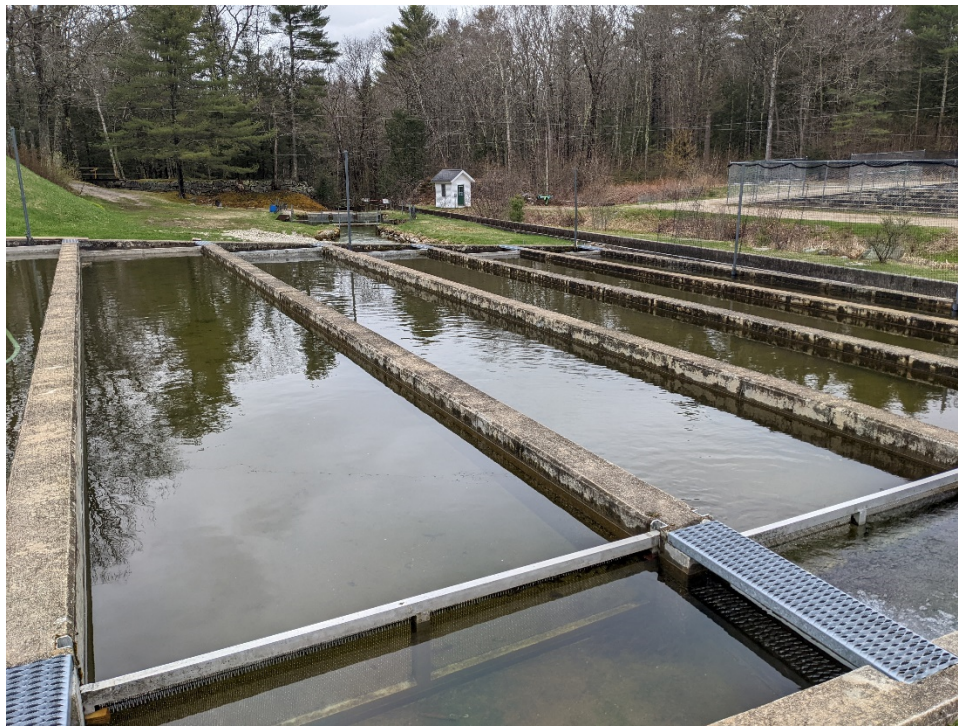
Figure 1-8: Raceway D

The cleanout plugs are not removed due to recent effluent restrictions and leakage from the adjacent river channel. For bird predation deterrence, pole-supported cables span over the raceways, high enough to walk under. Netting spans some of the poles like side curtains. These features are shown in Figure 1-8 though they are difficult to see.

The concrete is in worse shape than Raceways B and C and is in fair condition, with surface cracks in the channel walls and efflorescence every 3-5 feet along their length. The cracks are not full depth, and there is little to no spalling of concrete surfaces. There is minor surface erosion of the raceway walls below normal water flow levels. The depth of loss is 3/8" on average. The Raceway D concrete is a prime candidate for rehabilitation, including sealing of existing cracks, repair of spalled areas and applying a protective liner to the bottom and walls of the raceways.

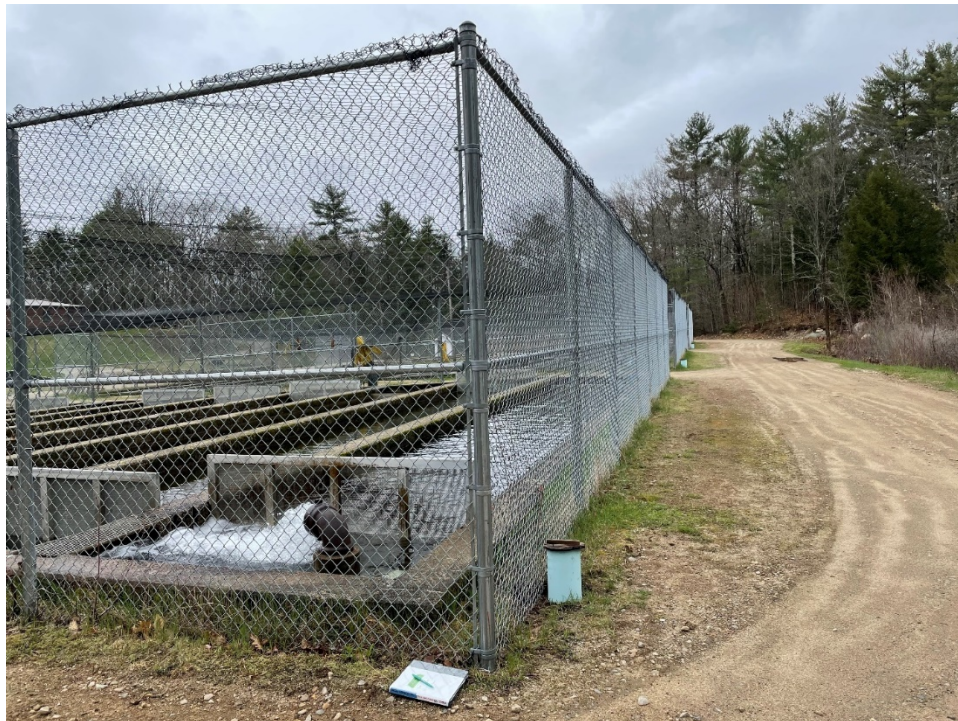
Figure 1-9: Raceways E, F, & G

Raceways E, F & G were added in 1972. Each group has ten 8' wide, 50' long raceways, see Figure 1-9. They do not have aeration systems but do have power distribution. These raceways utilize about 1,000 gpm of water or 328 gpm per bank. They are vacuumed cleaned one to two times per week or as needed. Flow pattern through each group is serpentine serial and the last raceway in each group is currently used for settling waste.

The concrete in Raceways E, F, and G is in fair to poor condition, with erosion of concrete surfaces of the bottom and walls of the raceways and intermittent spalls in the raceway walls. The spalls are up to 1" deep and the full width of the top of the interior walls, and up to 4" deep locally at the ends of the walls. Facility staff has performed concrete patching at some of the more extensive spalls in Raceway G. Soft water conditions have exacerbated the surface erosion of the raceways below normal water line of the walls. The depth of concrete loss is 1/8" to 1/4", resulting in exposed aggregate. The concrete condition makes the rearing units difficult to clean and causes fin erosion to the fish. There are expansion joints at the midpoint of the interior and exterior raceway walls,

some of which have opened up significantly, potentially allowing water to leak outside the facility. It was observed that water was bubbling up below the headwall of a stormwater structure and running into a stormwater swale to the east of Raceway E. The source of the water bubbling into the swale was likely leaks from the walls or slabs of Raceways E, F and G or their inlet piping.

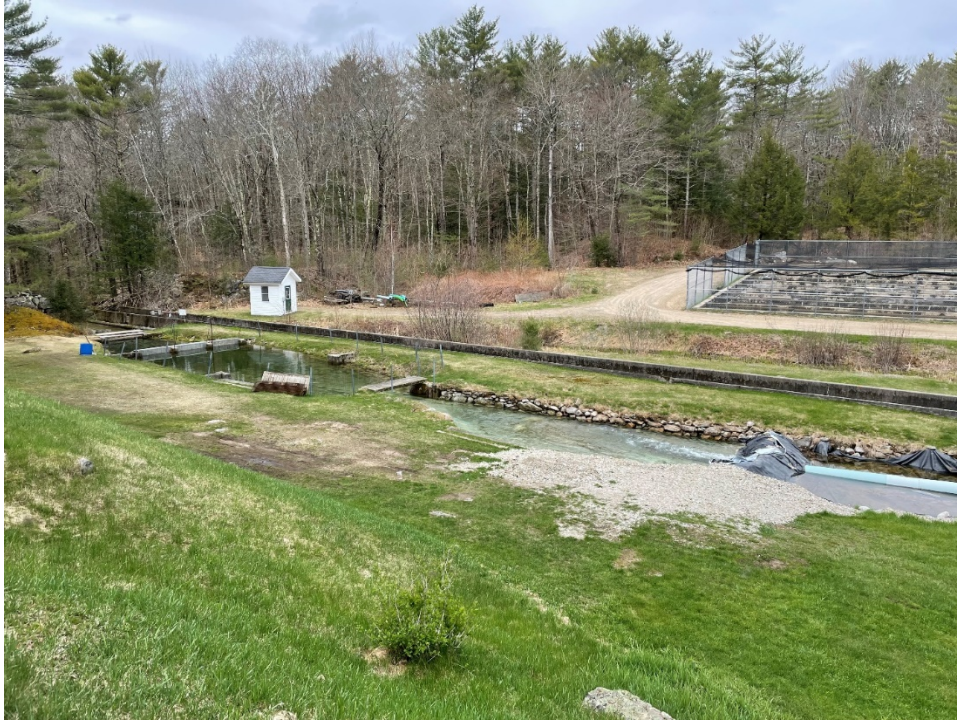
Figure 1-10: Show Ponds

The smaller upper pond was recently divided with a berm mid-length and the original discharge piping was extended with SDR 35 PVC across the upper half, see Figure 1-10. The upper half was membrane lined and was going to be used to settle waste from the main cleanout flume. However, due to the excessive infiltration of river water into the cleanout flume the project was abandoned.

The larger lower pond is pale colored from lime sediment coming from the Hatch House. The lower pond has structures for subdividing it into thirds, but only the lower structure is used (the upper structure is incomplete or partially removed) such that the upper two-thirds serves as one pond, which has waist-high vertical netting. The lower third serves as another pond, separated by fish screens and weir boards. At the time of inspection, fish were only in this last pond and consisted of yearling and older fish, see Figure 1-11. These ponds are only cleaned occasionally when small piles of fish waste develop after several months of operation.

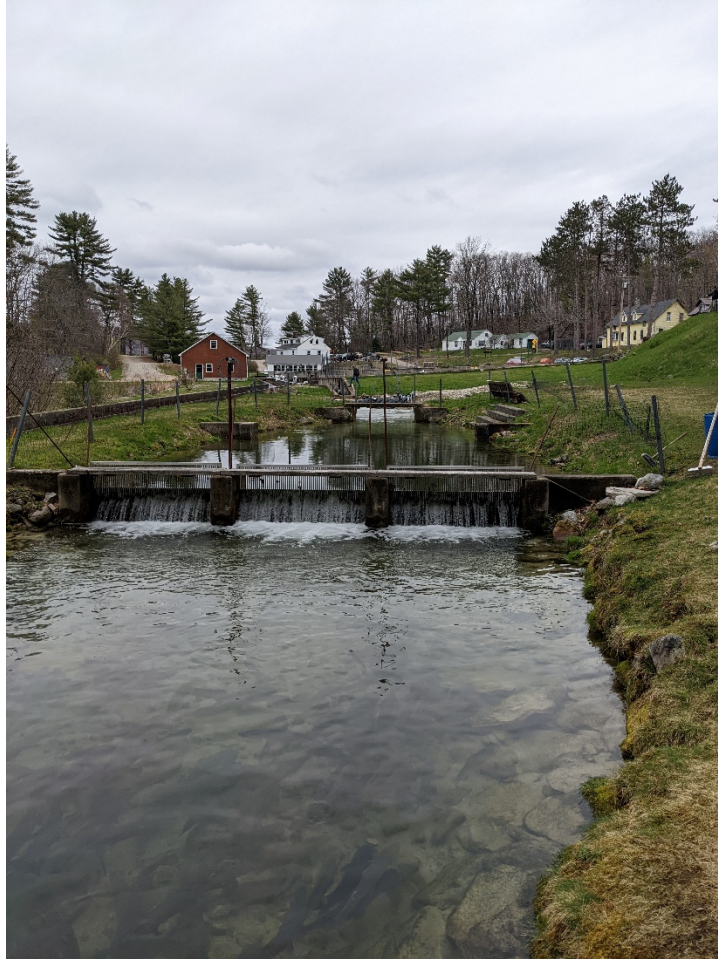
Figure 1-11: Show Ponds

As noted above, only one of the lower pond structures for subdividing it into thirds is used while the other two are incomplete or partially removed. This structure is made with concrete, fish screens, weir boards, and a metal walkway. This structure is in fair condition with minor surface cracks and spalls.

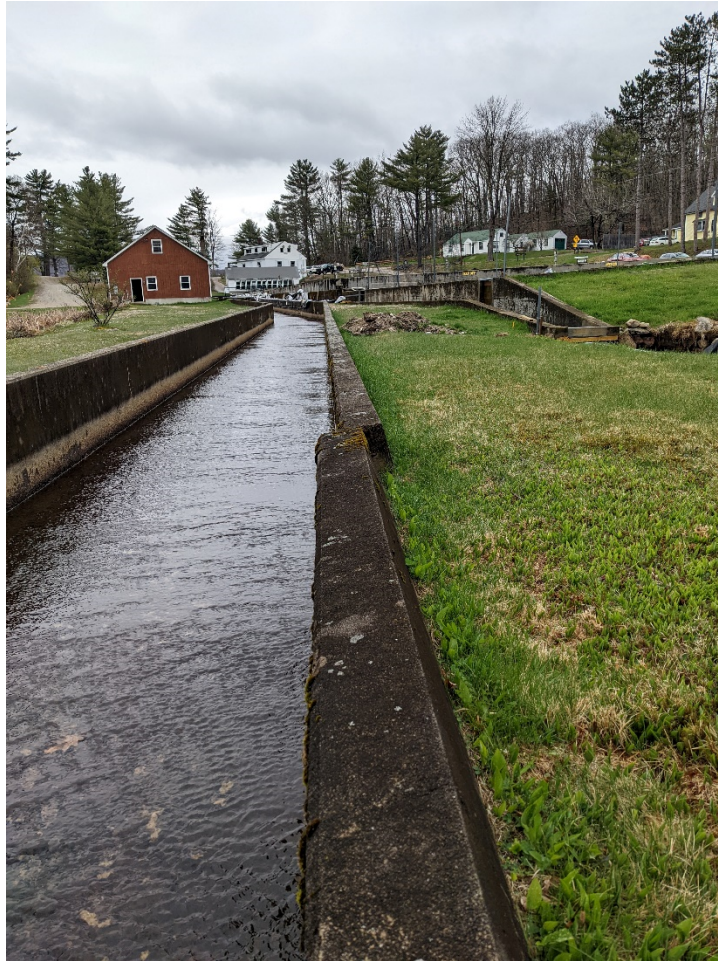
Figure 1-12: Lake Overflow Channel

The structural condition of the concrete lake overflow channel is deteriorated, particularly the section between Raceway D and where the concrete channel terminates. Multiple expansion joints in the easterly vertical walls of the channel have separated, allowing a section of the wall to rotate inward

toward the channel, see Figure 1-12. The wall is 8" thick and has rotated by as much as 6" inward at the top, so that it is no longer plumb. The rotated joints allow for water leakage to and from the channel. There is also settlement of the eastern wall of the channel in the sections that have rotated, resulting in the floor of the channel no longer being level. At the time of inspection, the water level in the channel was deeper along the easterly wall than along the westerly wall. There was an excavated area behind the easterly wall that exposed a buried pipe adjacent to the outside of the wall. The open excavation revealed that there does not appear to be a heel on the back of the vertical channel walls. Any modification to or rehabilitation of the concrete bypass channel must include replacement of the section of rotated easterly wall.

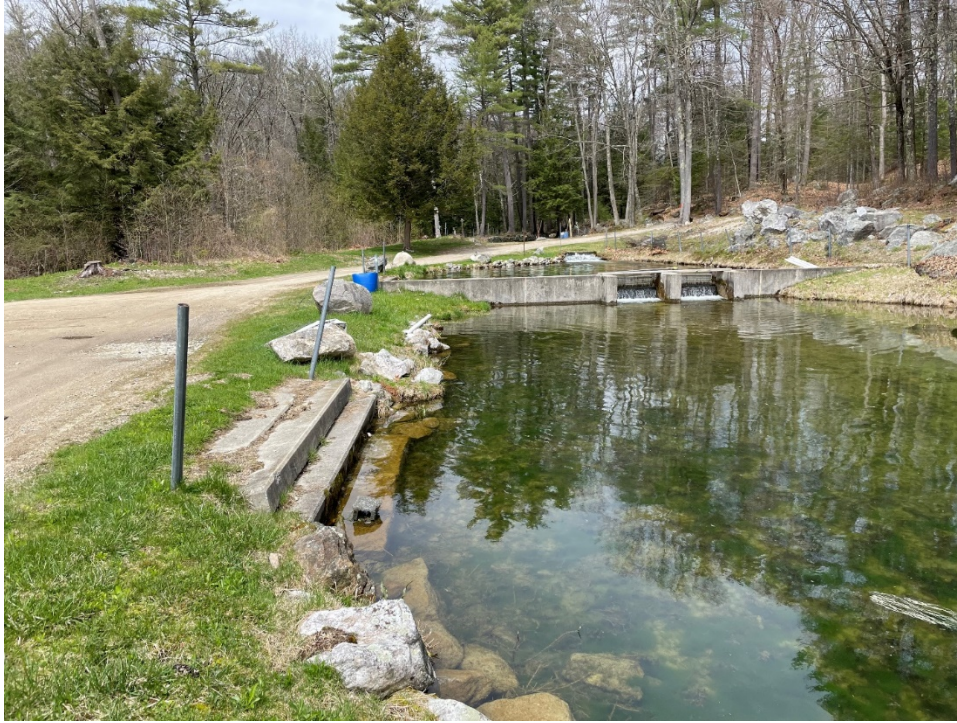
Figure 1-13: Woods Ponds

An open channel, generally about 5' wide and walled with stone, carries Show Pond water serially hundreds of feet south to the Woods Ponds. About a hundred feet upstream of the Woods Ponds there is a structure with a bar screen, stop logs, passive aeration screen and side overflow weir to release water if the bar screen clogs. Water flows serially through the Woods Ponds, shown in Figure 1-13. The first pond is separated from the other three by a gravel road with piping under it,

with a screened structure on the upstream end and a stop log structure on the downstream end. The other three ponds are separated by fish screens.

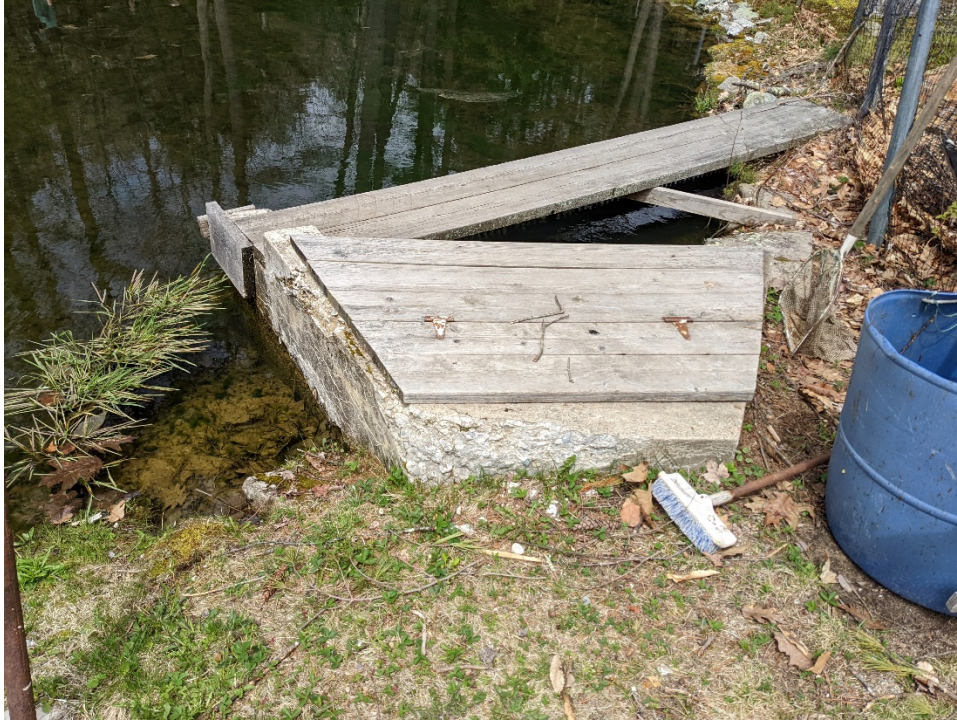
Figure 1-14: Woods Pond Outlet Box

The walls of the Woods Ponds are a combination of earth and dry-laid stone. The inlet walls for the first Woods Pond are dry-laid stone and are in fair to good condition. The discharge from Woods Pond 1 travels through a concrete outlet box that is covered with timber planking. The concrete of the outlet box is in poor condition, with cracking, efflorescence and spalling on the corners and edges up to 3" deep and full width. There are existing concrete repairs at some of the larger spalls of the Woods Pond outlet box, see Figure 1-14. The concrete outlet box at Woods Pond 1 should be rehabilitated.

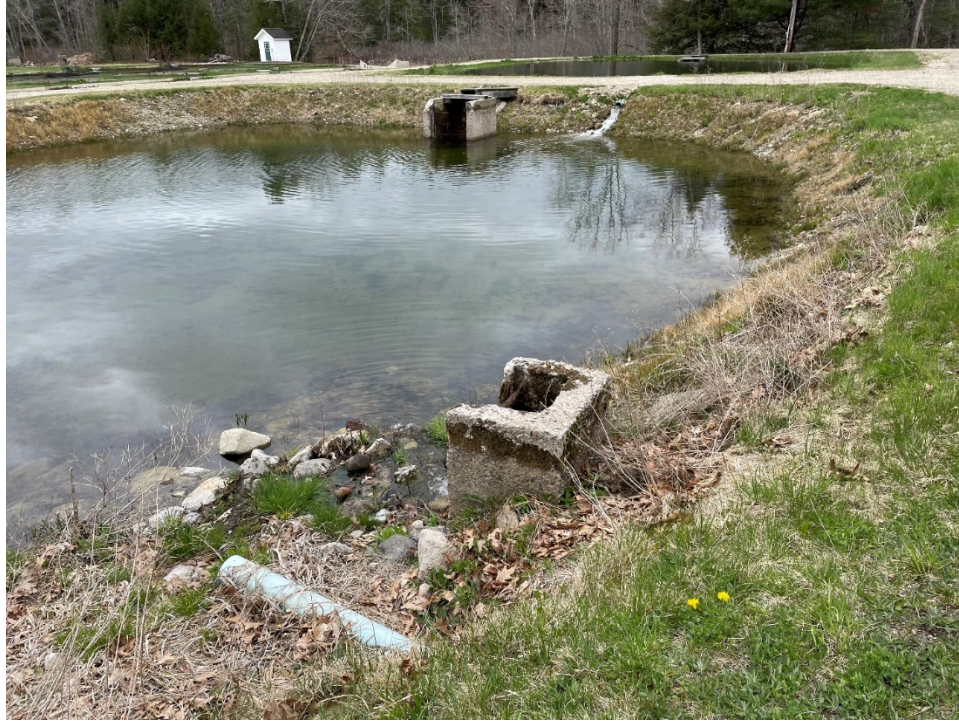
Figure 1-15: Bass Ponds

A 1976 drawing indicates a buried 12" RCP supply line from Woods Ponds arriving at a rectangle between the four Bass Ponds, suggesting that the two sources mix in the structure, shown as T-shaped in other drawings. Contrarily a 1957 drawing indicates a 12" transite pipe from the Woods Ponds crosses under the aqueduct supply and is not connected to the T-shaped structure and is instead branched independently to four valves at the four Bass Ponds. Four valve street boxes were observed in the vicinity at the time of inspection.

Recently, shallow 6" PVC overflow pipes were added from Bass Pond 1 to 2 and from 3 to 4. The ponds are being used to settle waste. They originally drained independently to the river but are now connected to a common drain.

Old drawings indicate that all the bass ponds' concrete was installed prior to the 1960's. There is a concrete T-shaped water diversion box near the intersection of the four ponds that is in fair condition. Each pond has a small concrete water supply weir box in each corner and a larger concrete outlet structure inside each central end. All those structures are in poor condition.

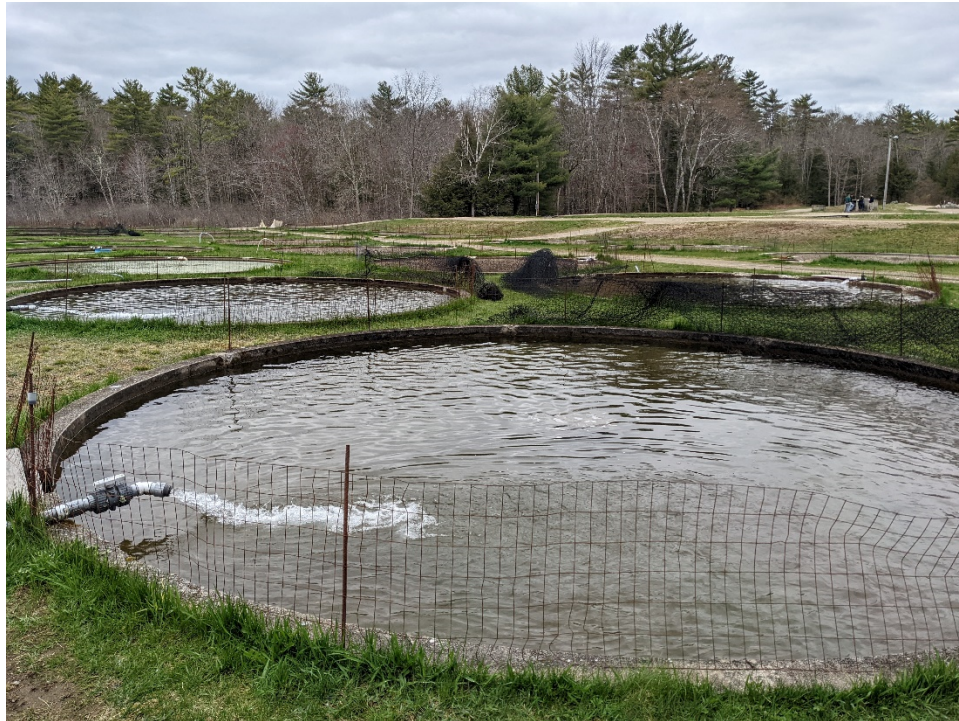
Figure 1-16: Circular Tanks

Three tanks near the middle of the south row of nine are currently dedicated to effluent treatment. Vacuumed waste from the rearing units is emptied into the outer two tanks. Overflow pipes (3" diameter) connect the outer tanks to the middle tank and effluent is siphoned from a sand filter in the center to a 15' x 15' x 4' filter bag in the ground 20' to the south. After 6-8 months use, only a little sand was found in the filter. This year, thirty 600 gallon loads of sludge have been vacuumed out of the outer tanks and hauled and emptied into a town sand pit. This process has been in place for 3 years.

The circular tanks have concrete floors and walls, and concrete outlet structures. The condition of the tanks varies but is typically fair with eroded surfaces below normal water level, exposed aggregate, and moderate cracking and spalling of the tank walls and outlet structures. At the time of inspection only about one third of the tanks contained water and only one had fish in place. Several of the tanks had concrete repairs to the larger spalls on the walls and outlet structures.

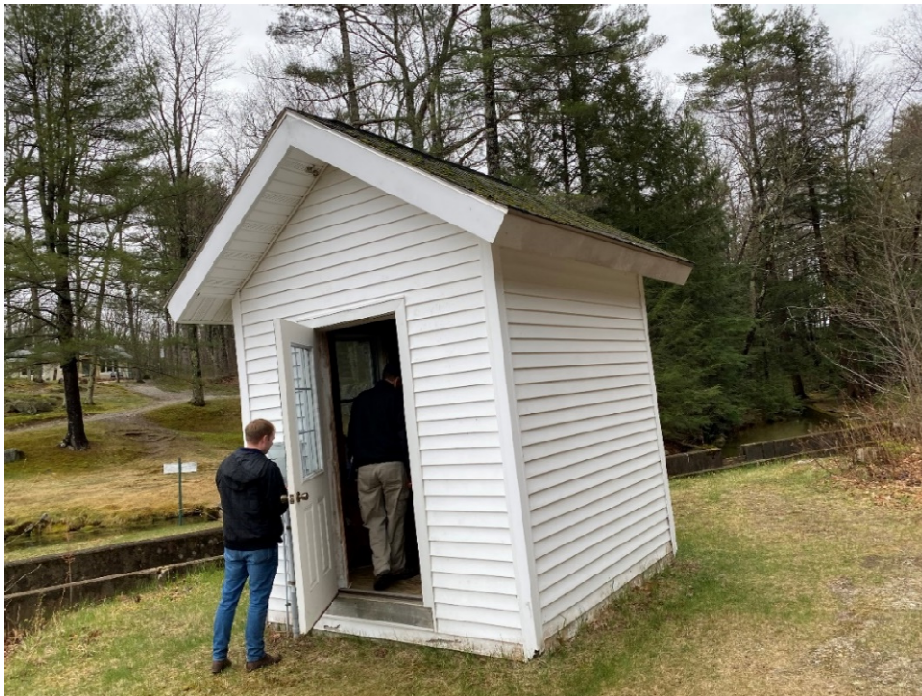
Figure 1-17: Outfall Sampling Shed

There are sampling sheds located near each of the two outfall locations. Each shed is an insulated wood frame shed structure over an access well to allow monitoring and sampling of the water that is discharging to the Merrymeeting River. Both sheds appear to be in fair to good condition.

The exterior of both sheds is finished with vinyl siding, which appear to be in good to fair condition. Some cracking of the corner trim was observed at Outfall 002.

The finish floor of both sheds is approximately 14 inches above the ground, and there are no steps up to the door. Hatchery staff noted that this is occasionally a tripping hazard as shown in Figure 1-17.

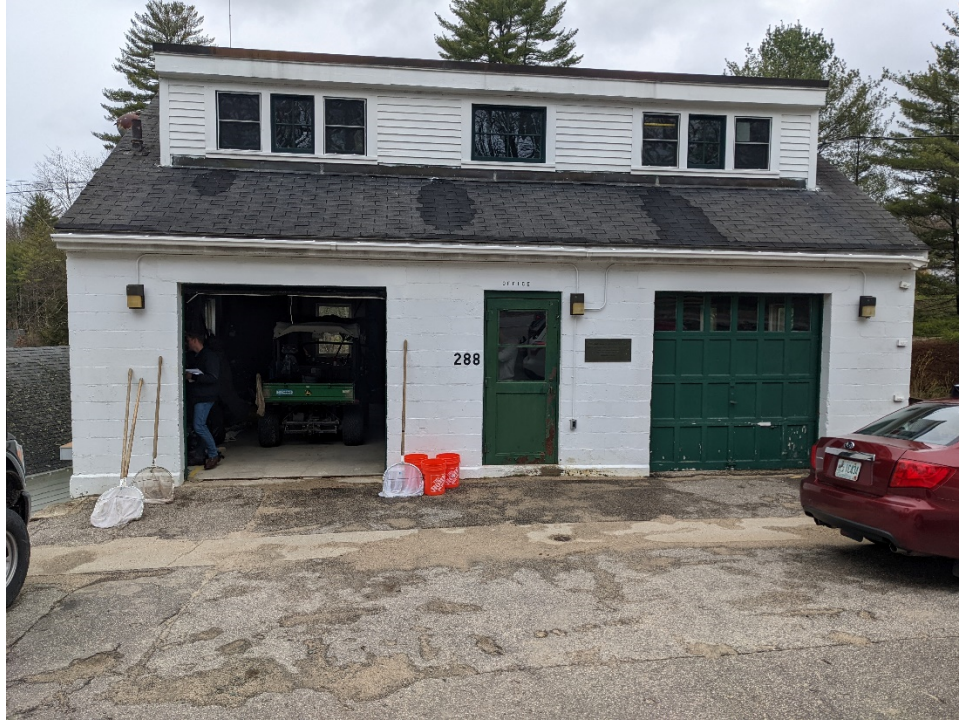
Figure 1-18: Hatchery Headquarters

The main office building (2,026 SF) was constructed in 1947 (see Figure 1-18). The wood and concrete building consists of three floors of operable space. The top floor includes a break room with kitchen and laboratory. The main floor serves as a garage and storage area while the basement contains a bathroom with shower, changing/boot room, one room visitor center, and a furnace/utility/storage room. An underground storage tank (UST) leak detection system is installed for the USTs located adjacent to the building.

This building consists of three floors, with a concrete foundation basement, CMU walls at the first floor, and wood frame construction on the second floor.

The main front entrance is at ground level, which consists of two garage bays with rollup doors primarily used for vehicle and equipment storage. The upper floor is used as a break room, laboratory and office. The basement level consists of a change room, a restroom, furnace/utility/storage rooms and a room with public displays, which is rarely used due to accessibility limitations.

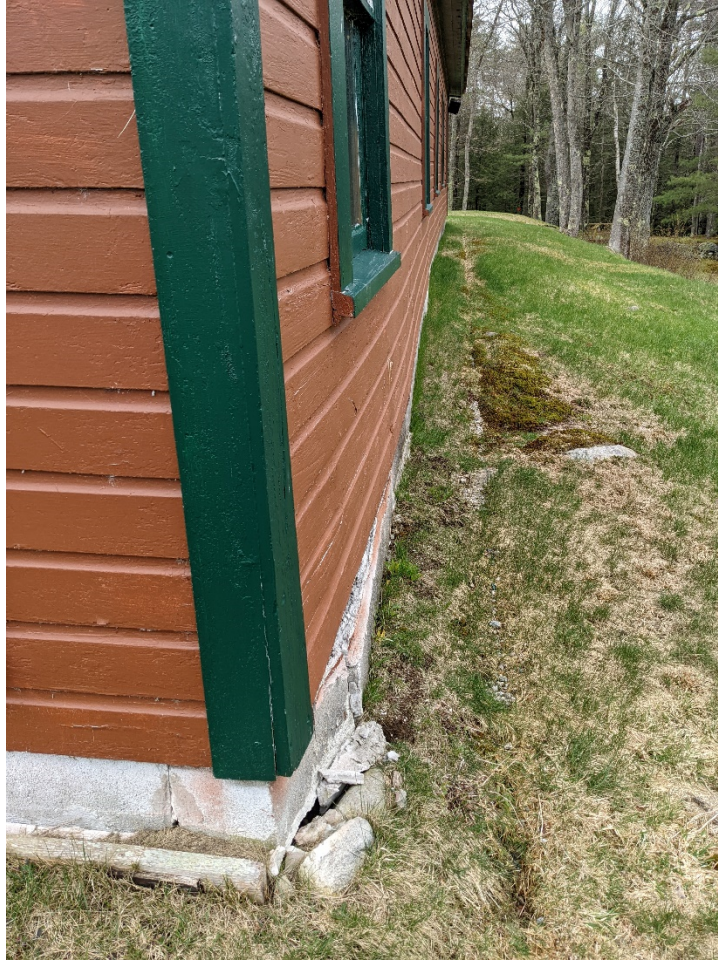
Figure 1-19: Feed Storage Building

The southern feed storage building is also a wood frame structure to hold bagged feed for the lower circular rearing units and is in good condition (unknown age). The feed storage building is not temperature controlled. Truck access is provided but no unloading features are present. A large garage door and ramp provide access to this building.

The southern feed storage building is a wood framed shed sitting on concrete sonotubes, with the floor raised approximately 16 to 24 inches above the ground. This building consists of an observation room for monitoring the circular rearing tanks and a storage room. This building currently has no electricity. The observation room has asbestos panel interior walls and ceiling finishes. The storage area is unfinished. The doors and windows were observed to be operable, but none of them were observed to provide tight seals, which provides multiple opportunities for rats to access the building and get into the feed. This building provides adequate space for feed storage but is inefficient due to the loss of feed caused by the inability to maintain proper temperatures and prevent rodents from accessing the feed.
