# Existing Conditions and Facility Evaluations – Twin Mountain

POWDER MILL FISH HATCHERY FEASIBILITY  
STUDY

New Hampshire Fish and Game Department

May 25, 2023

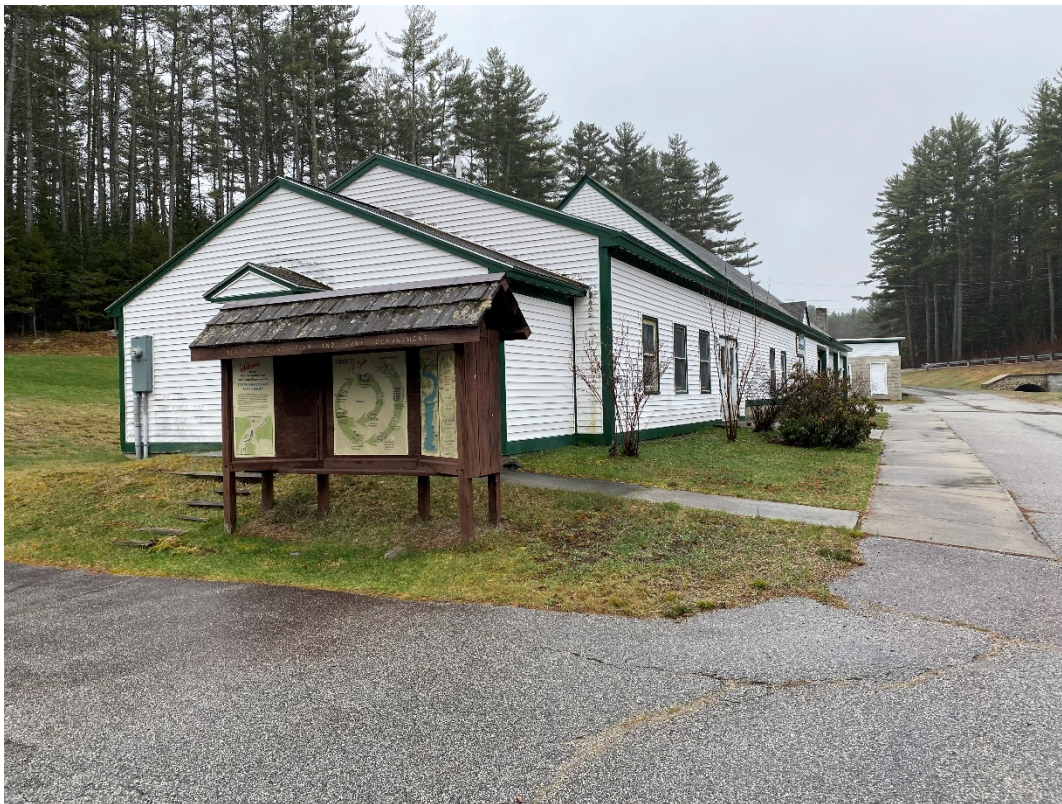
Twin personnel estimate that approximately 10,000 people visit the facility annually. Visitor's amenities include a visitor's center (Figure 3-1) with public amenities, visitor's parking, information signs, brochures, fish feeding, and fish viewing areas.

**Figure 3-1: Visitor's Center & Information Sign**

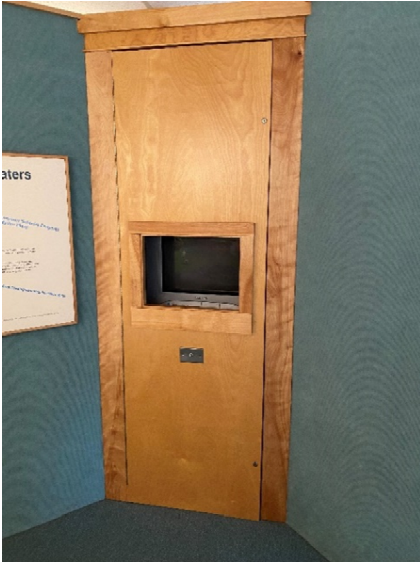
**Figure 3-2: Digital Display**

- Patch the water damaged areas of the walls in the bathrooms
- Provide fresh coat of paint on all walls
- Upgrade the digital display to a new LED screen, with new controls, so this display can be easily changed.
- Install internet or a WIFI system so that it can be used in the visitor's center.

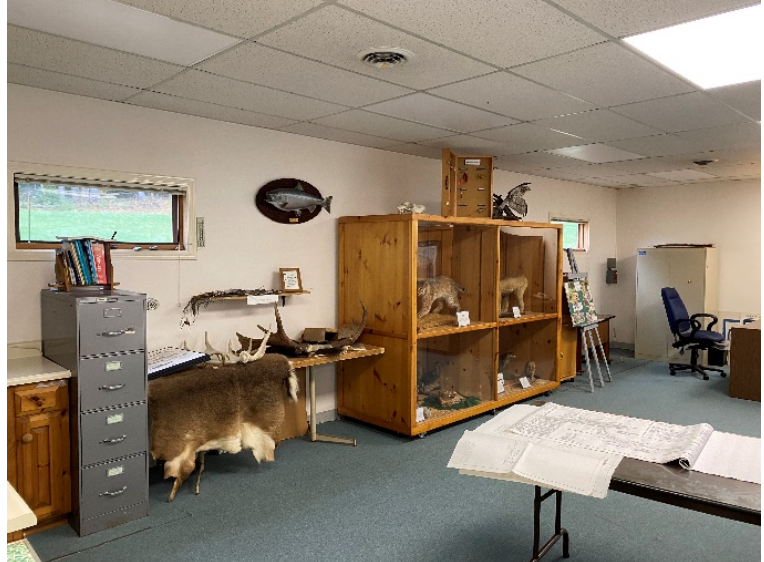
The finishes consist of vinyl sheet flooring in the vestibules and thin carpeting in the meeting room and display room, gypsum board walls, and acoustic ceiling tiles, all of which are original to the 1992 renovation. The vinyl sheet flooring appears to still be in good condition, but the carpeting is showing signs of wear and tear and has large rips in various locations in the meeting room (Figure 3-3). The ceiling tiles are in good shape other than some water damage in few locations from leaks through the roof (Figure 3-4). The doors appear to be good to fair condition, other than some rusting on the double doors at the exit vestibule (Figure 3-5). The windows are wood double hung windows with double pane insulated glazing, which are installed as part of the 1992 renovation and are in good condition. Some staining and water damage to the walls was observed in the bathrooms.

**Figure 3-3: Meeting Room with rips in carpet**

- Replace the roof
- Replace ceiling tiles with water damage
- Replace the carpeting
- Replace the rusted double doors at the exit vestibule

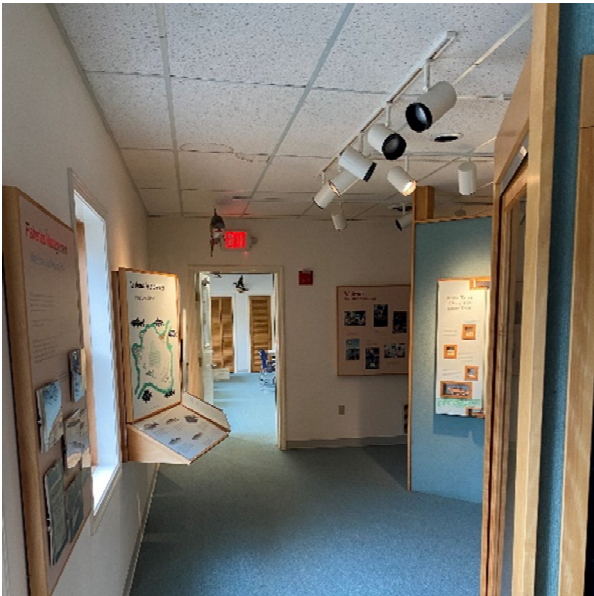
**Figure 3-4: Display Room with water damaged ceiling tiles**

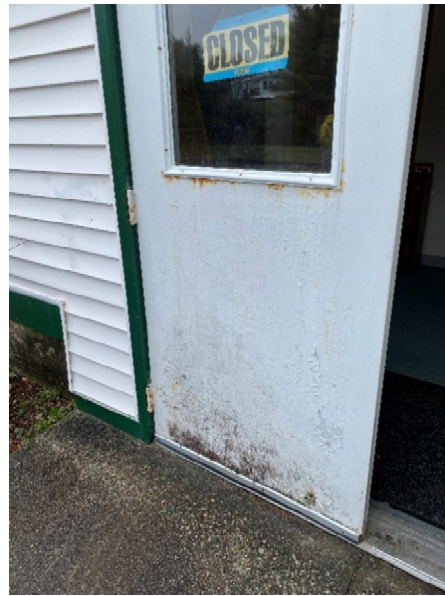
**Figure 3-5: Rusted door at Exit Vestibule**

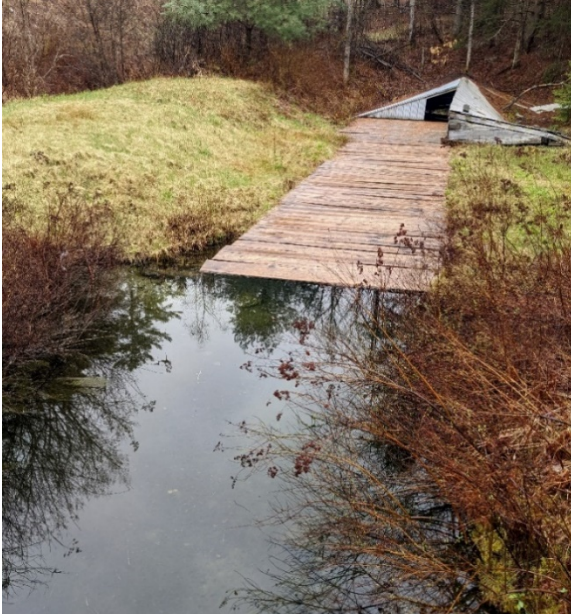
The covered spring pool is approximately half uncovered and the cover over the upper half is collapsed (Figure 4-1). It has a screened pool outlet box (Figure 4-2) with piping leading to a junction box (Figure 4-3) leading to B-Series Raceways. There is also a pipeline leading to the Hatchery Building. The pool has a concrete headbox impoundment that can spill into an unnamed tributary to Carroll Stream. The headbox concrete is in good condition. It should be cleaned of debris and vegetation and a new headbox cover should be installed.

The roof of the covered spring collapsed approximately six years ago and has not yet been repaired. Staff noted that partial repairs took place around 2005, but they did not have enough funding to repair the entire structure. The part of the walkway over the spring leading to the covered spring that was replaced during the 2005 repairs appears to be in good condition. It is recommended that the structure over Covered Spring be replaced, and any built up debris be removed.

**Figure 4-1: Covered Spring**

- The headbox concrete should be cleaned of debris and vegetation and a new headbox cover installed.
- The structure over Covered Spring be replaced, and any built up debris be removed.

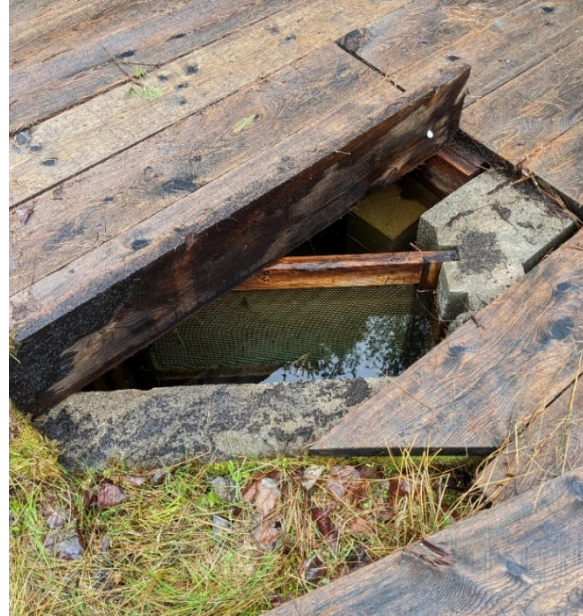
**Figure 4-2: Screening Structures Below Wooden Cover of Covered Spring**

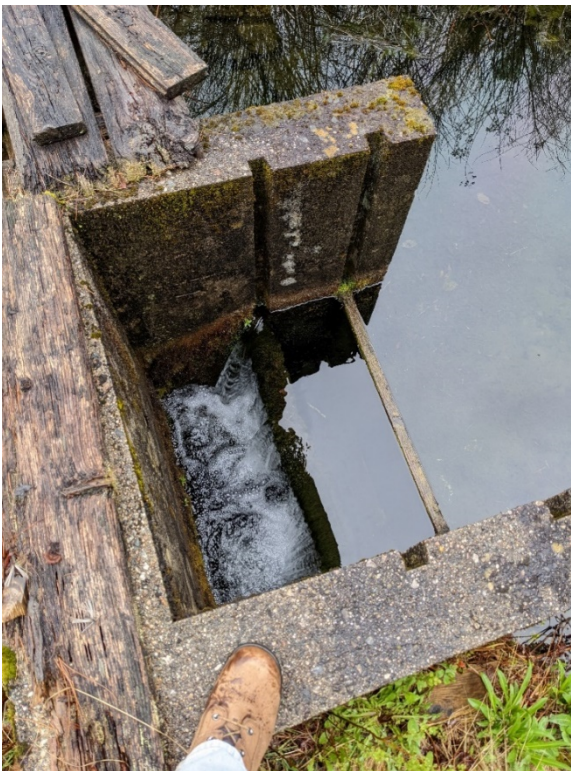
**Figure 4-3: Concrete Headbox of Covered Spring**

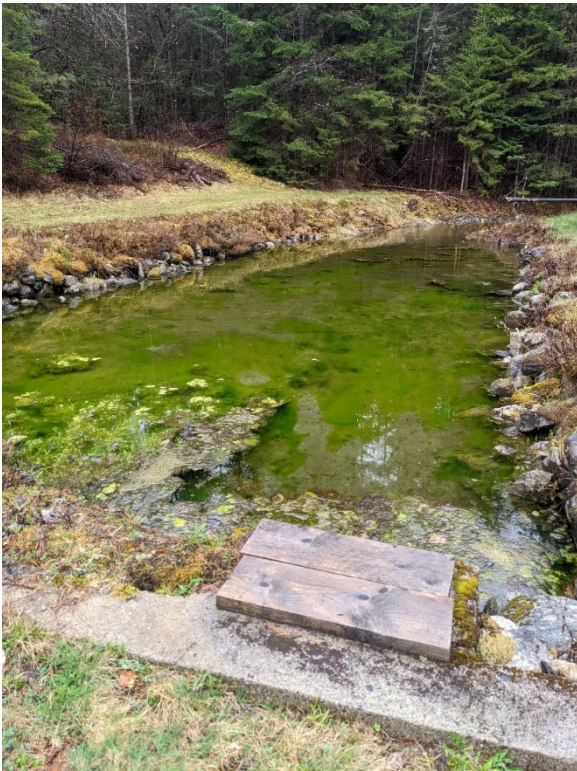
All other springs and two unnamed pools are all uncovered. Left Spring and Right Spring are shown in Figure 4-4 and Figure 4-5, respectively. Flows from all of the springs, but Right Spring and Pine Tree Spring, are collected into two lines join within a distribution box. From here, the line continues north to a junction box where flow from Right Spring merges in prior to entering a channel within the abandoned A-Series. Pine Tree Spring water is piped to approximately the center of the header of A-Series Raceways. From here, the line joins with flow from Covered Spring and crosses under the road near the main entrance and before discharging into B-Series Raceways.

The spring pools contain sediment, algae, and storm related debris that should be removed periodically. Some of the intakes include screening. The concrete headboxes at the outlet of the spring ponds are in various conditions but most are in fair to good condition (Figure 4-6). These headboxes should be cleaned of debris and vegetation. If the concrete has been degraded, removal of loose and deteriorated concrete and installation of new concrete to the original structure dimensions should be completed. Additionally, the headbox covers should be replaced along with inlet screening.

**Figure 4-4: Left Spring with Headbox in Foreground**

- Sediment, algae, and storm related debris should be removed.
- Concrete headboxes at the outlet of the spring ponds should be cleaned of debris and vegetation. If the concrete has been degraded, removal of loose and deteriorated concrete and installation of new concrete to the original structure dimensions should be completed.
- Headbox covers should be replaced.
- Inlet screens should be replaced.
- All springs should be covered.

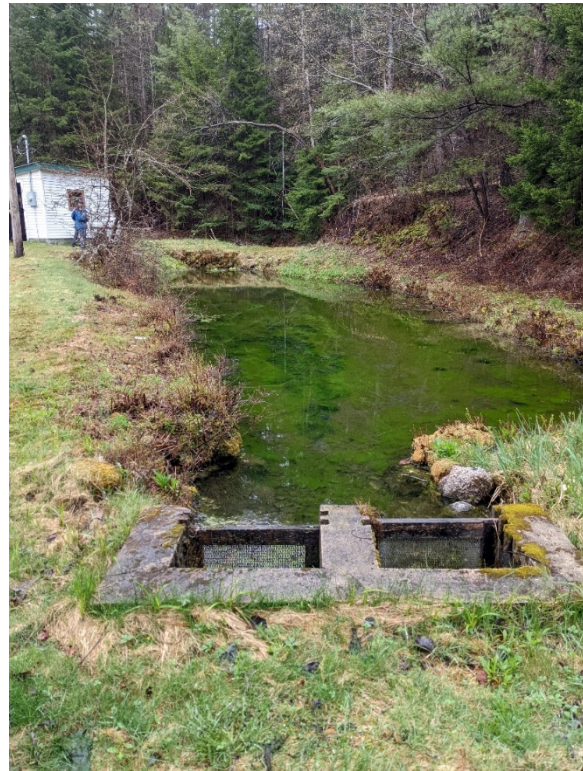
**Figure 4-5: Right Spring with Headbox in Foreground**

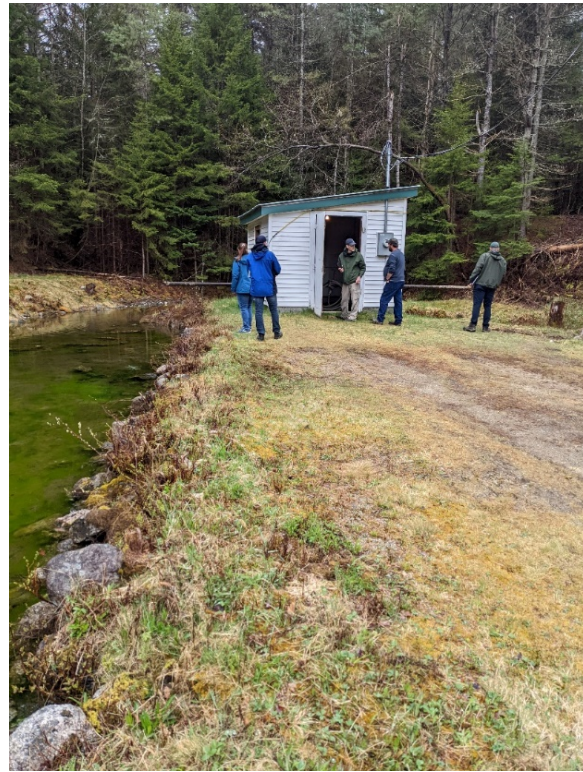
The well / pump house consists of a wood frame structure sitting on a concrete foundation and slab (Figure 4-8). The structural foundation appears to be in good condition, but the slab on grade is cracked and appears to be settling, with various size gaps between the slab and foundation. As this space floods and water seeps up through the slab (Figure 4-9), an opening has been installed at the low point in the slab to allow the water to drain out of the building towards the right spring. The well/pump house floor slab and floor drain system should be rehabilitated or replaced.

**Figure 4-8: Well / Pump Building between Left and Right Springs**

- The well/pump house floor slab and floor drain system should be rehabilitated or replaced.

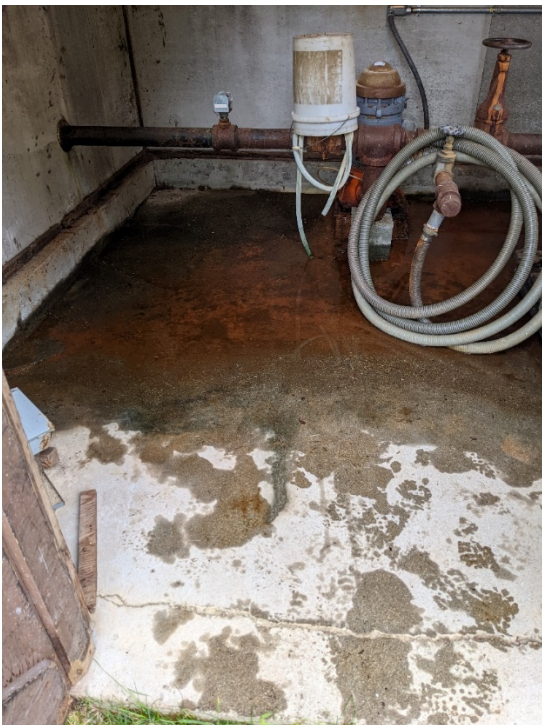
The well house interior consists of asbestos panels walls and ceiling, which have water stains from moisture build-up within the structure. The exterior walls are clad with vinyl siding and the roof is a corrugated metal roof. There is a wood door on the south façade and wood frame windows on each of the other three façades.

**Figure 4-9: Interior of Well/Pump House**

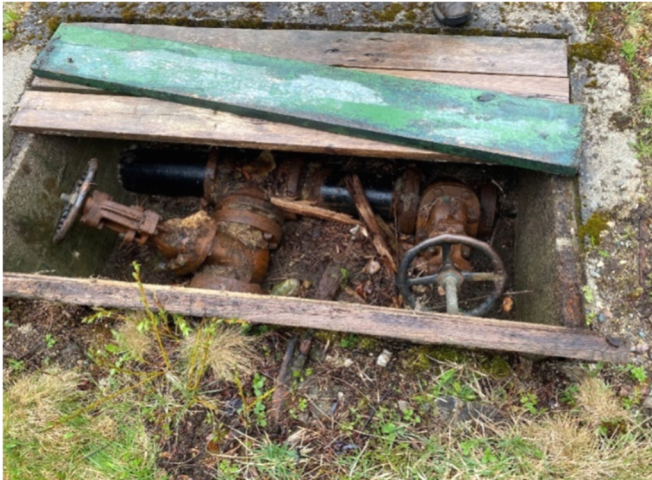
Hatchery personnel report that the collection and distribution system is in good condition and that the 6-inch diameter, ductile iron piping system is drainable. However, the concrete of these structures is severely deteriorated, and wood planks serve as covering for the structures. Each structure should be rehabilitated by removing loose and deteriorated concrete and installing new concrete to the original structure dimensions. Each structure should have a new fiber-reinforced plastic (FRP), or similar cover installed.

Figure 4-10 Distribution Box

- Each structure should be rehabilitated by removing debris and deteriorated concrete and installing new concrete to the original structure dimensions.
- Each structure should have a new FRP, or similar cover installed.

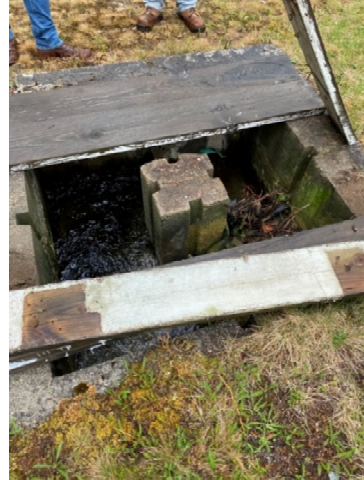
Figure 4-11 Right Spring Junction Box

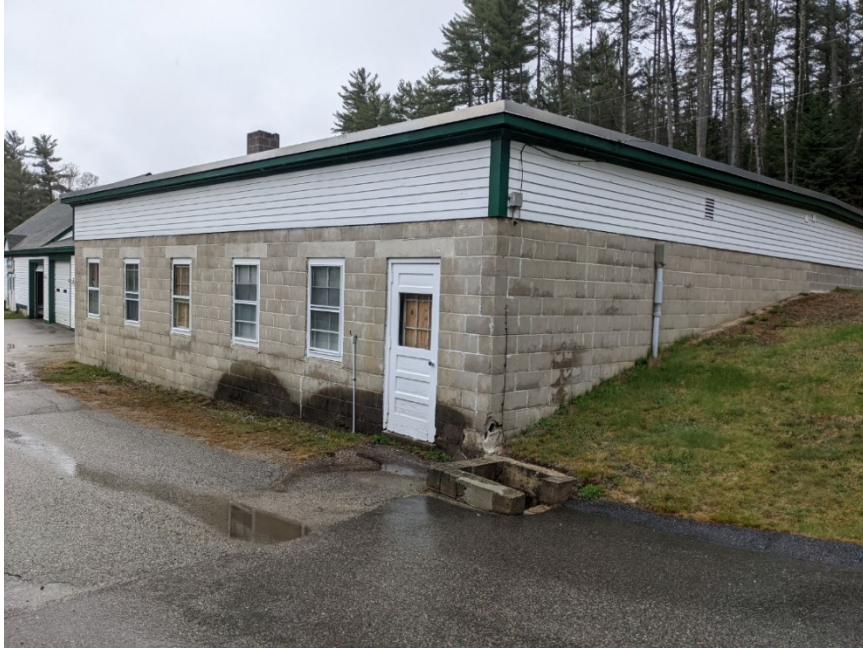
The Hatch House is a one-story masonry block building, consisting of CMU block walls and foundations and a concrete slab-on-grade floor (Figure 5-4 and Figure 5-5). The roof structure was not visible, but due to the low slope of the roof and lack of interior columns, it is believed that the roof structure is a steel beam or truss system spanning between CMU walls. The structural condition of the building is fair to good. There is some deterioration of the masonry blocks at the SW corner of the building (Figure 5-6). This may be compounded by ponding/collection of site runoff from the driveway at a catch basin at this location, or leakage into the masonry from the roof and freeze/thaw cycles. It is recommended that the masonry blocks be repointed and any cracks are sealed that allow leakage of water into the wall

**Figure 5-4: Front Face of Hatchery Building**

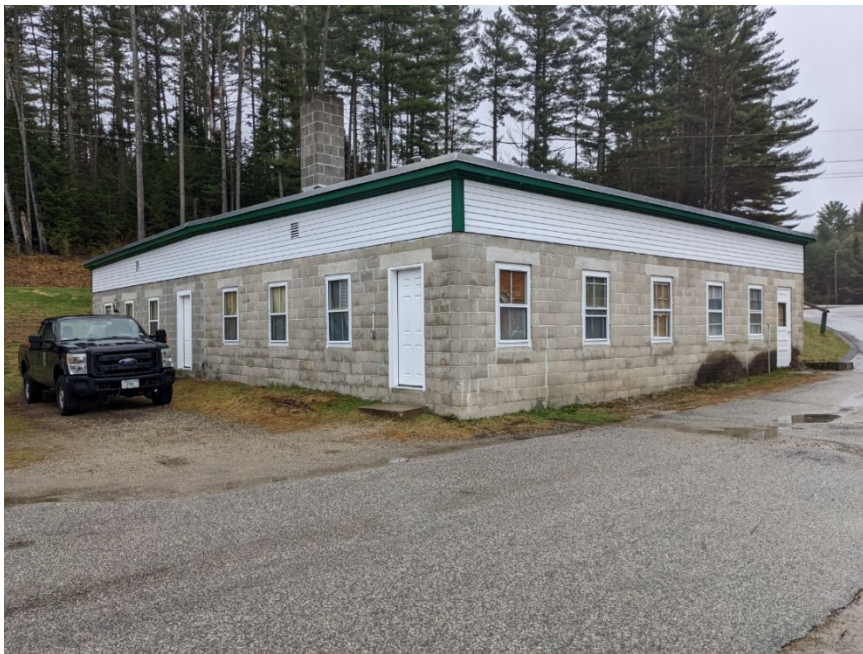
**Figure 5-5: Hatchery Building North and West Faces**

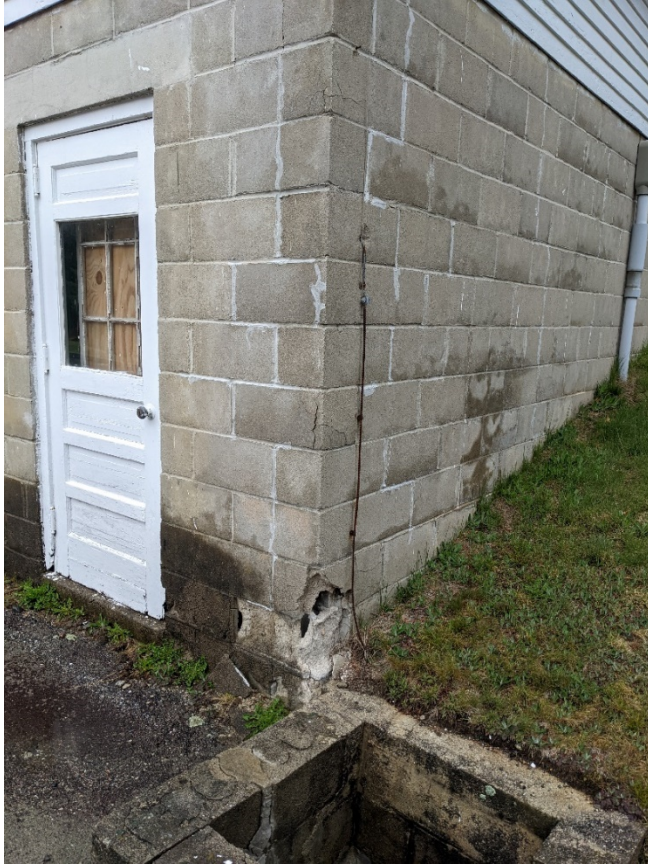
**Figure 5-6: Cracking of Masonry Block at Hatchery SW Corner**

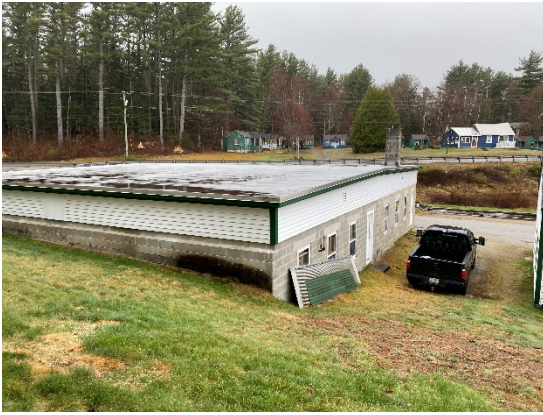
The roof is a low slope sheet membrane roof that appears to be in fair condition. However, some locations of ponding were observed (Figure 5-7). Staff noted in the winter, they have to remove snow from the roof, due to the low slope.

**Figure 5-7: Hatch House – Low Slope Roof**

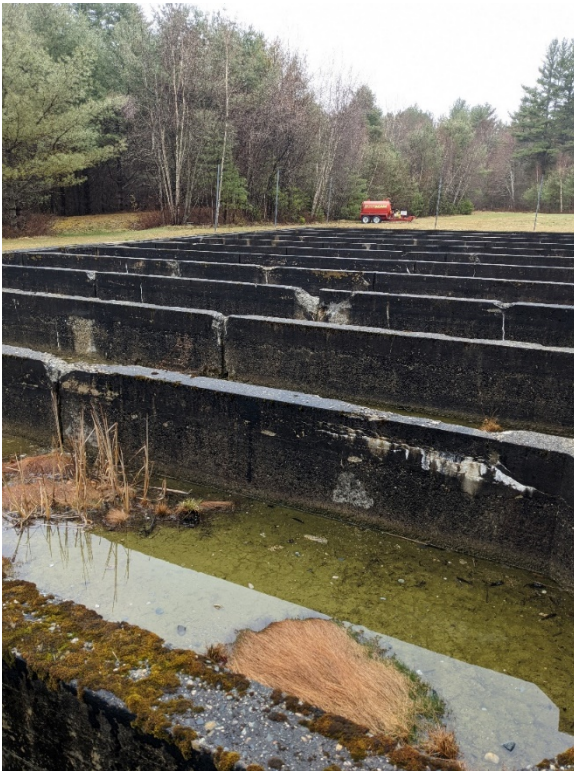
The A-Series raceways consist of twelve (12) raceways located on the west side of Route 3. The concrete of these raceways is in poor condition (Figure 5-9). The raceways are no longer used for production or water treatment. There was a section of nursery units as well in this area, but they have been abandoned and buried.

Figure 5-9: Abandoned A-Series Raceways

The concrete of the A-Series raceways is in poor condition and should be removed and replaced. The bypass channel (Figure 5-10) that is part of these raceways that carries source water to the rest of the facility should be replaced with buried piping.

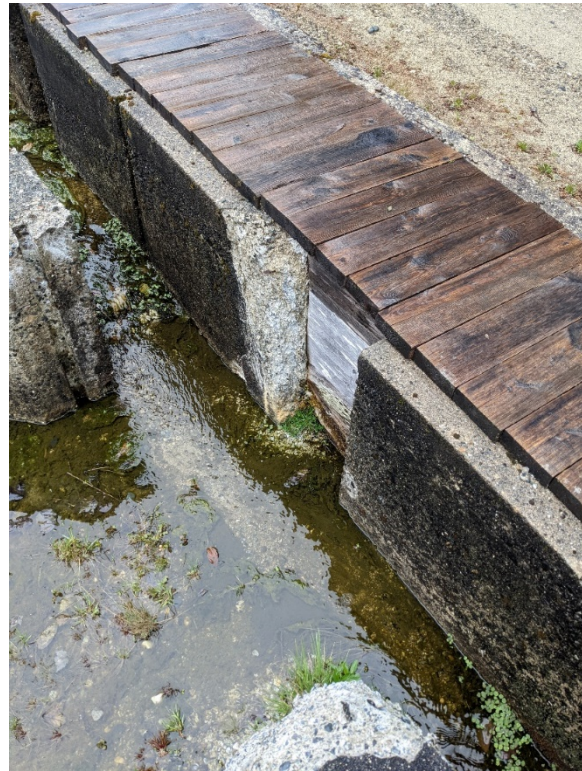
Figure 5-10: Covered Bypass Channel at A-Series Raceways

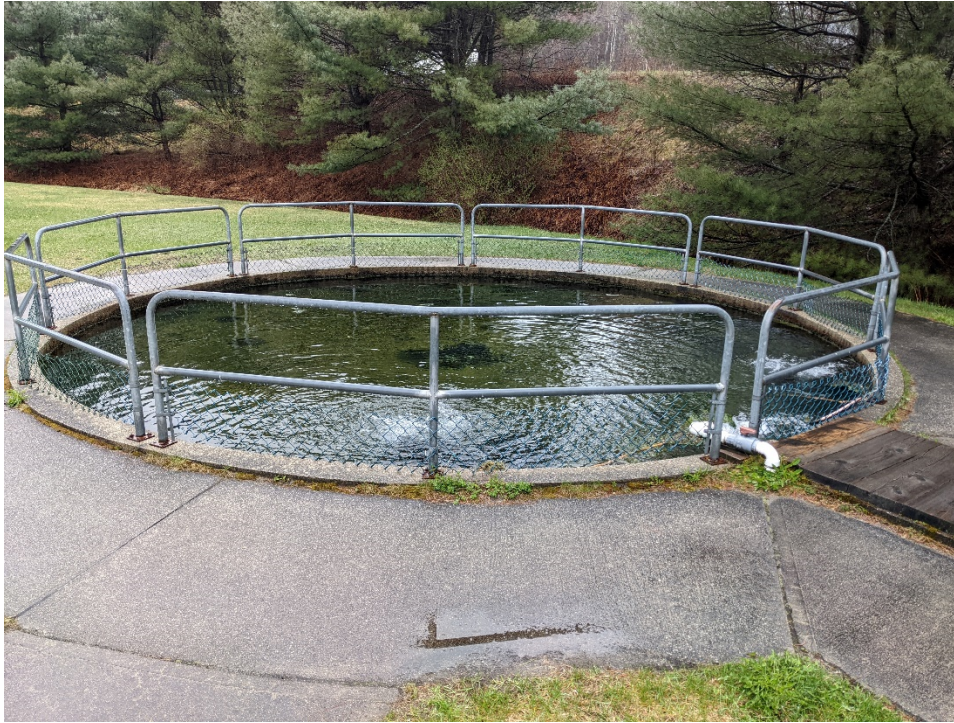
The show pool concrete is in fair to good condition, with minor chipping of exposed surfaces and minor abrasion and loss of mortar (less than 1/8-inch average depth) below the water line.

**Figure 5-12: Show Pool**

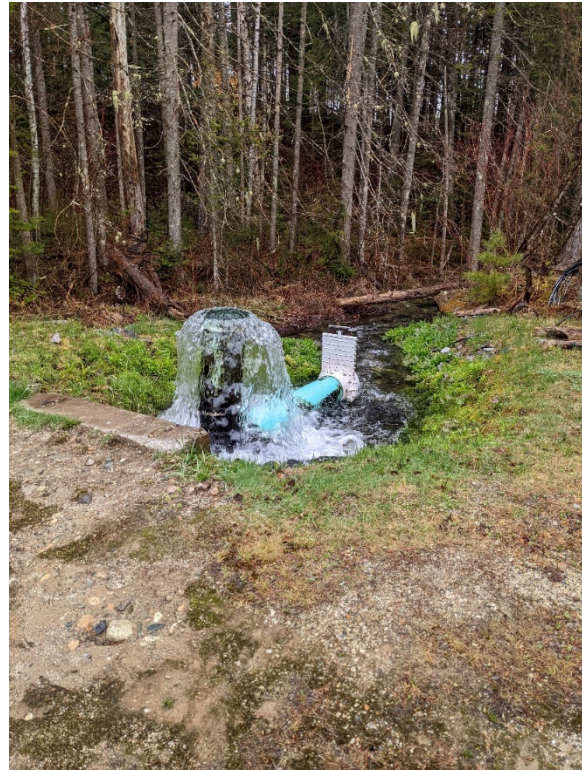
The outfall is a standpipe and closed knife gate valve that assures a full pipeline that the meter needs (Figure 5-14). The knife gate can be opened to service the pipeline. The outfall pipe is protected by a reinforced concrete headwall. The headwall concrete is in fair condition, with minor chipping and spalling.

Figure 5-14: Outfall Pipe

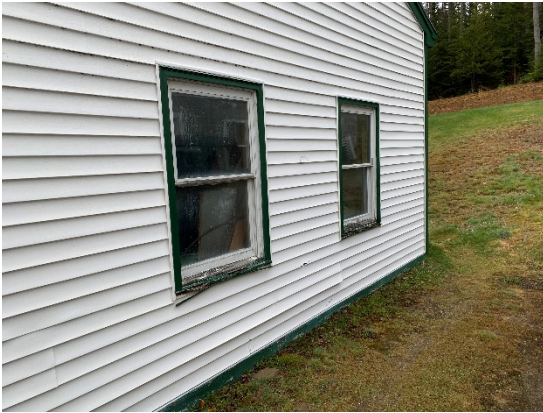
There are two double hung windows on the south end of the double garage bay that are wood frame single-pane windows. The sills of both windows are rotted and falling apart (Figure 7-7). All three overhead garage doors appear to be in fair to good condition and are all operable.

**Figure 7-7: Visitor's Center Garages Damaged Windows**

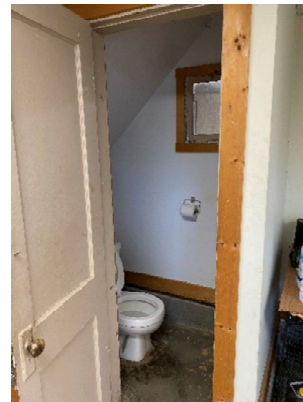
Since this building was originally constructed as a garage and maintenance shop, the layout does not comply with current codes for the current office uses. The headroom over the toilet drops down to 4'-2" above the back of the toilet, which is less than the minimum 6'-8" allowed per building code. And the door to the bathroom is only 24-inches wide (Figure 7-14).

**Figure 7-14: Bathroom**

In order to bring this building up to code, it will need to be gutted and the layout completely revised. It is recommended that this building no longer be used for office space, and remain in place for storage only, and a new office space be provided elsewhere on-site.
