# Existing Conditions and Facility Evaluations - Warren

POWDER MILL FISH HATCHERY FEASIBILITY  
STUDY

New Hampshire Fish and Game Department

May 25, 2023

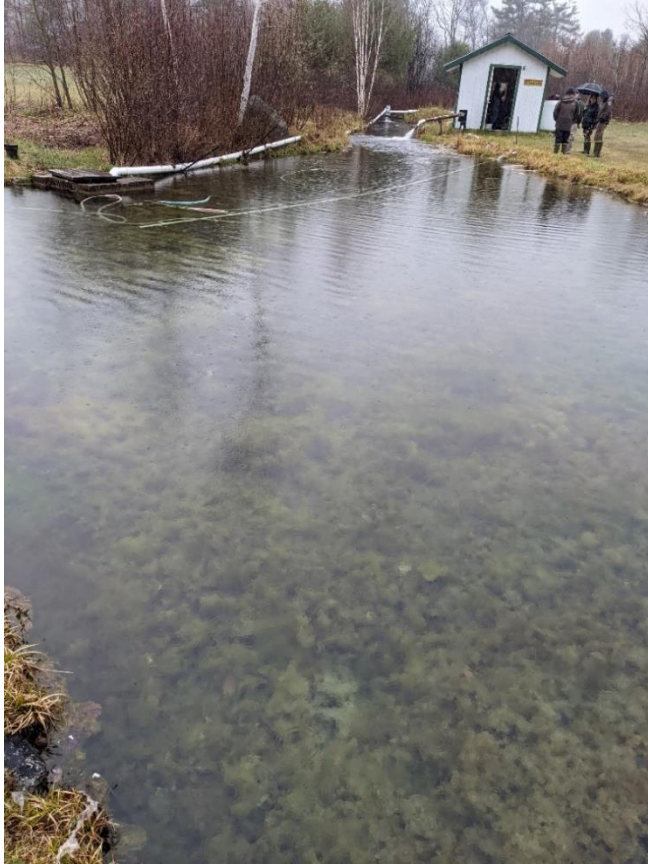
**Figure 4-1: Well/Pump House #1 and Spring Reservoir**

Well #1 is housed next to Pump 1 Reservoir and fills the reservoir, see Figure 4-1. The pump is a 5 horsepower (hp) end-suction centrifugal pump that must be manually primed. Its nameplate says Rice Pump & Machine Co. When they are searched on the internet, results include [vintagemachinery.org](http://vintagemachinery.org) and the National Museum of American History (Smithsonian). A new pump is justifiable. Self-priming pumps are available, although they might be less efficient.

Heating for Well # 1 is provided by a wall-mounted, propane fired heater which appears to be in fair condition and should be replaced soon.

- Replace wall-mounted heater in well house.

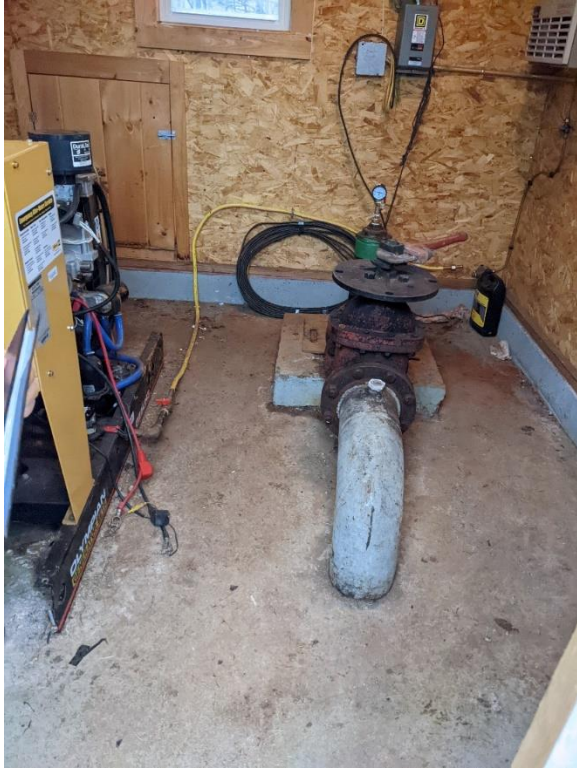
**Figure 4-2: Well/Pump House #2 and Generator**

Well #2 experienced a pump and motor failure in 2022. Currently, staff are borrowing a pump and motor to maintain operation. It is recommended by the well company that this well be abandoned due to a corroded screen and failing well capacity. A new well is estimated to cost \$125k.

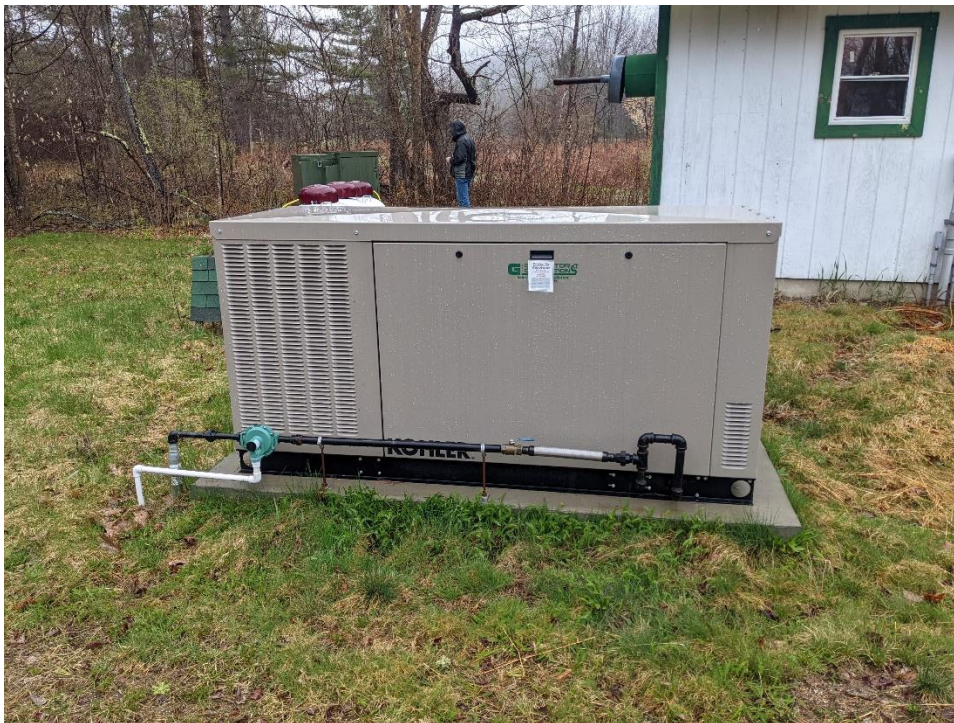
**Figure 4-4: New 25kW Standby Propane Generator**

A new (2020) 25kW standby propane generator is located near Well #2 to provide backup power to all three well houses, shown in Figure 4-4. The generator has an automatic transfer switch, and three circular propane tanks for fuel. The well house contains an abandoned indoor generator.

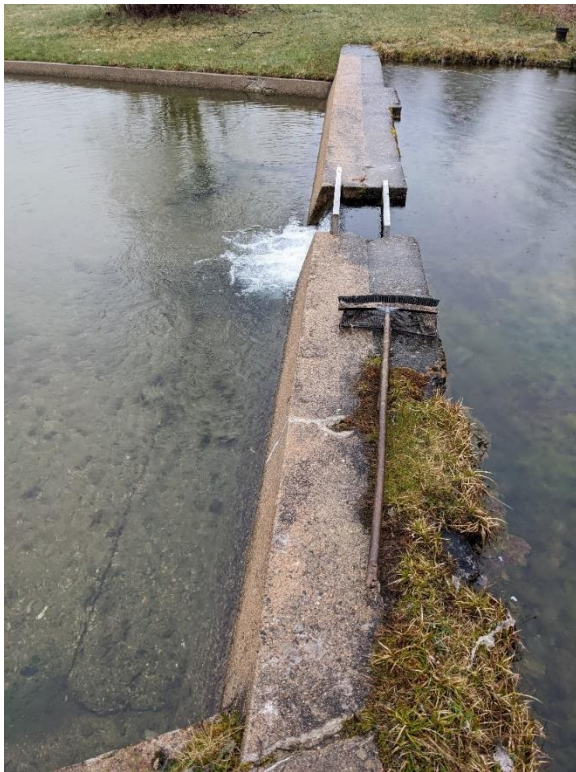
Figure 4-5: Pump 1 Reservoir Dam

The low head dam that impounds the water of Pump 1 Reservoir has an opening with weir boards and bar screens (Figure 4-5). Here water enters the Upper Reservoir Pond. The concrete of this structure is fair to good, with surface cracking and efflorescence and some vegetation growth on exposed surfaces. Other than routine cleaning, no maintenance actions are currently necessary.

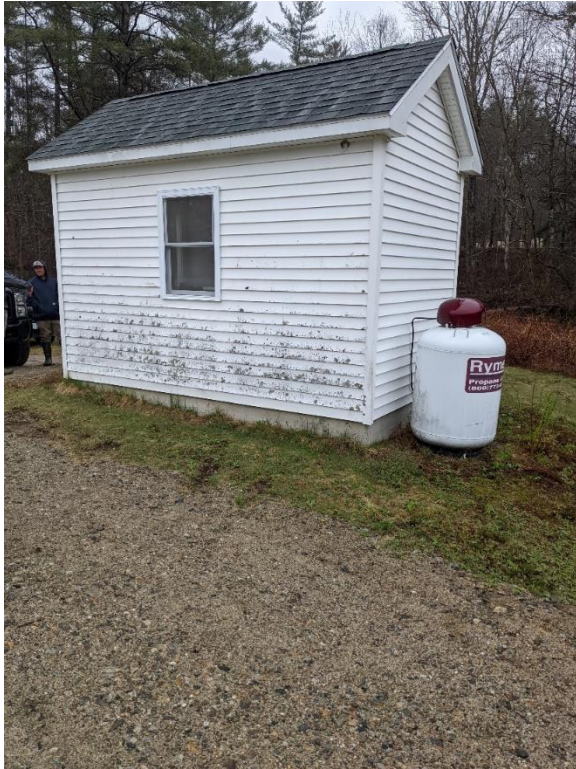
**Figure 4-6: Well/Pump House #3**

Primary and backup power to the Well #3 pump house (Figure 4-6) is served by a 60A, 208/120V circuit from the main distribution panel at Well #2. The well house has a 60A panelboard that powers the well pump, alarm system, as well as ancillary lighting/receptacles. Backup power is provided (automatically transferred) to all loads from the generator located at Well #2. The electrical infrastructure is in adequate condition. In several cases, there is insufficient clear working space in front of electrical panels (per NEC).

The pump is controlled by an on/off combination starter. An antenna is used to provide wireless communication of alarms/status to the main alarm panel in the Hatchery building. There is no automatic or remote control of the pump. Heating for Well Pump #3 is provided by wall mounted heaters which appear to be in fair condition and should be replaced soon.

- Replace wall-mounted heater in well house.
- It is recommended that Well #3 be evaluated and reconditioned.

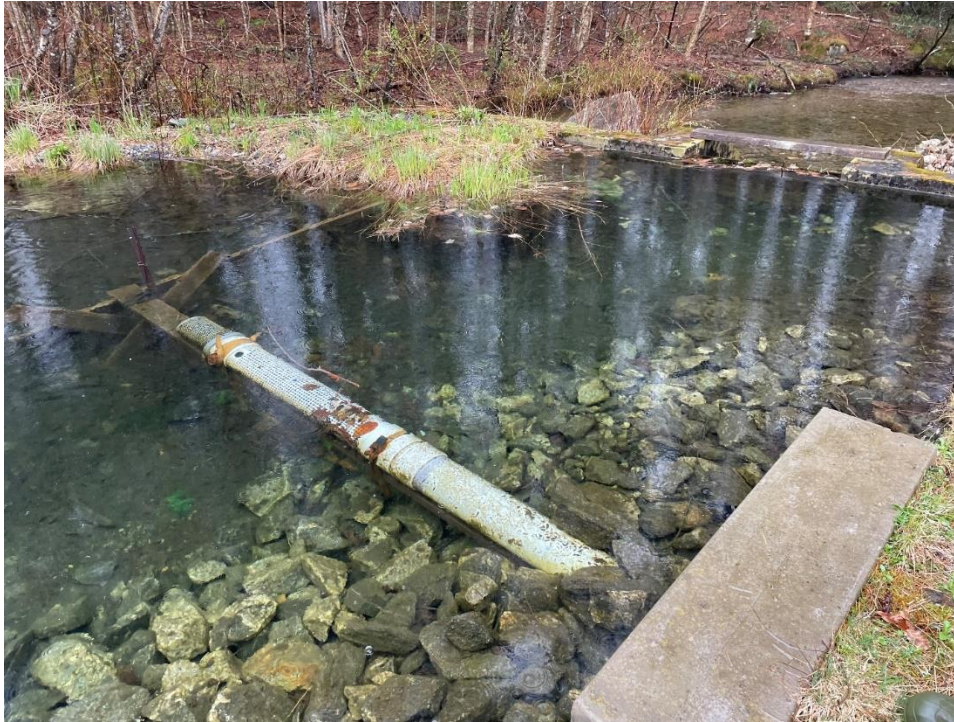
**Figure 4-7: Cylindrical intake screen in Spring Reservoir**

A cylindrical intake screen in the south end of Spring Reservoir carries water in buried 6-inch blue-green PVC pipe (Figure 4-7) to either Spring Pond (the uppermost pond of Block 2) or the Lower Reservoir Pond (the third pond of Block 1).

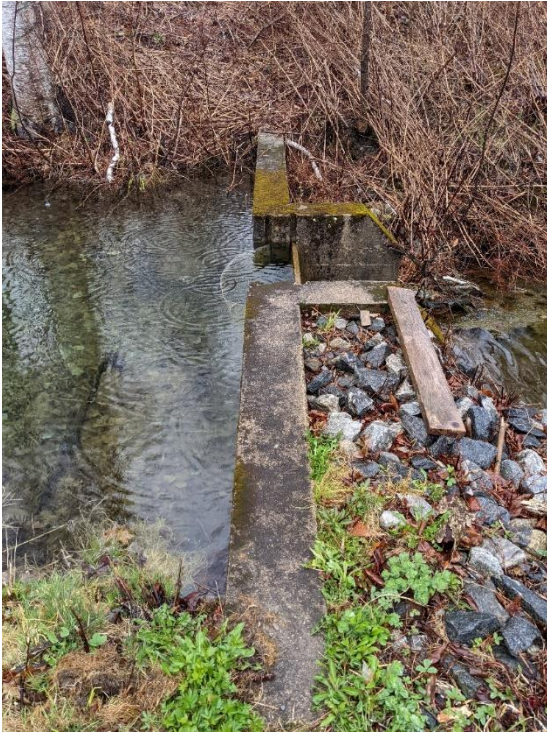
Figure 4-8: Impoundment/Dam of Pump 3 Reservoir

A concrete control structure/dam impounds water in Pump 3 Reservoir (Figure 4-8) that is collected from the Main Springs Area as well as Well #3. Impoundment height is controlled with weir boards. Riprap has been recently added downstream of the impoundment (Figure 4-9). Impounded water depth is 2-3 feet. The concrete of this control structure is in fair to good condition, with minor surface cracking and some vegetation growth on exposed surfaces. There is no recommended maintenance at this structure at this time.

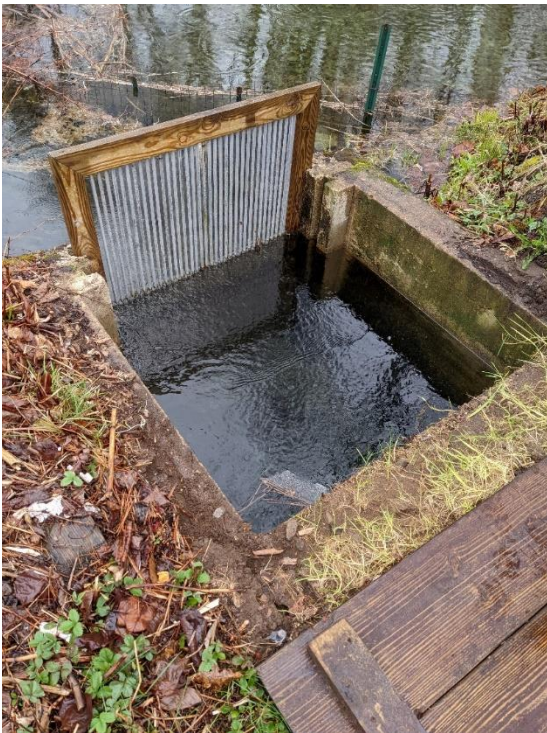
Figure 4-10: Screen Box in Pump 3 Reservoir

A screen box near the middle of the springs area protects a pipe inlet with bar screen (Figure 4-10). The pipe conveys water from Pump 3 Reservoir to Pump 1 Reservoir approximately 3,500 feet south. The structural condition of this screen box and inlet screen is fair to good. Other than routine cleaning of debris, no rehabilitation actions are necessary at this time.

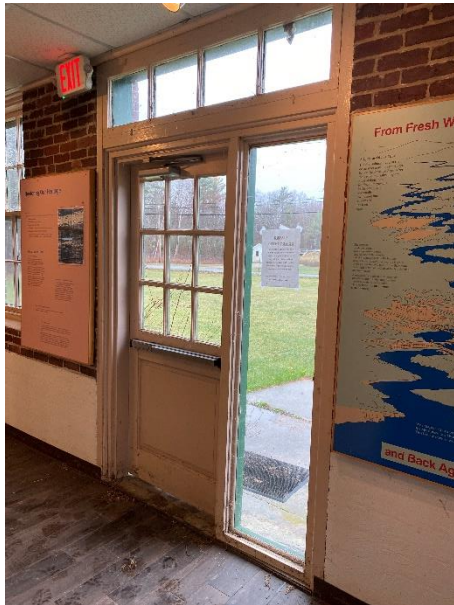
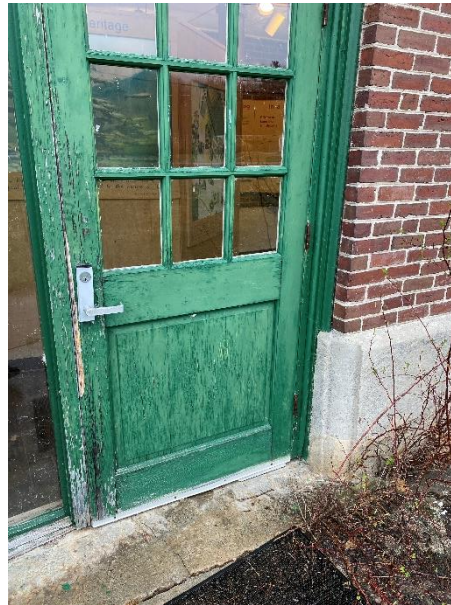
The front door, which provides access to the visitor's area is a solid wood door with glass vision panels, a glass side light, and a glass transom. The door is operable and in fair condition, however the door is not insulated, the glass panels are single pane glass, the door does not fit squarely into the frame, the weather seal is missing most of the rubber gasket, and the exterior paint is peeling. The concrete sill has some minor cracking. There is a concrete slab landing in front of the door, which is also cracked. There is no accessible route from the parking area to the front door (Figure 5-12 and Figure 5-13).

**Figure 5-12: Front door from interior**

**Figure 5-13: Front Door from exterior**

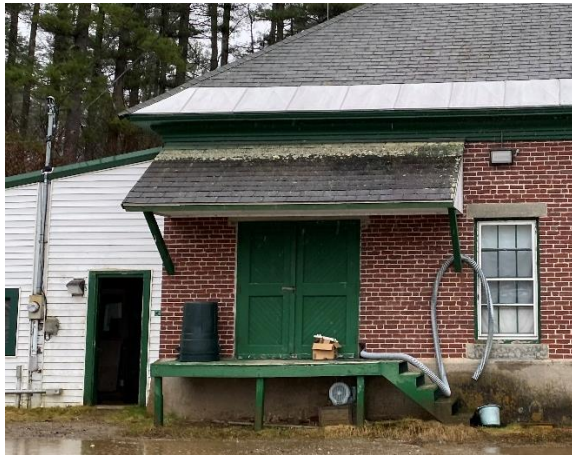
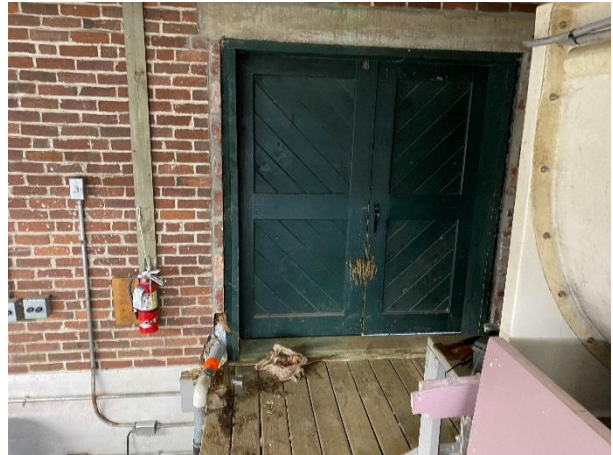
At the north side of the original hatchery building, there is a double door that provides access between the main tank room and a loading dock. This door is used for loading only and is not used for access. The door is operable and appears to be in good condition, other than the fact that the door is not insulated and does not create a tight seal, especially at the bottom of the door. This door locks from the outside only via a latch and padlock (Figure 5-14 and Figure 5-15).

**Figure 5-14: Side Loading Dock Door**

**Figure 5-15: Loading Dock Door from Inside**

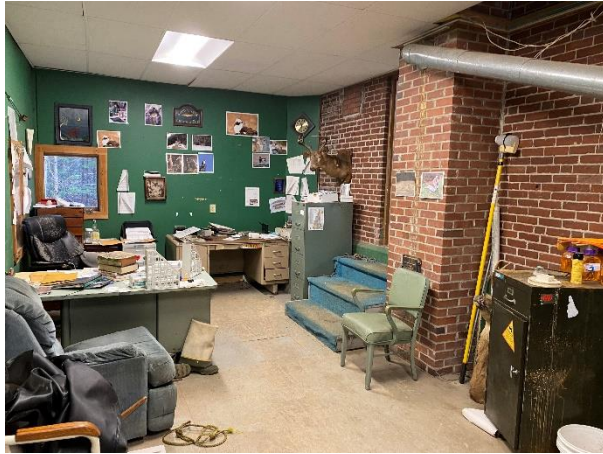
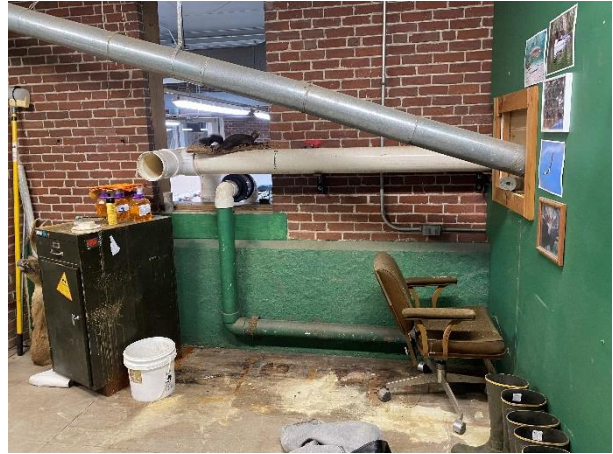
asbestos paneling walls over wood framing, and exposed brick and concrete walls. The floor, ceiling and panel walls appear to be in fair condition (Figure 5-24 and Figure 5-25).

**Figure 5-24: Office Space & Stairs to Main Tank Room**

**Figure 5-25: Office Space window opening to main tank room**

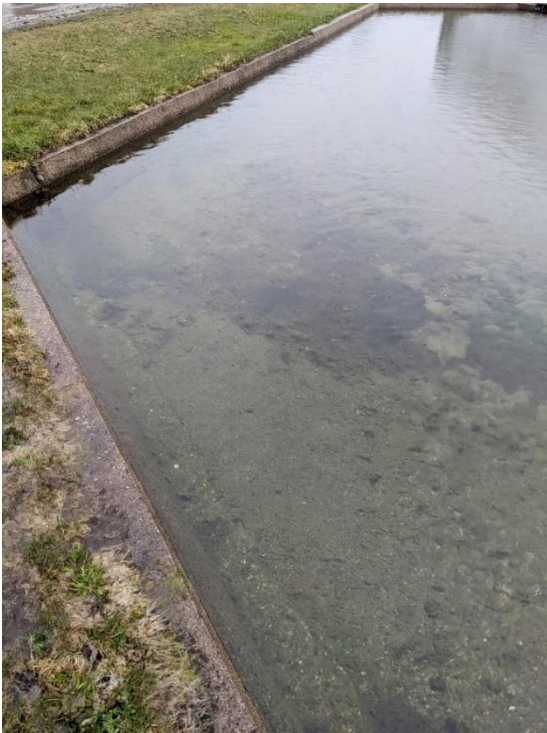
with epoxy mortar would reduce loss of water due to leakage. The water level at the shallow ponds is typically kept near the top of the walls, which acts to reduce deterioration due to temperature changes and weathering (Figure 5-28 to Figure 5-32).

**Figure 5-28: Walls at Upper Reservoir Pond**

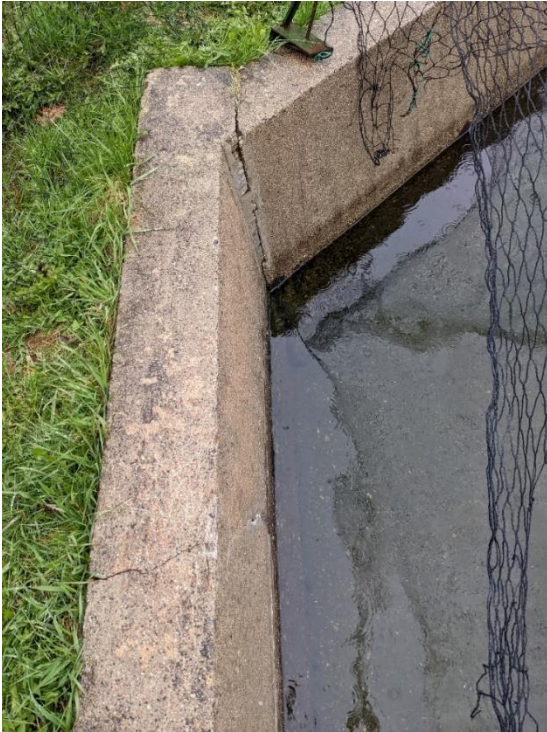
**Figure 5-30: Typical Pond Wall Cracking at Angles/Corners**

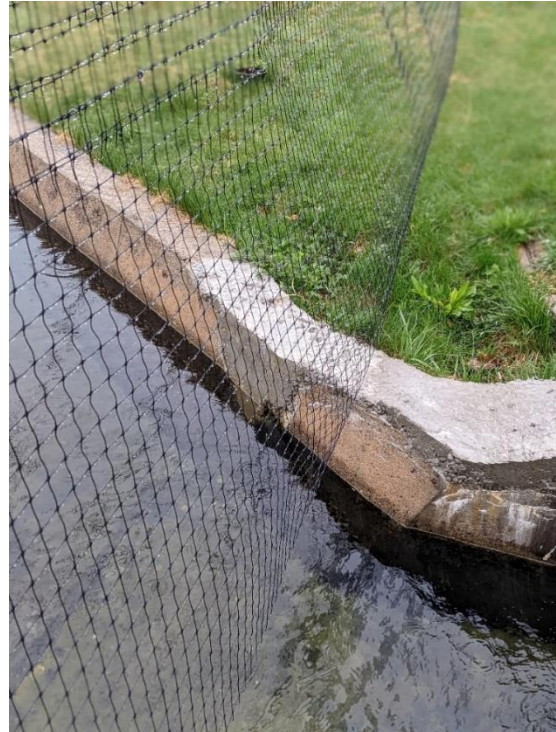
**Figure 5-31: Previously Repaired Wall at Inlet to Middle Reservoir Pond**

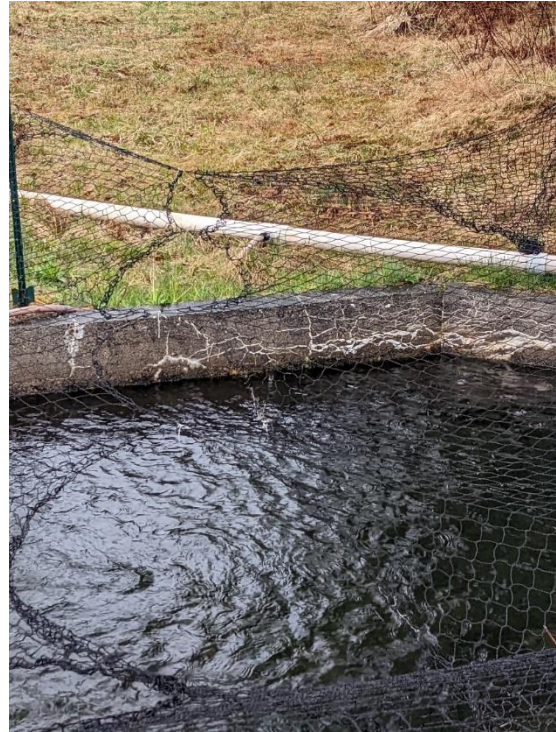
**Figure 5-34: Concrete Deterioration at Block 2 Ponds**

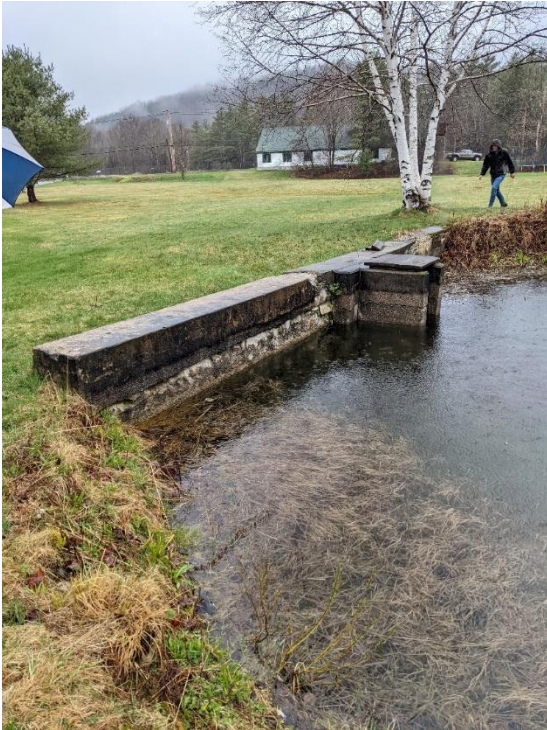
Figure 5-36: Impoundment/Outlet Box at PR Pond

The structural condition of the headwall and outlet box at the PR (Public Relations) Pond is fair, with moderate cracking and spalling and efflorescence. The outlet box concrete should be rehabilitated to repair spalling as part of routine maintenance. The headwall concrete should also be scheduled for routine maintenance and patching of spalls, etc.

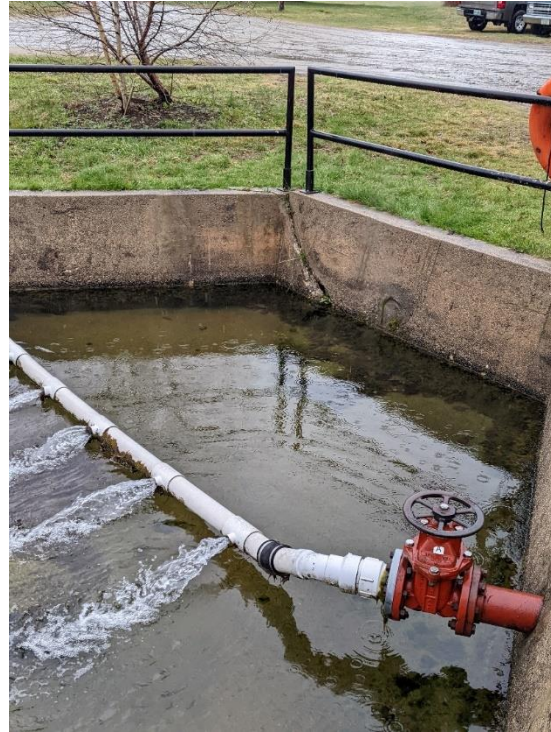
Figure 5-39: Typical Wall Cracking at Show Pond

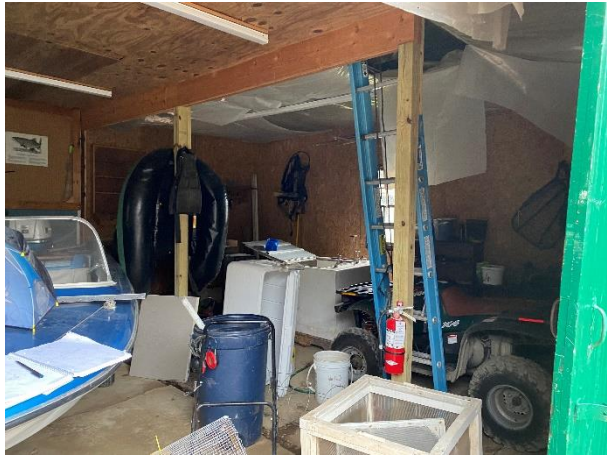
The Garage is adjacent to the Visitor Center and Assistant Residence behind the Hatch House, see Figure 6-1. It is a 19-foot by 19-foot wood structure that is used for the storage of miscellaneous vehicles, equipment, and storage, consisting of two garage bays and a storage loft above the eastern bay. The structure consists of a concrete foundation and floor slab with timber framed walls, roof, and two wood columns that support a central wood beam for the storage loft. The wood framing appears to be in good condition, but the concrete slab was observed to have significant cracking, most notably along the column line in the middle of the garage (see Figure 6-2).

**Figure 6-2: Cracked Floor and Plastic Sheetting**

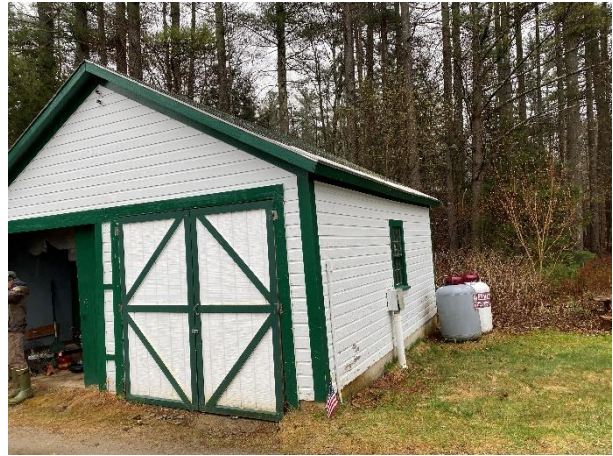
Power to the garage is sub-fed underground from the Visitor's Center building panel. The building has receptacles and fluorescent lighting. The condition of electrical infrastructure appears adequate for the needs (see Figure 6-3).

**Figure 6-3: West Facade Electrical Connection and Propane Tanks**

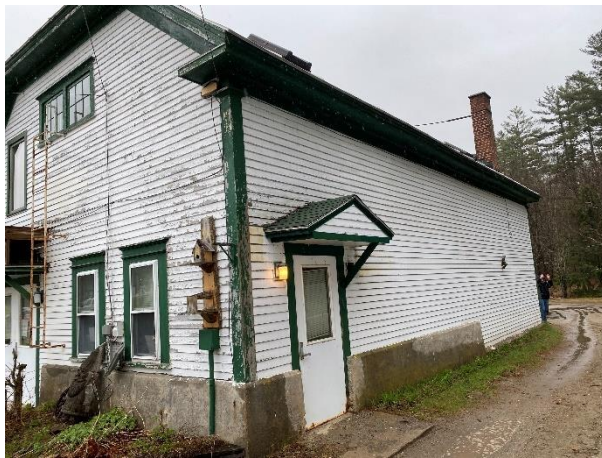
Otherwise, the public bathrooms were in good to fair condition. Although both rooms showed visible rusting on the bottom of the doors, and on the radiators, which is likely due to frequent flooding in this area.

**Figure 6-22: Rusty bottom of door to Visitor Center**

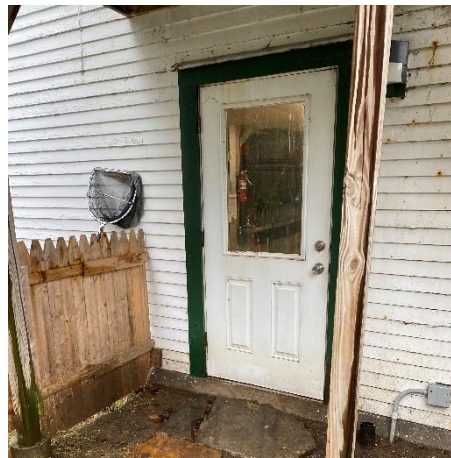
**Figure 6-23: Rusted Hinges on Door to Mechanical Room**

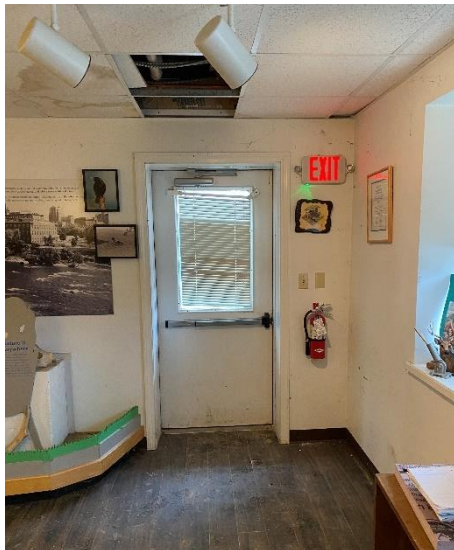
**Figure 6-24: Visitor Center Water Damaged Ceiling Tiles**

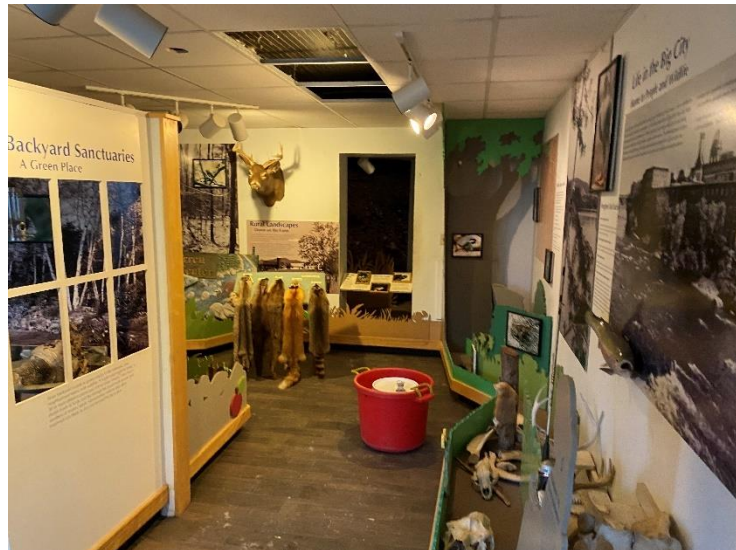
**Figure 6-25: Visitor Center Missing Ceiling Tiles**

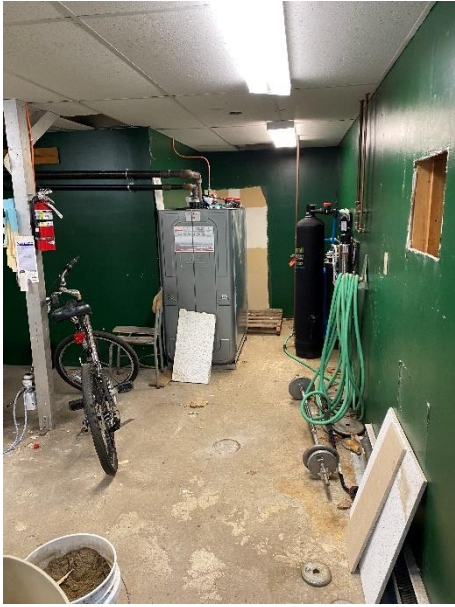
**Figure 6-26: Mechanical Room cut outs in wall**

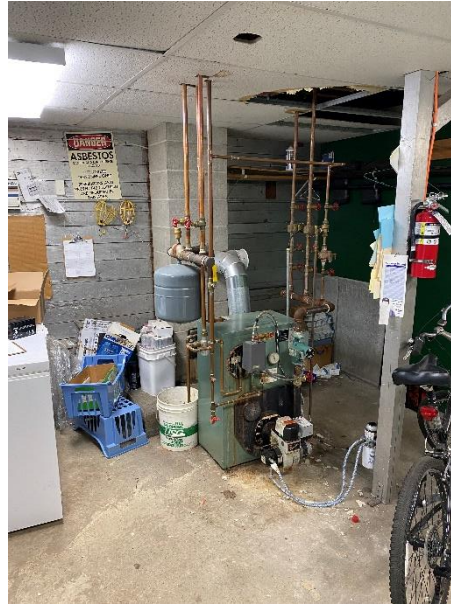
**Figure 6-27: Mechanical Room missing and broken ceiling tiles**
