Existing Conditions and Facility Evaluations - Berlin

POWDER MILL FISH HATCHERY FEASIBILITY
STUDY

New Hampshire Fish and Game Department

May 25, 2023

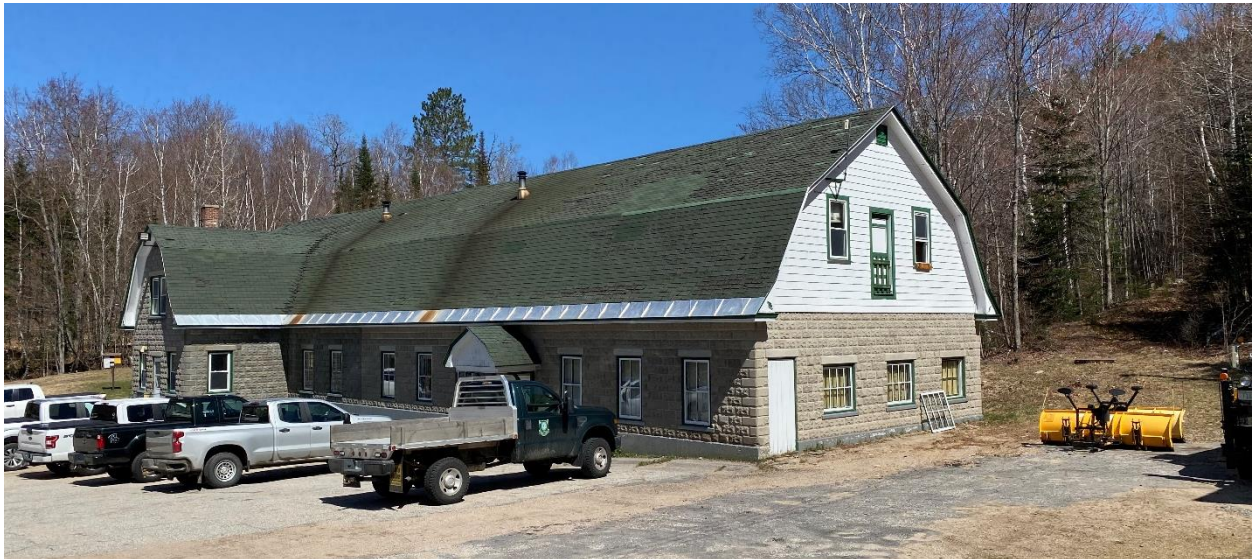
Figure 5-1: Headquarters Office and Hatchery Building

The Headquarters Office and Hatchery Building (Figure 5-1) consists of the original section, constructed in 1930-1932, along with additions built in 1949 and 1985. The building has a total area of 7,245 square feet, including two floors with a partial basement. The first floor houses the hatchery area, process boiler room, degasser room, and main entrance with a bathroom. The second floor houses office spaces, a break room with kitchenette, storage areas, and a laboratory. The partial basement is a single space located below the main entrance. A water heater and boiler that supports the buildings hydronic space heating resides there.

The Headquarters Office and Hatchery Building is a CMU block building on a concrete foundation with a wood framed second floor and roof structure. The overall structure appears to be in good condition.

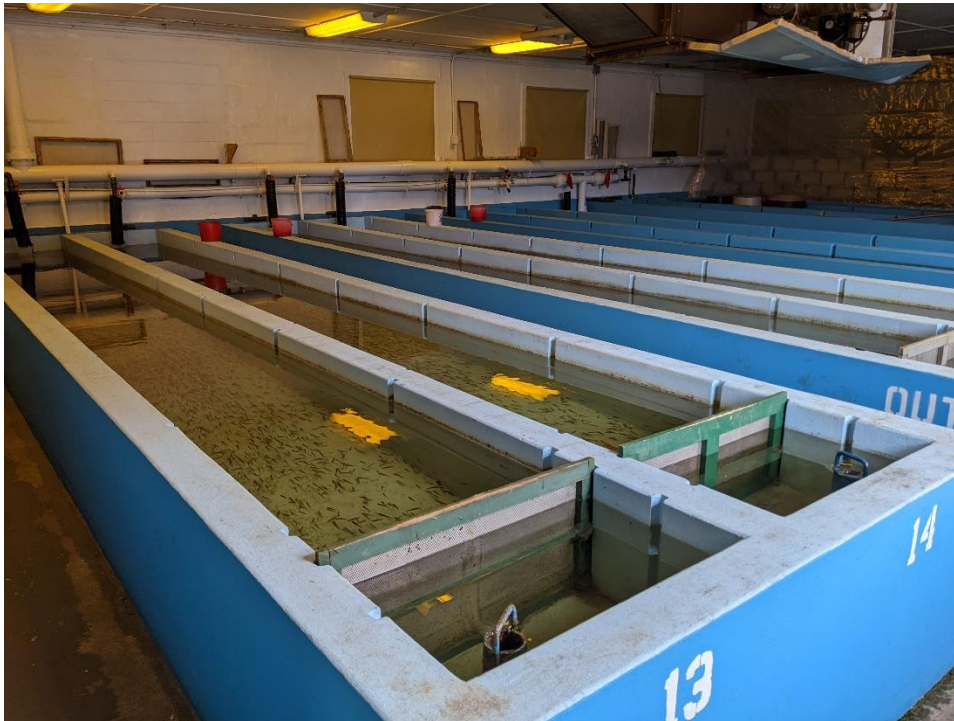
Figure 5-2: Interior Raceways

Water within the indoor rearing units is also degassed, first-use well water. Berlin operates and maintains twenty-four (24) concrete raceways (see Figure 5-2), allowing for a maximum flow rate of 20 gpm and forty-eight (48) aluminum troughs with capacity for flow rates up to 75 gpm. Hatchery personnel report that the indoor raceways are brushed and cleaned daily.

The concrete raceways in the Hatchery Building are painted and appear to be in good condition.

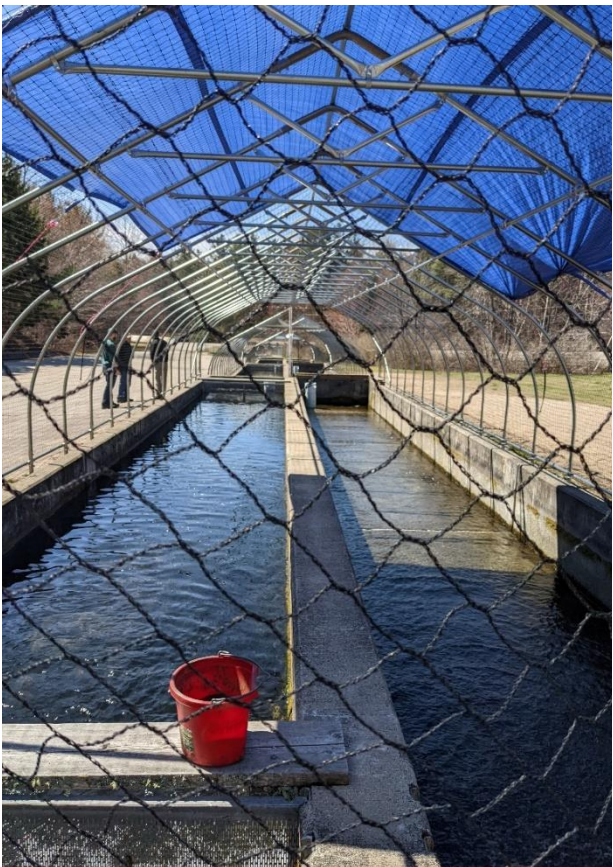
Figure 5-5: Young's Raceway

The concrete is in fair to good condition, with minor surface cracking of the walls spaced every 10-15 feet. Expansion and contraction joints in the walls have required periodic maintenance to correct spalling and cracking dating from construction (Figure 5-6). Water stops were not used during construction, which have caused leakage and wall lifting. Young's Raceways are protected against predation by metal-framed canopies covered with open netting.

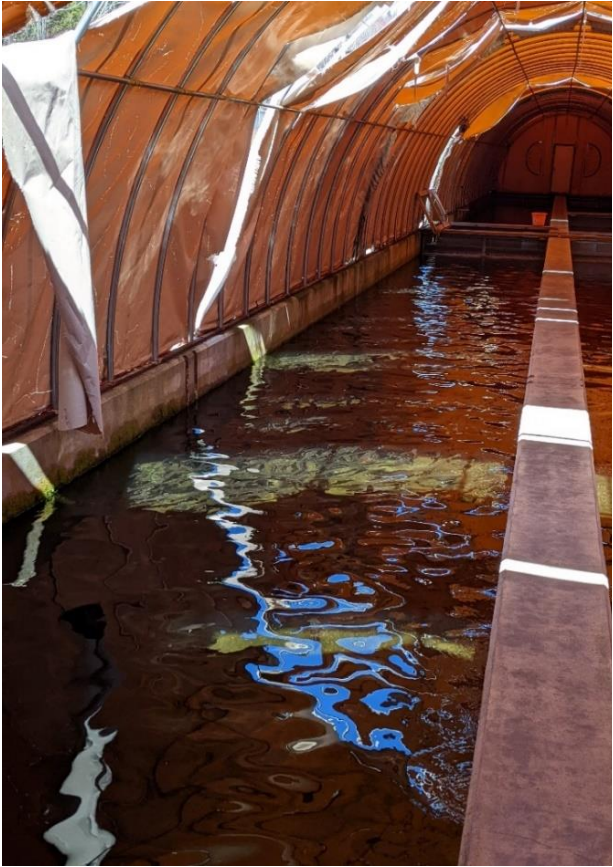
Figure 5-8: Inside of Foster's Raceway

Foster's Raceway has receptacles embedded in the concrete structure for the purpose of plugging in aerators. Electrical power is routed in conduit embedded in the concrete. The receptacles do not have mechanical protection. Many receptacles have been damaged and are no longer operational. The equipment has also caused the concrete to prematurely degrade. There is currently no need to replace these receptacles unless there is a new need to supply aeration devices in this raceway. There is no lighting at Foster's Raceway.

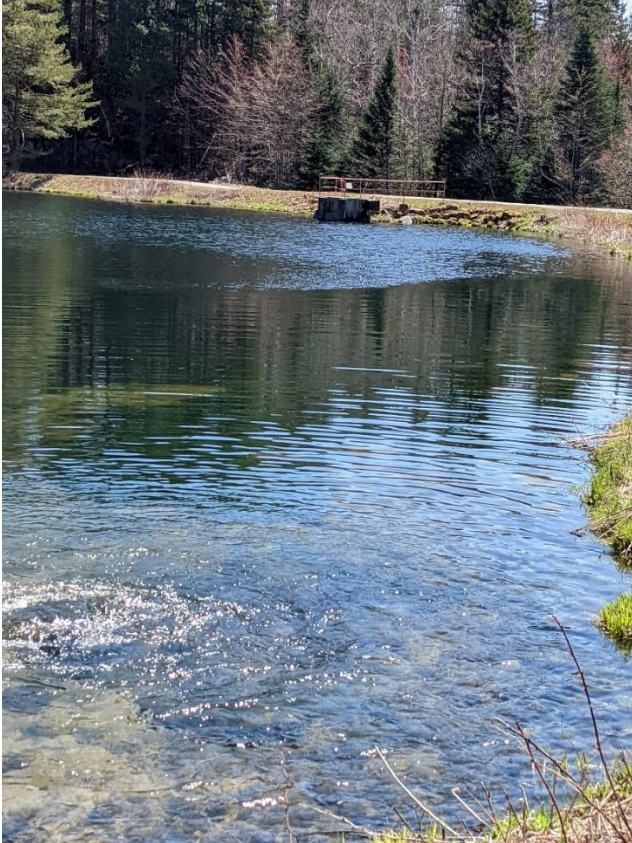
Figure 5-10: Flat Pond

The pond has a screened overflow structure piped to a ditch that flows to Cold Brook. Hatchery staff indicated that this piping from the dam is undersized for heavier flows and that the dam is prone to overtopping. They indicated that the addition of an overflow spillway is needed to ensure the dam remains functional long-term. There is a paved vehicular access roadway on top of the dam, with a visible low point and evidence of newer stone embankment armoring adjacent to the concrete outlet box. The slopes of the earthen dam both toward the pond and down to Cold Brook were vegetated and appeared stable. The concrete of the outlet box was in fair to good condition, with minor spalling at the corners of the top of the walls (Figure 5-11).

Should this pond be determined to be reused as part of the facility after the improvements required to meet anticipated phosphorous effluent limits it is likely that this pond will be required to be dredged. Lining of the pond may be required should it be used for solid waste storage.

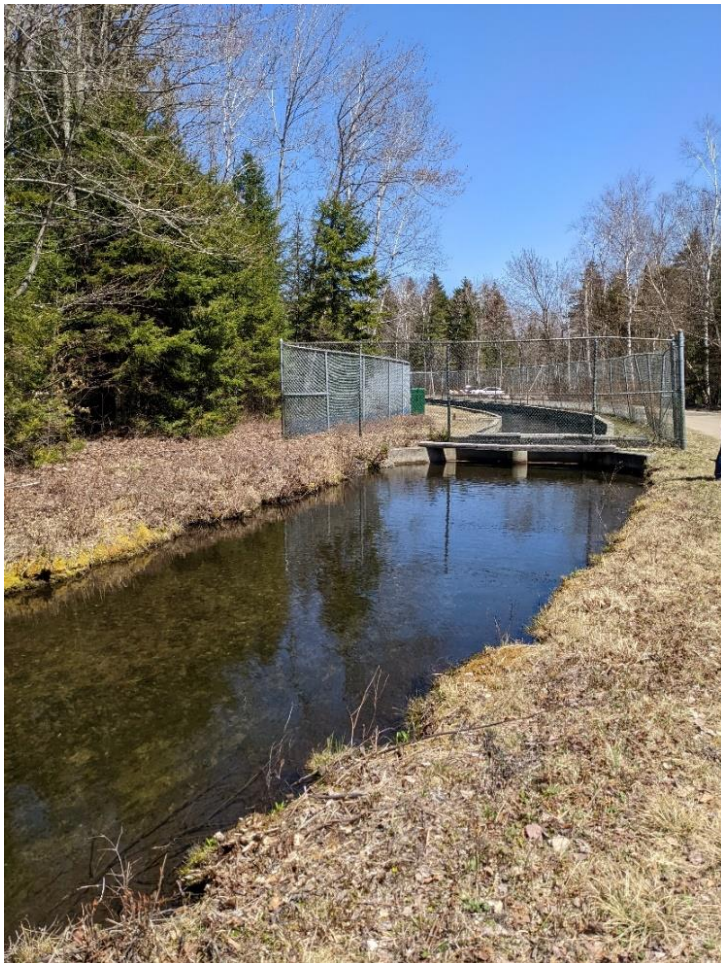
Figure 5-12: Canals A and B

There are flared concrete walls at A Canal's outlet to B Canal (Figure 5-12). The concrete walls are in good condition. Only B Canal is used for fish production and is constructed of has a concrete floor, concrete walls, screens, and stop logs (Figure 5-13). B Canal's vertical concrete walls were cast in long segments with expansion joints to allow the canal channel to curve to the left. B Canal is enclosed by chain link fence for predator protection and has monofilament lines above the fences for avian protection. The concrete condition of B Canal is fair to good, with minor spalling at the wall expansion joints.

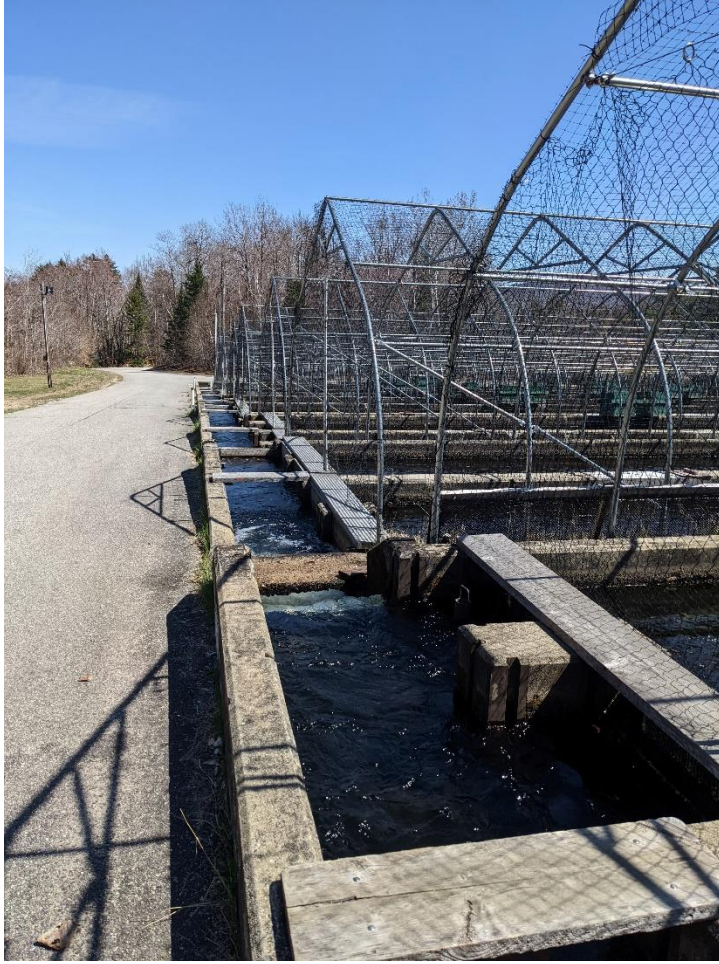
Figure 5-15: West Branch Raceways

The West Branch Raceways have concrete base slabs and concrete walls, are laid out parallel to each other along their long sides and are constructed in pairs, with a dividing wall between the individual units of each pair (Figure 5-15). The 8 upper pairs are protected by open metal-framed enclosures topped by netting for predation protection. The 2 lower pairs were unprotected at the date of the inspection. The current netting system is very labor intensive. The concrete condition of the raceways is fair to poor. Many of the raceways have spalls at the top of the walls measuring 3" wide by 3" deep, spaced every few feet along their perimeter and worse spalling (Figure 5-16 and Figure 5-17). Hatchery staff indicated that each year they perform local patching of the worst areas of the walls, and there are many previously repaired areas. The walls have map cracking and efflorescence over up to 50% of exposed surfaces. There is surface erosion of the wall surfaces below normal water lines up to ¼" deep, with exposed aggregate. There are many locations in the raceway system where spalling at vertical slots which accept timber boards to allow the flow in the raceways to be dammed results in the boards leaking. The raceways freeze during the winter but use of Styrofoam/wooden feeding boxes allows for fish feeding during that time. Raceways are equipped with a drain, small quiescent zones and a drain plug.

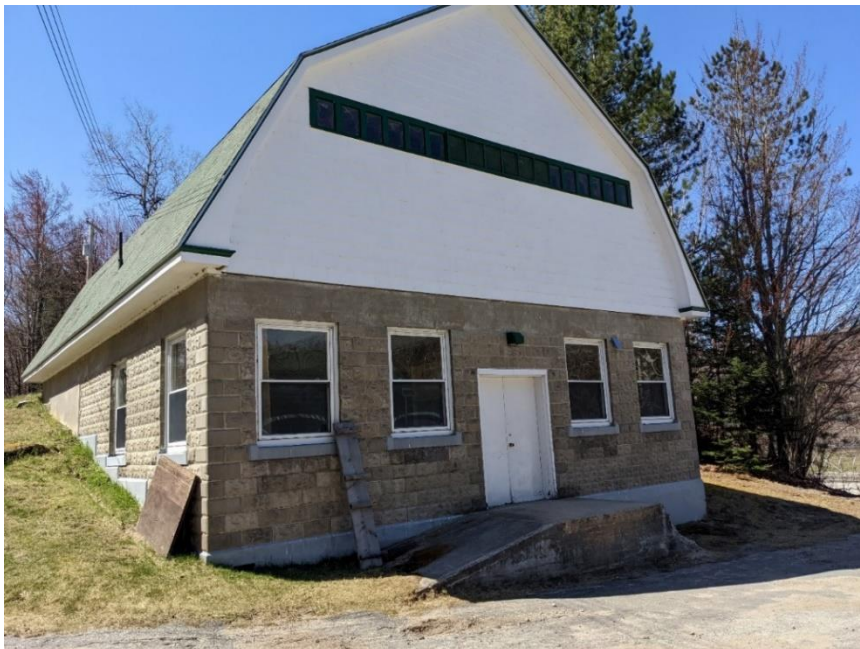
Figure 6-1: Feed Storage Building Front Facade

The Feed Storage Building is heated by a single 106,250 BTU/HR oil fired furnace with a short supply duct run with short branching cylindrical ducts to distribute air. The oil-fired furnace vent is routed along the first floor ceiling and up through the roof. The furnace appears to be in fair condition.

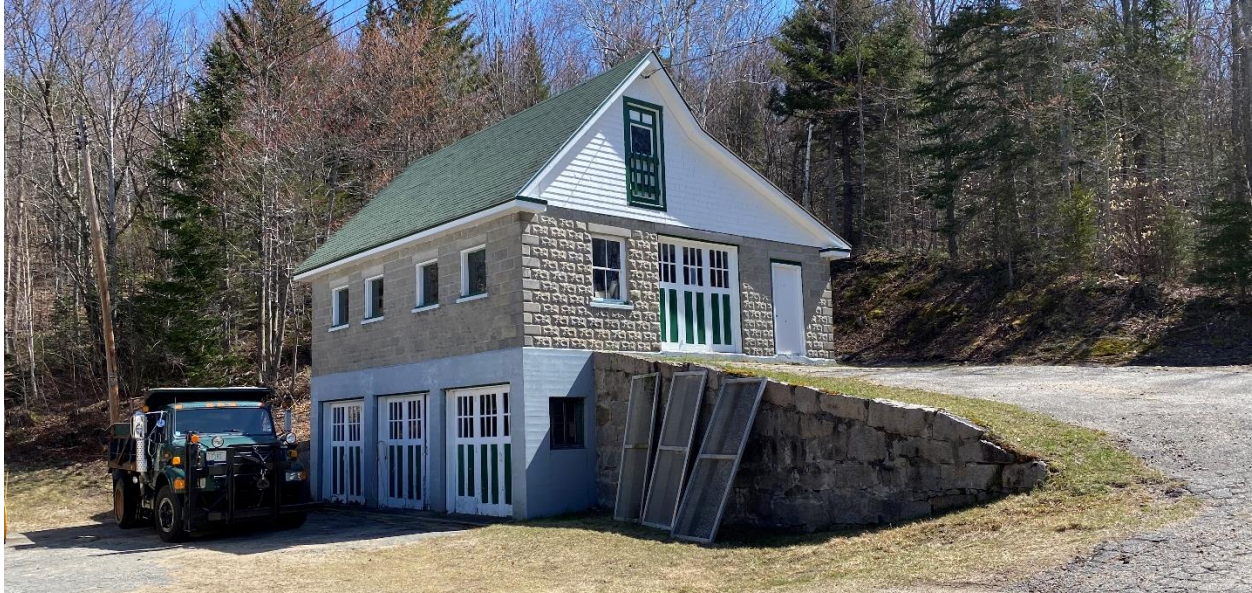
Figure 6-4: Pipe Shop Overall View

The Pipe Shop is located next to the Headquarters and Hatchery Building and consists of two floors with an attic (Figure 6-4). This building is currently used for miscellaneous storage as the building is not heated and is too cold during the winter to work. Like the Feed Storage Building, the Pipe Shop has been built into the side of the hill, so both the lower and upper levels have direct access from grade.

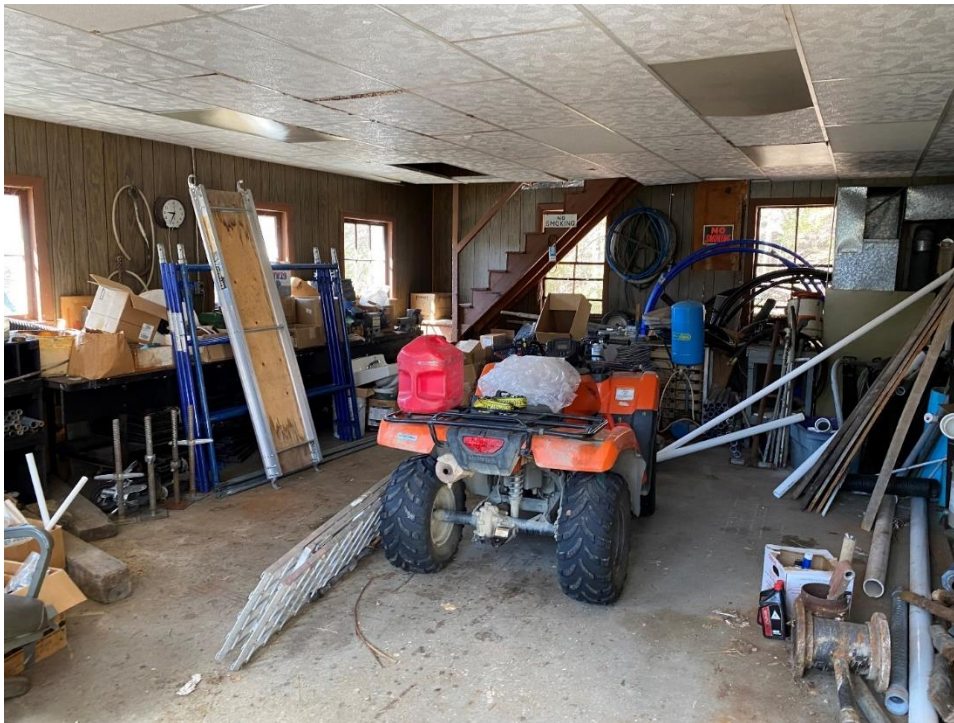
Figure 6-7: Pipe Shop Upper Level Interior

Access to the upper level is provided by a man-door, which is in good condition, and a carriage style garage door, which is in fair condition (Figure 6-7). The windows are the original wood frame single-pane glass double-hung windows. The frames appear to be in fair condition, however, the windows on the east façade have been boarded up. It is recommended that the windows be replaced with insulated glazed windows. If the windows on the east façade are not wanted, these should be blocked up instead of being replaced.

The upper level is divided into two sections: a smaller tool storage area with lockable cabinets; and a larger shop area, which is currently used for miscellaneous storage. The ceiling in both spaces is an acoustic drop ceiling, which is in fair to poor condition, with both missing and water-stained ceiling panels. The floor is an unfinished concrete slab. The walls are either painted concrete blocks or wood paneling directly over the concrete block, with no insulation. It is recommended that insulation be installed along the exterior walls, ceiling and under the floor slab.

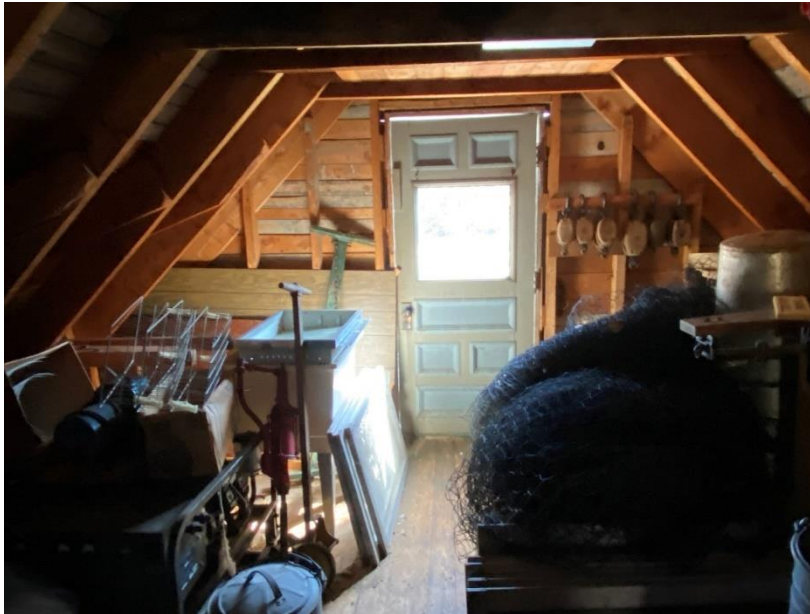
Figure 6-8: Pipe Shop Attic Level

The attic space is accessed via a wood stair in the shop area and an access door in the ceiling. The stairs include a partial railing along the open side of the stairs, which does not meet current OSHA requirements (Figure 6-8). The attic is an open storage area with wood flooring and exposed roof rafters. There is a door at one end of the attic, which does not appear to properly fit the door frame, as light can be seen coming through the gaps between the door and the frame.

Lighting is provided by recessed fluorescent fixtures on the main level, and incandescent bulbs in the lower level and attic. The fixtures are in adequate condition, but several are not operational. The lighting levels are insufficient for safe utilization of the space.

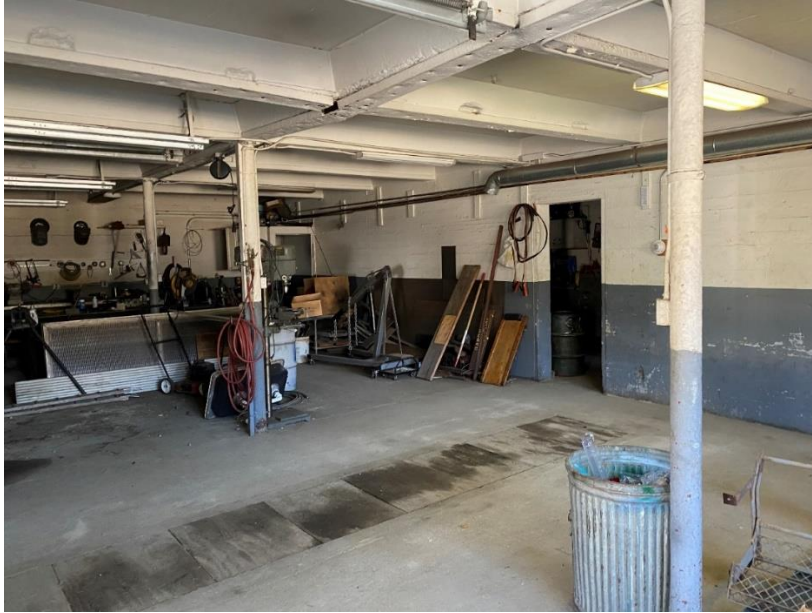
Figure 6-12: Carpenter's Shop Lower Level Garage Bays

The lower level of the Carpenter's Shop consists of three garage bays and a workshop area in the front and three smaller areas behind the workspace for parts storage and mechanical equipment (Figure 6-12). Each of the garage bays is accessed by a roll-up garage door, which are all operable and appear to be in good to fair condition. The sloped concrete pad in front of the garage doors is cracked and deteriorated. The workshop area can be accessed from a wood door, which appears to be in fair condition. The floor is a concrete slab on grade that has a slight pitch towards the garage doors and is in good to fair condition. There are two large windows over the work bench that are the original wood frame, single-pane windows. These appear to be in fair condition but they provide little insulation during the winter. There is no access from the lower level to the upper level.

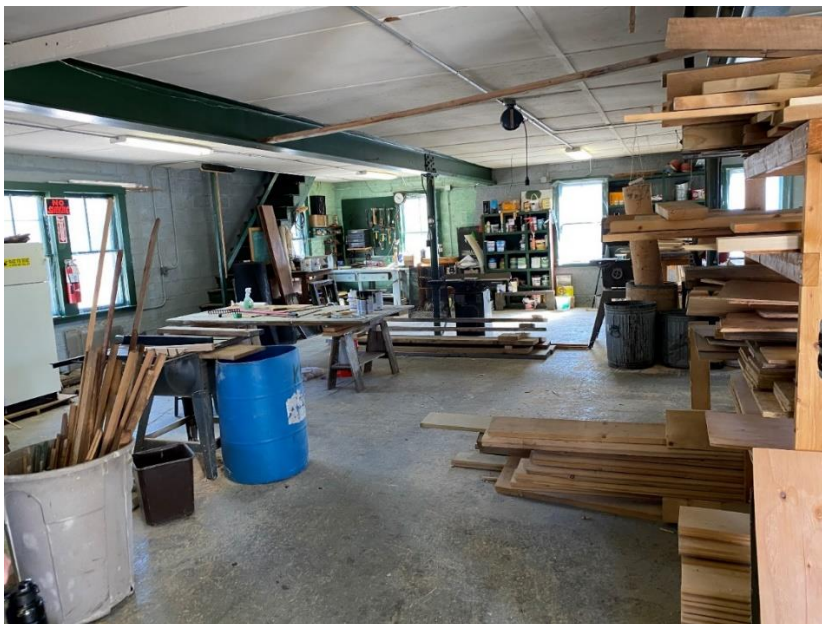
Figure 6-13: Carpenter's Shop Interior

The upper level is a single open space that serves as a carpenter's shop. The interior finishes include unfinished concrete floor, unfinished concrete block walls with no insulation, and an asbestos panel ceiling, all of which appear to be in good condition (Figure 6-13). The windows are the original wood frame, single-pane double hung windows. A sheet of plastic has been installed on the inside of each of the windows to provide some additional insulation.

The attic space can be accessed from the Carpenter's Shop via a wood stair and access door in the ceiling. The stairs have a handrail on the open side, but does not meet current OSHA regulations. The attic consists of wood flooring and exposed roof rafters.

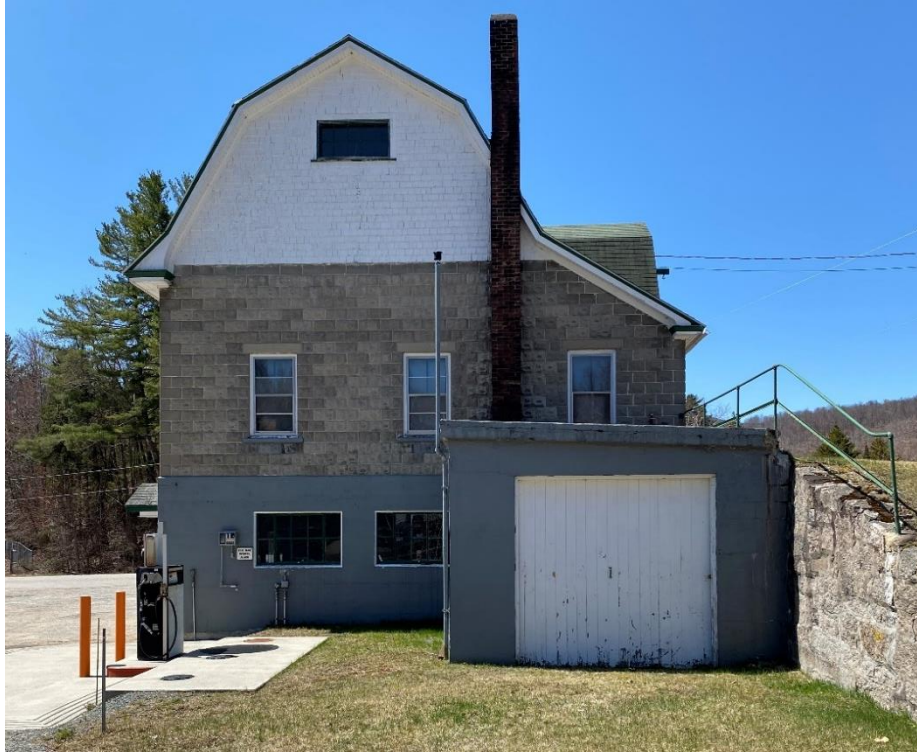
Figure 6-14: Carpenter's Shop Storage Garage and Gas Pump

Along the north side of the building, there is a single-story garage space measuring approximately 10ft x 20ft that is attached to the lower level, but there is no interior connection between the spaces. This garage is currently used for miscellaneous and hazardous storage, such as used oil. The roof over this space consists of the original concrete roof with a concrete slab on top of the original in order to provide pitch and to allow for embedded posts of a railing system to prevent people from walking onto the roof. There is no roofing membrane on top of the roof structure. At the northeast corner of the roof, severe spalling of the concrete was observed, exposing the railing post embedment. This should be corrected through ongoing facility maintenance.

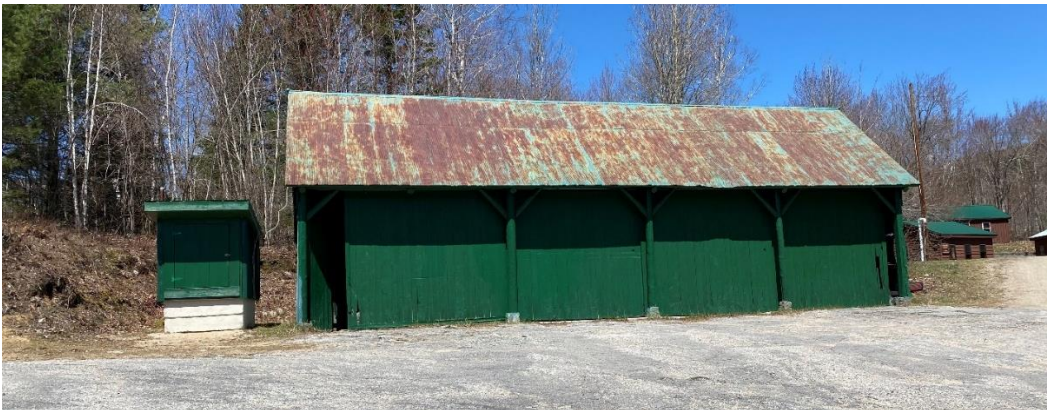
Figure 6-16: Pole Barn

Staff noted that the barn works for the storage of the larger vehicles in the winter, but this structure is not insulated or heated, so it cannot be used for vehicle maintenance during the winter.

A cylindrical aboveground 330-gallon petroleum storage tank with a mounted fueling pump is located in the pole barn. The tank appears to be in good condition.

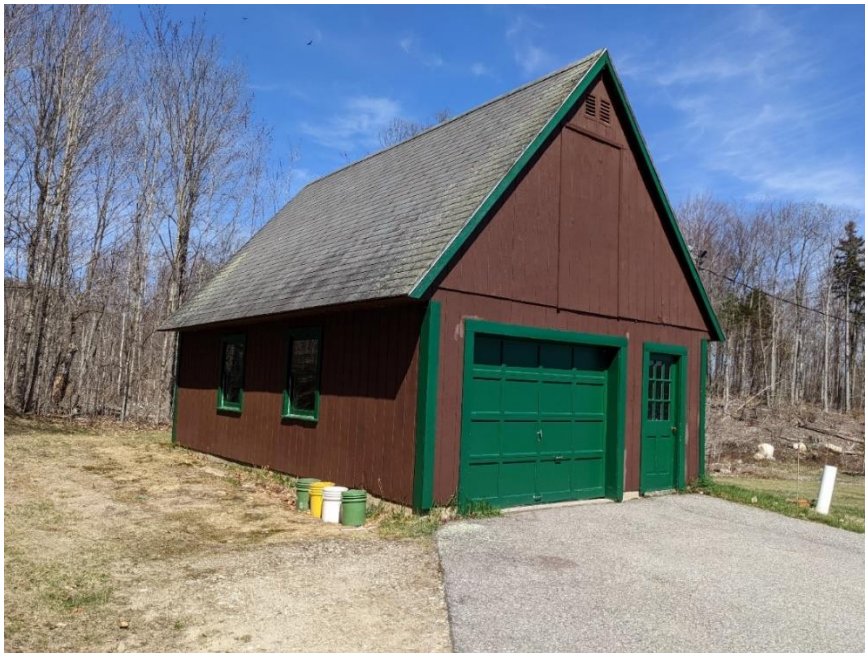
Figure 6-17: West Branch Garage

The West Branch Garage was constructed in 1986 adjacent to the West Branch Raceways. The garage consists of wood framed structure on a concrete foundation. The structure appears to be in good condition. The garage is approximately 504 square feet and is used for feed and miscellaneous storage for the West Branch Raceways (Figure 6-17).

There is a man door and overhead roll-up door at the front of the shed, which both are operable and appear to be in good condition. The roof was recently replaced and is in good condition. The exterior is finished with vertical wood siding. At some locations, the bottom of the siding is beginning to rot and found to be soft to the touch. This condition has superficially been covered up by a recent coat of paint.

There is an attic above the main floor that can be accessed via an access hatch and ladder from inside, or a large access door on the front. The attic is not currently used due to an infestation of bats or rats. This is recommended for correction through ongoing maintenance activities.

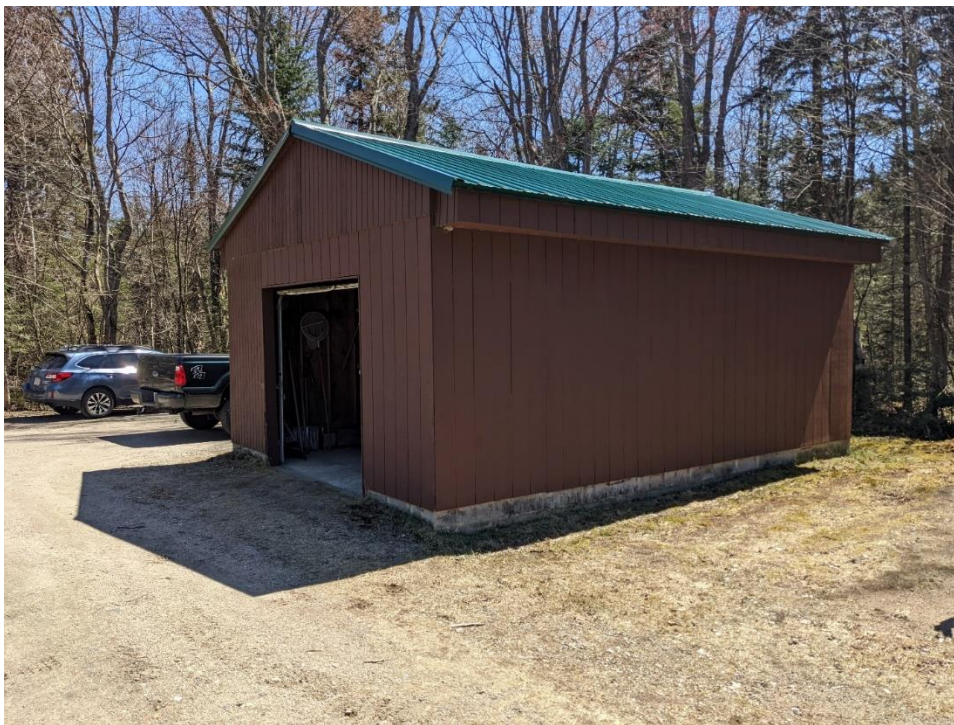
Figure 6-18: Upper Canal Garage

The Upper Canal Garage was constructed in 1983 across the road from the B Canal. The garage consists of a wood frame structure on a concrete slab, with an area of 352 square feet. The structure is in good condition (Figure 6-18).

The exterior walls are vertical wood siding over plywood sheathing, and the roof is an aluminum roof. Both the siding and roof are in good condition. The shed is accessed via an overhead roll-up door, which is in good condition. The shed has no electricity or mechanical equipment.

The shed is used for miscellaneous storage for the Upper Canal, and for feed storage for the B Canal. The feed is stored in trash cans to prevent rats and other animals from getting into it, as there is no area to safely keep the feed.

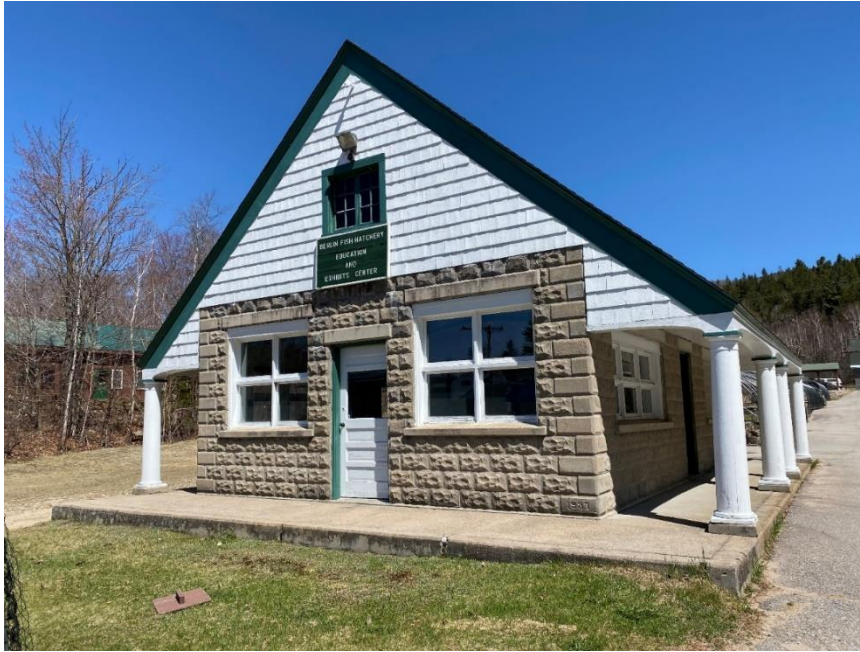
Figure 6-19: Visitor's Center

The Visitor's Center is visitors center is located between Young's Raceways and the Display Pool. The building was built in 1987 (Figure 6-19 to Figure 6-21).

The interior consists of two display areas and a separated storage room. The interior finishes consist of carpeted floors, gypsum board walls, and acoustic tile ceilings. All of the finishes appear to be in good condition, however there was a strong odor that smelled like mold and mildew. No visual signs of water damage were observed.

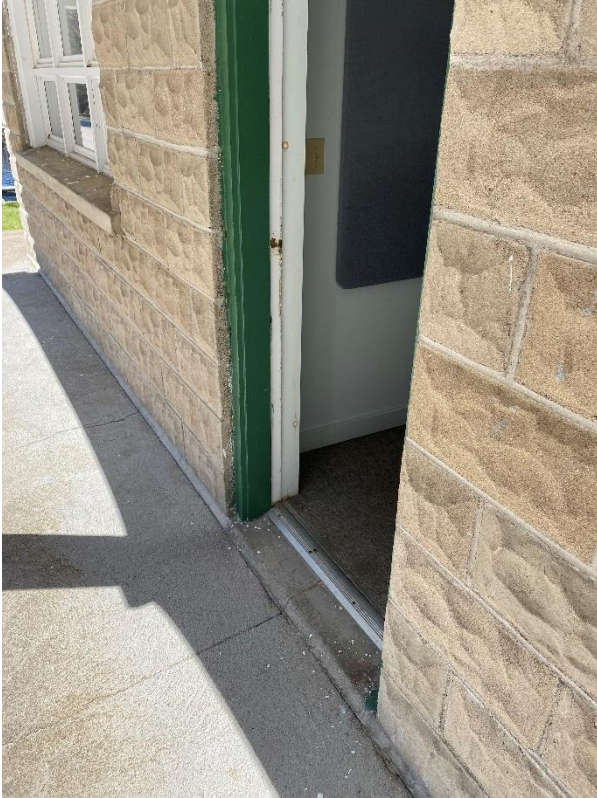
Figure 6-22: Visitor's Center Door Sill Lip

The windows are wood framed casement and fixed windows. The casement windows are operable, and all windows appear to be in good condition. There are access doors located on the east, south and west sides of the building. Each access door is a wood framed door with a vision panel, and they are all in good condition. However, there is a concrete lip at the threshold for each of these doors that exceeds the 1/4" maximum vertical rise allowed per ADA. The access doors were measured at 32", which is the minimum door size allowed per ADA. On the north side, there is a hollow metal emergency exit door that is in fair to poor condition with noticeable rusting at the bottom of the door and along the top of the frame. There is no threshold at this door, and light can be seen coming in from under the door (Figure 6-22). This is believed to be the source of the water infiltration into building, soaking into the carpet and creating the moldy / mildew smell. Carpet removal is recommended.

- Replacement of rollup garage doors.
- Visitor's Center
 - Improvements to entryways to meet ADA requirements.
 - Replace exterior doors and threshold for weather security.

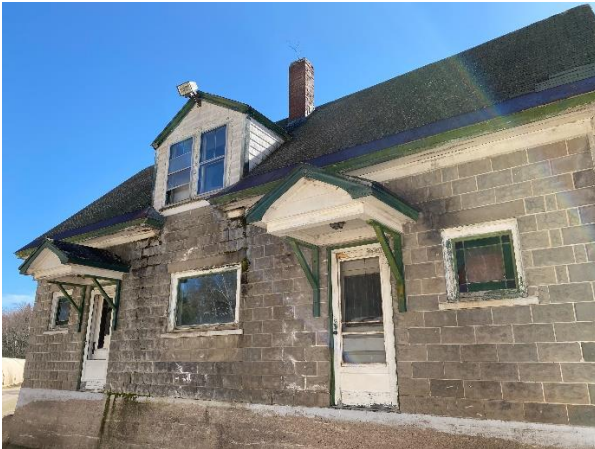
Figure 6-24: Q2 Front Facade

The Q2 Residence Building is located near the middle of Foster's Raceways, and consists of a partially below grade basement, first and second floors (Figure 6-24 and Figure 6-25). It's constructed of a concrete foundation, concrete block walls at the first and second floors, and a wood framed roof. The building is not currently in use, and was observed to be in poor condition, with broken windows, a damaged and leaky roof, missing exterior stairs, rotted trim and doors, and moss growing on the walls. However, the structure appears to be intact.

Berlin staff noted that this building is not used and has not been maintained because it is believed this building was intended to be demolished by the Federal Fish Hatcheries when the Berlin facility was transferred from the federal system to the NHFGD. Staff noted that since the structure is intact, they would like to use the basement of this building for storage. Determination if the federal hatchery system intends on demolishing this building needs to be made before any recommendations can be made for this.
