Existing Conditions and Facility Evaluations - Milford

POWDER MILL FISH HATCHERY FEASIBILITY
STUDY

New Hampshire Fish and Game Department

May 25, 2023

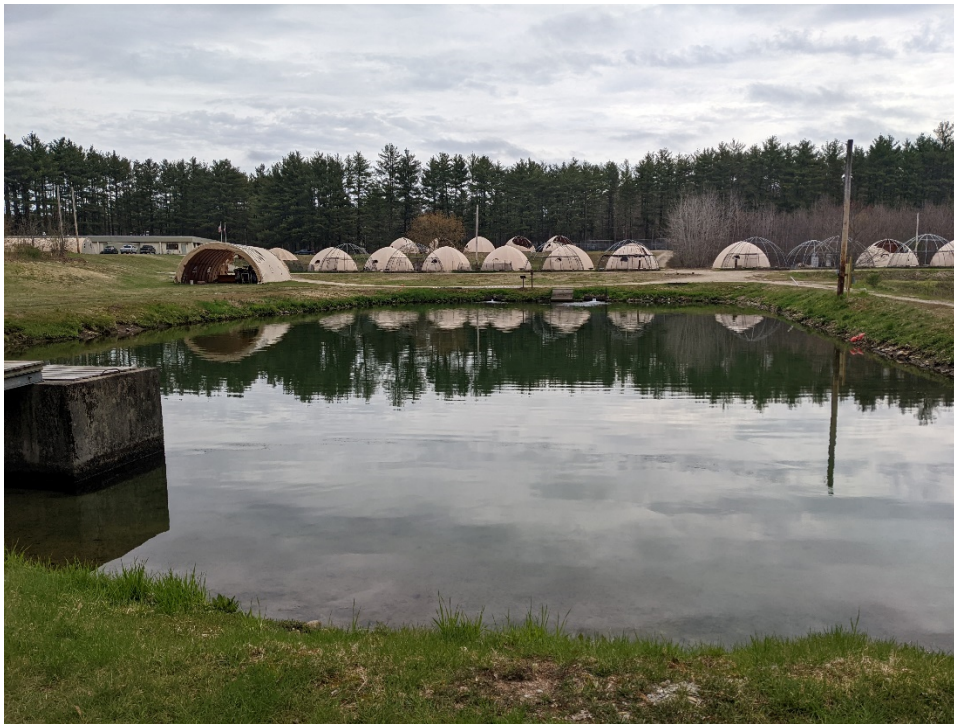
Figure 2-1 West Pond (production) Looking from its Outlet

Occasionally a contractor is hired to clean out the settling pond with a backhoe. The East Pond has not been cleaned for several years. The West Pond was cleaned in 2011.

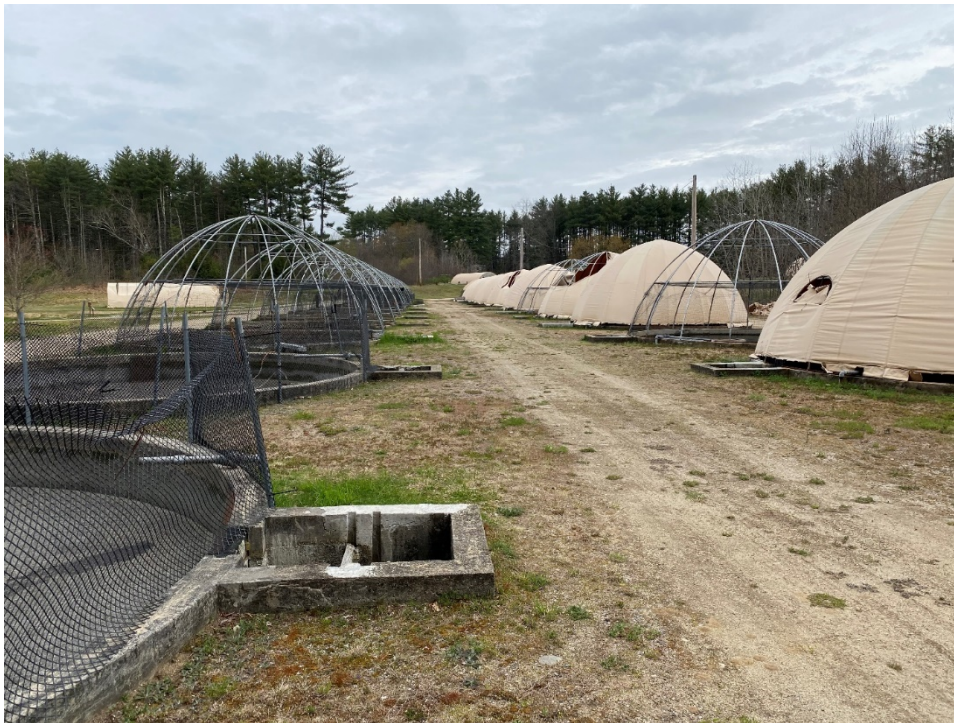
Figure 3-1: Lower Pools Predatory Controls

Protective domes consisting of metal structure frames and reinforced PVC covers are used to deter bird and mammalian predation and provide shade control of the circular units. Problems with snow load failure and breakdown of the covers due to exposure to the sun and wind have resulted in significant damage to many and only a few of them appeared to provide complete protection at the time of the site visit. At the lower pools, the covers remain on approximately half of the circular tanks, but the remaining covers were in various stages of poor condition. Where covers have completely come off, netting to approximately three feet high has been applied to the dome frames to provide protection against ground predators, but these nets appear to provide no protection from predatory birds. NHFGD staff have noted that all pools holding fish are entirely netted over most of the year. These nets are removed seasonally from November through March due to risk of snow structural damage and accidental gilling of fish. Lower pools predatory controls are shown in Figure 3-1. Note many of the structures shown in Figure 3-1 and Figure 3-2 show pools that did not contain fish, once fish are added to the pools staff install predatory controls as appropriate and described in this section.

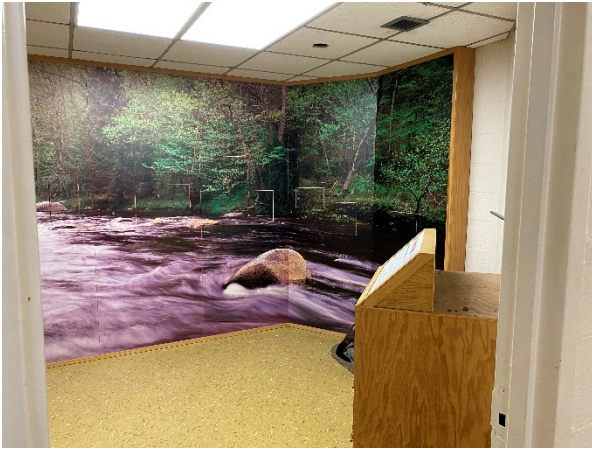
Figure 3-4: Education & Display Room

This facility has a visitor center that consists of a general meeting area, an education and display room (Figure 3-4), public restrooms, and viewing area into the hatchery (Figure 3-5). The lower parking lot is designated for visitor parking and appears to be adequately signed to inform visitors where to park. There is a large welcome / information sign at the corner of the visitor parking area. At the lower pools, one of the circular tanks is set up as a show pond for visitors. These visitor facilities appear to be in fairly good condition, although many of them are not fully accessible.

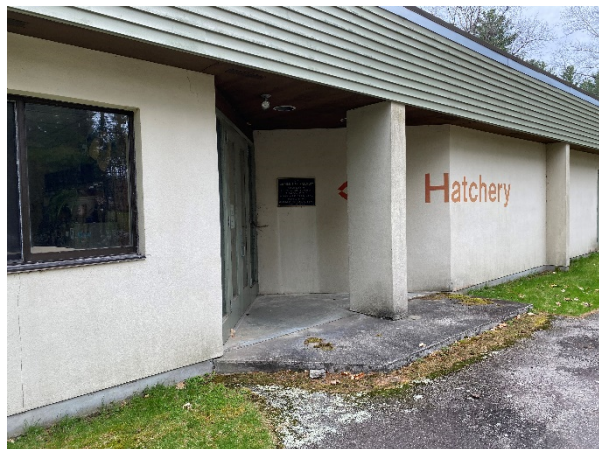
Figure 3-7: Main Public Entrance

The visitor's parking lot does not have any designated accessible parking spaces, and there are no accessible routes from the visitor parking into the Hatch House where the public spaces are located, as the parking lot is lower than the building, there is only a set of stairs up from the parking lot, but no ramps. Both the main entrance and employee entrance have a step up to get into the building. The concrete stairs between the visitor parking lot and the building appear to be in fair to good condition, but these stairs do not have any handrails, and the transition between the top landing and the asphalt paved walkway is deteriorated and a tripping hazard Figure 3-6. At the main entrance from the visitor's parking, moss was observed to be growing on the walking surfaces along with some minor concrete cracking and spalling, see Figure 3-7. It is recommended to provide ADA compliant access should the building continue to be in service.

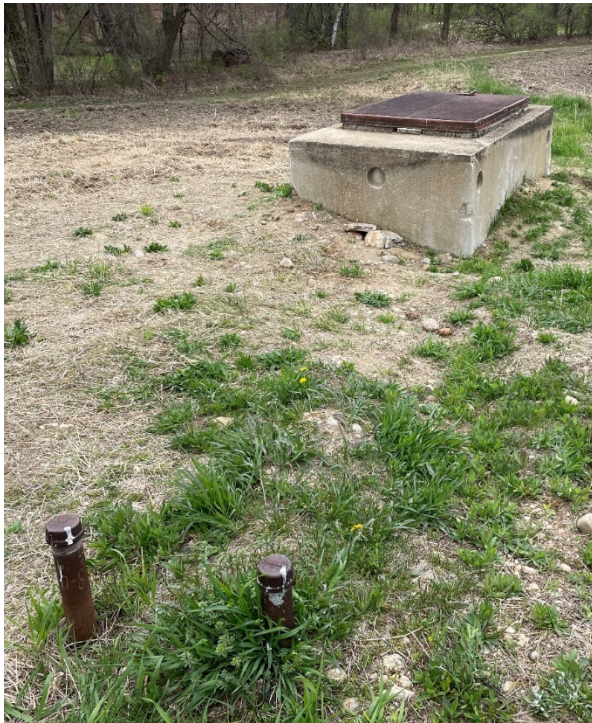
Figure 4-1: Vaulted Field Well

As its names implies, the Field Well is in an agricultural field. The area immediately around the well and well house is filled slightly above the field. The well is in a gravel pack and its head is in a concrete vault protruding above grade, see Figure 4-1. Field well water temperature ranges from 49 to 57 deg F.

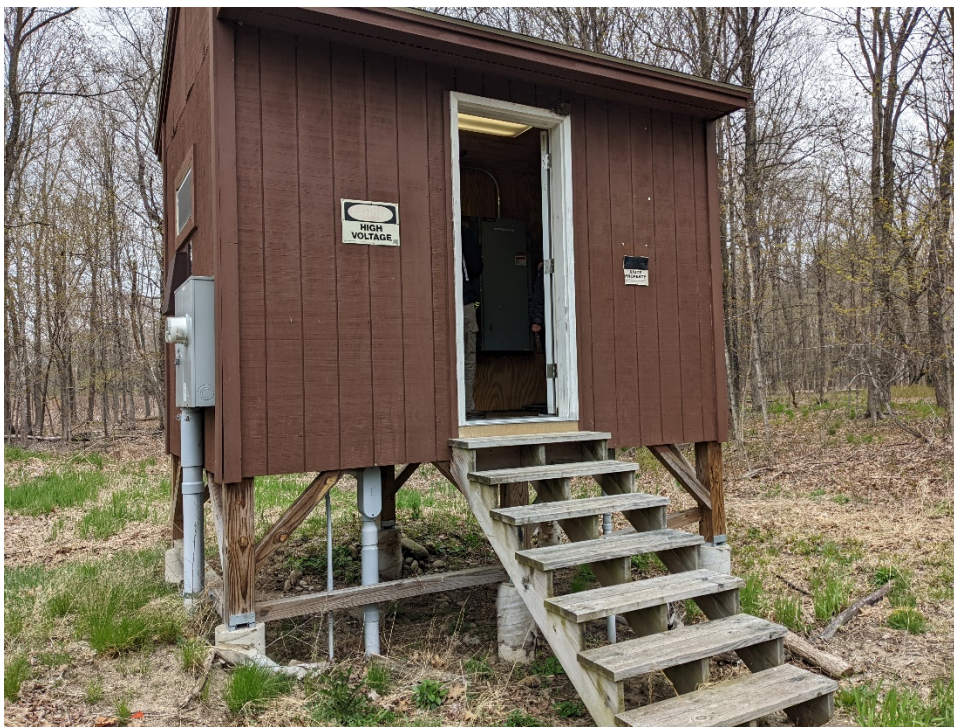
Figure 4-4: Newer River Well (No. 4) Structure

As its names implies, the River Well is near the Souhegan River in a wooded area. The well head is in a concrete vault protruding above grade. The well pump is a submersible turbine. Well pump controls are in a newer wooden well house on posts, see Figure 4-4. The well was built in 1986 and chemical cleaned using high pressure and a Muriatic Acid flush and NuWell 310 Bio-Acid Enhancer in 2014. The River Well was slated to be cleaned again in 2022 but because of the unforeseen issues with the Field Well that did not occur before fish needed to come on station. The River Well will be chemical cleaned in early spring of 2023. The River Well has high levels of manganese, which is discussed further along with the aeration/degas towers in Section 4.3. Its temperature ranges from 46 to 63.5 deg. F.

All electrical equipment in the River Well House appears to be relatively new and in good condition. The generator is exhibiting advanced corrosion on the exterior surface and should be evaluated for replacement soon. A small wall mounted exhaust fan and louver in the river well structure provides ventilation. The fan appears to be in good condition.

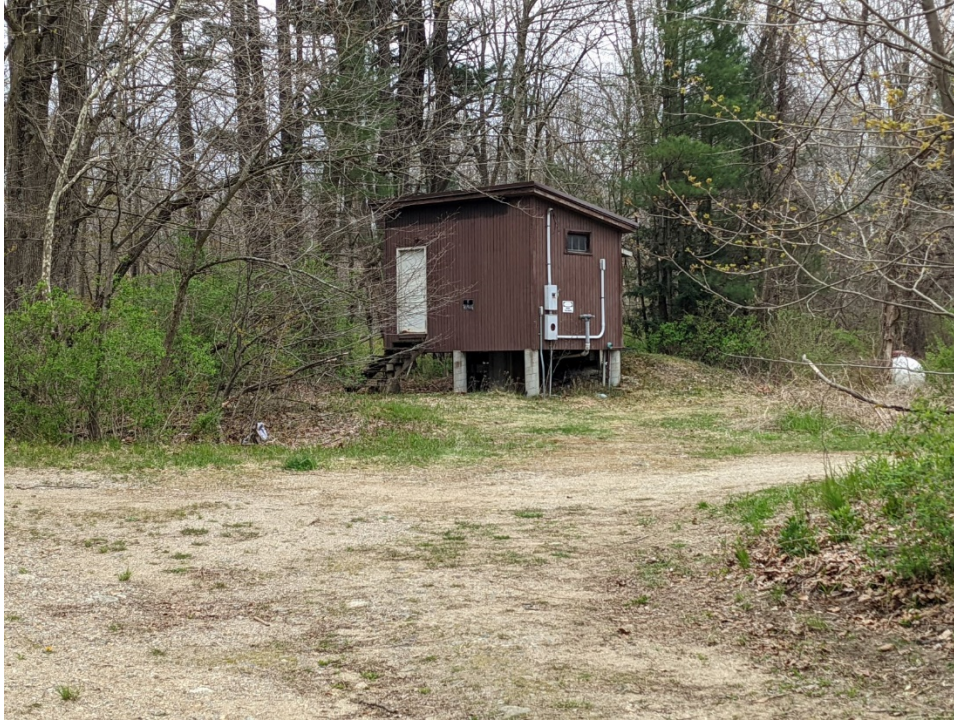
Figure 4-5: Old River Well (No. 3) Structure

Backup power is provided by a 100kW propane generator and automatic transfer switch with a 1,000-gallon tank. The generator and propane tank are located approximately 100 feet away across the access road at the location of the Old River Well House, see Figure 4-5. The automatic transfer switch is located in the New River Well House.

- Backup generator should be replaced in the near future.

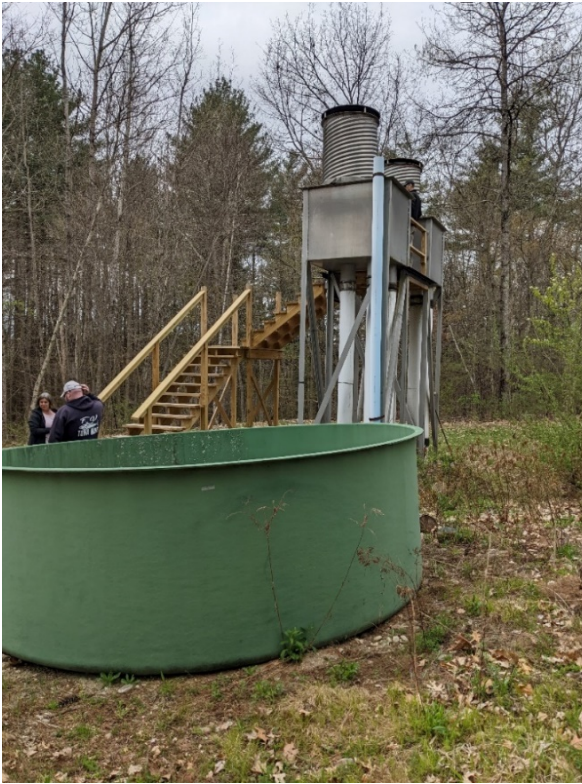
Figure 4-6: Broodstock Holding Tank (not in use) near Aeration-Degassing Headbox

An abandoned green tank, residing next to the towers, used to occasionally hold broodstock; but has been abandoned for years, see Figure 4-6. Undesirably, the tank's use created an additional effluent point.

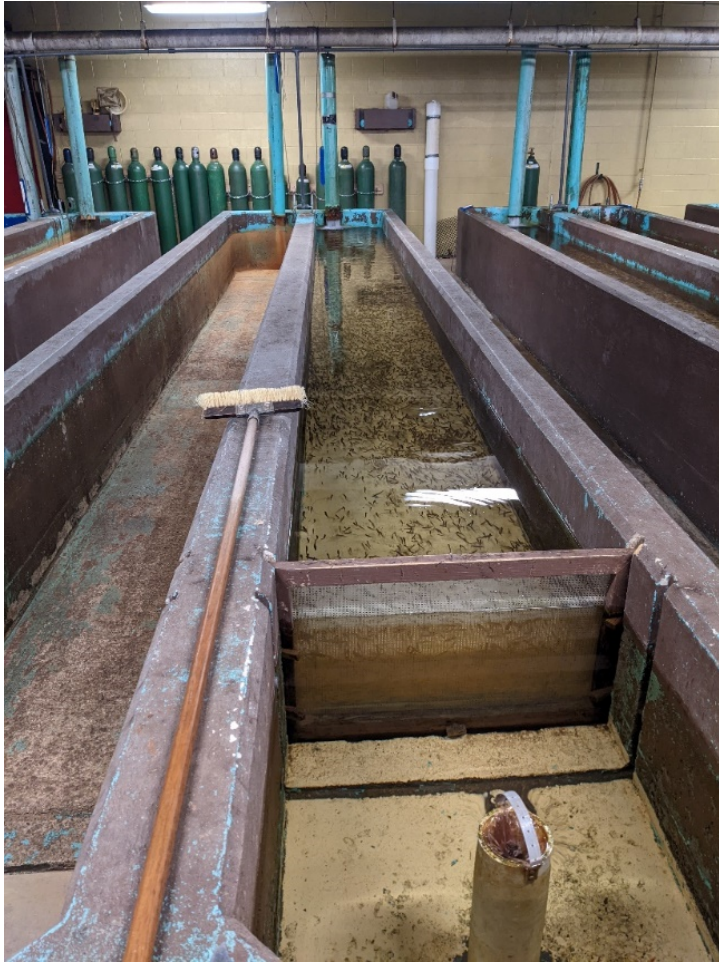
Figure 5-2: Indoor Linear Rearing Tanks

The Hatch House Tank Room contains twenty (20) linear concrete tanks (26-ft x 2.16ft x 2.41ft), see Figure 5-2. The operating water depth of the tanks is approximately 1.67-ft providing 93.2 cubic feet (CF) per unit or 1,864 CF total. Water flow per unit varies from 5 to 25 gpm giving a volume exchange rate per hour (R) of 0.4 to 2.2. Each tank can be drained within 5 minutes. The tanks have

packed columns for influent aeration and degassing and oxygen meters and ceramic oxygen diffusers. In May of 2022 there were approximately 15 high pressure oxygen gas cylinders in the tank room and one was connected with vinyl tubing to a SCH 80 PVC distribution system. The National Fire Protection Association recommends only brazed copper or stainless steel for distribution piping; so that upgrade is recommended. Portable liquid oxygen (LOX) cylinders or a microbulk LOX tank would be safer and require less frequent refilling. If there was a campus-wide bulk LOX tank-based system, it could be branched to the hatch house and then the smaller tanks would not be needed. An upgrade to one of these forms of LOX is recommended. The water leaves orange deposition, especially noticeable on the packed columns and their packing.

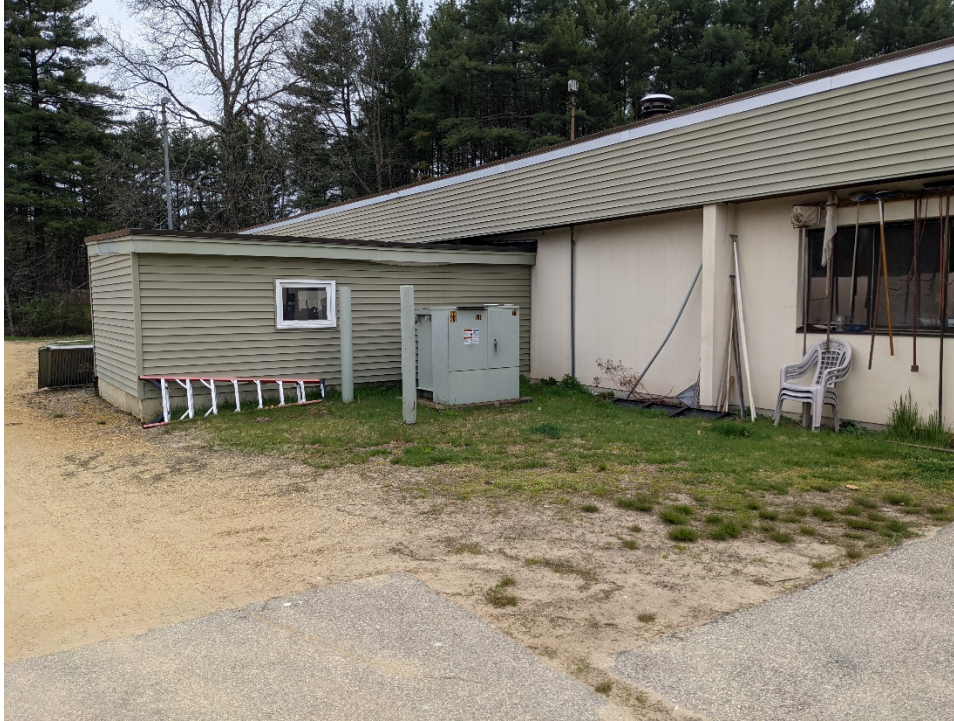
Figure 5-4: Rear Facade of Hatch House and Addition

The Hatch House is a one-story masonry block building with interior masonry-block partition walls and a flat roof made of galvanized roof decking supported by steel roof trusses. The roof is prone to leaking, with known leaks in the lounge area and in the furnace/mechanical room. The hatchery area is largely open. No significant deterioration of the building foundation, walls or roof support system was noted. Due to lack of working HVAC systems, in the summer months the Hatch House experiences high temperatures and humidity, resulting in mold. The incubation room is particularly prone and shows significant rusting of the steel hangers supporting incubator piping. Hatchery

personnel noted that mold is also an issue in the open hatchery area, due to inadequate ventilation. An area of the suspended ceiling in the lounge area near the front of the building had been removed due to roof leakage and resulting mold. The concrete of the rectangular rearing tanks is in good condition.

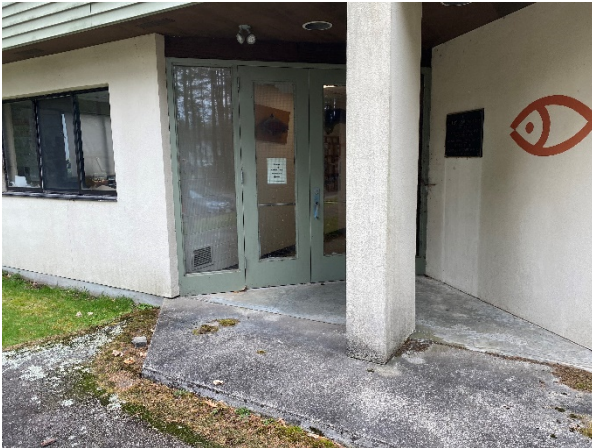
Figure 5-8: Main Entrance Doors

The hatchery building has (7) seven exterior doors; (2) main entrance doors into the public access and employee areas, (3) doors into the tank room, (1) door to the garage bay, and (1) door to the mechanical space. The main entrance doors are metal doors with glass lites and side lites see Figure 5-8. The doors appear to be in good condition but are not insulated. The doors to the garage, mechanical spaces, and hatchery space are all hollow metal doors, with no insulation. Staff noted that during the winter, up to a couple inches of ice accumulate on the inside face of the doors in the tank room, making them freeze shut. The doors around the tank room (Figure 5-9) show varying levels of rusting. It is recommended that all the exterior doors be replaced with new insulated doors with thermal break frames.

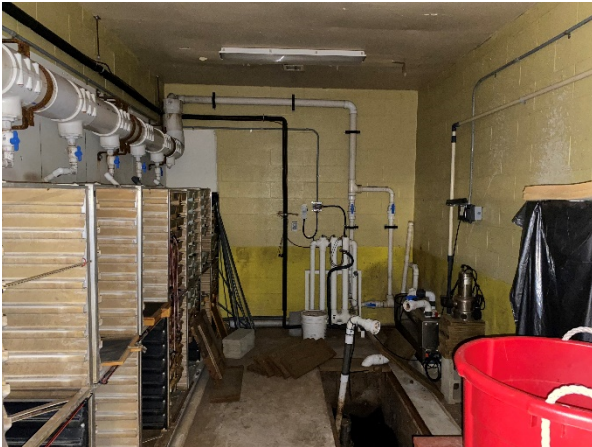
Figure 5-15: Incubation Room

The tank room takes up the entire western half of the Hatch House, with the support rooms along the east side. The incubator room (Figure 5-15) consists of a row of incubation tray racks along one wall with pumps and other equipment along the other walls. The door that separates the incubation room from the tank room has been removed due to the fact that the door swings inward, which takes up too much space within the room.

All of the support spaces have similar finishes as described earlier for the interior finishes, and the rooms appear to be in fair condition. However, the equipment, shelves, doors, or other components related to the functionality of these rooms appears to be outdated or being used in ways other than what was originally intended. It is recommended that as part of the renovation work noted for the interior finishes, that these support rooms be renovated and updated to better meet the needs of the staff and facility.

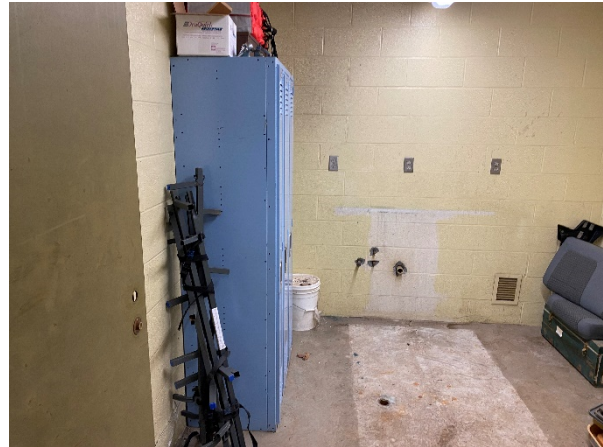
Figure 5-16: Lab Space

Next to the incubation room is the old lab space (Figure 5-16), which is currently used by conservation officers. The lab sink has been removed, and the water pipes have been capped, while the drain pipe has been cut and left exposed. The handle and lock to the door have been removed. There are three lockers and a refrigerator currently in this room.

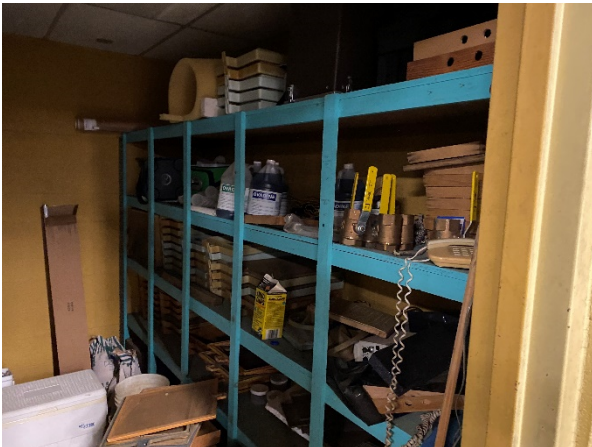
Figure 5-17: Storage Room

The next room is the storage room (Figure 5-17), which consists of storage shelves on either side of the room to store trays and miscellaneous parts for the tanks. The door to this room swings out into the tank room but was being propped open by various materials at the time of the site visit.

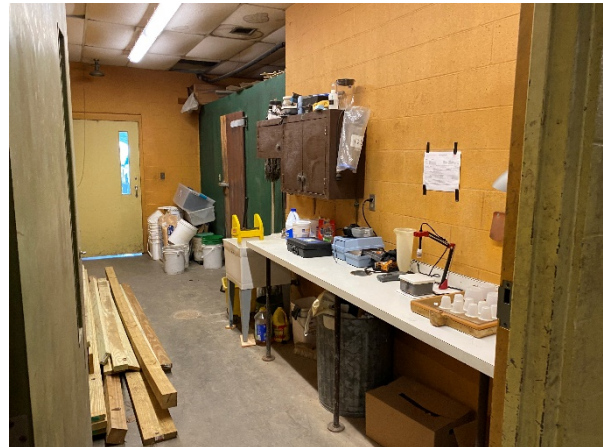
Figure 5-18: Preparation Room

Next to the storage room is the preparation room (Figure 5-18), which consists of a long countertop for preparation work, a utility sink, and a cold storage room. This room also provides access between the garage and the tank room with doors on either side.

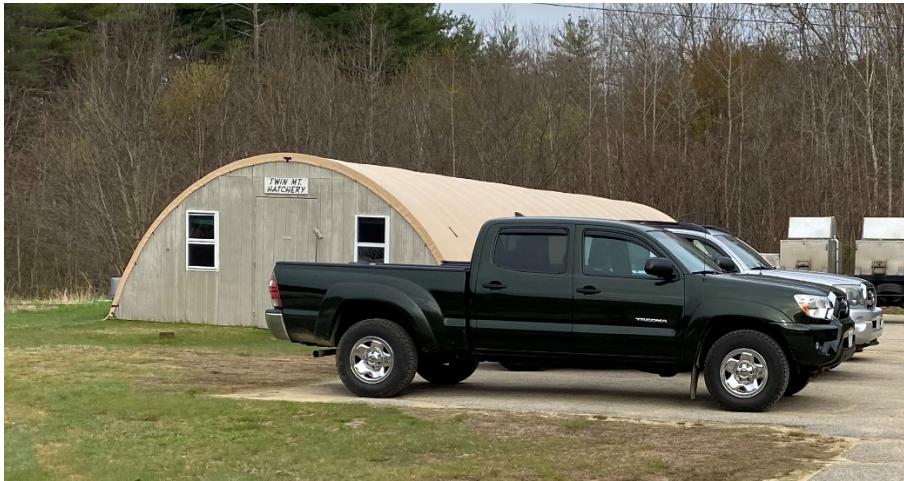
Figure 5-25: Twin Mountain Hatchery Hut

The Twin Mountain Hatchery Hut is a separate structure adjacent to the Hatch House, previously used for early rearing, see Figure 5-25. The structure consists of a curved Quonset Hut metal frame on a concrete slab on grade foundation, with a fabric covering and wood sides on the two ends. The structure appears to be in good condition.

Twelve (12) circular fiberglass rearing tanks are located in the Twin Mountain Hut. The tanks are 8 feet in diameter and are 2 to 2.5 feet deep. The typical water flow per early rearing tank varies from 1 to 6 gpm with a maximum rate of 20 gpm. The individual rearing tanks can be drained in 2 to 5 minutes. The tanks are galvanized steel and have been corroded to the point of significant leakage. Thus, the building has been abandoned.

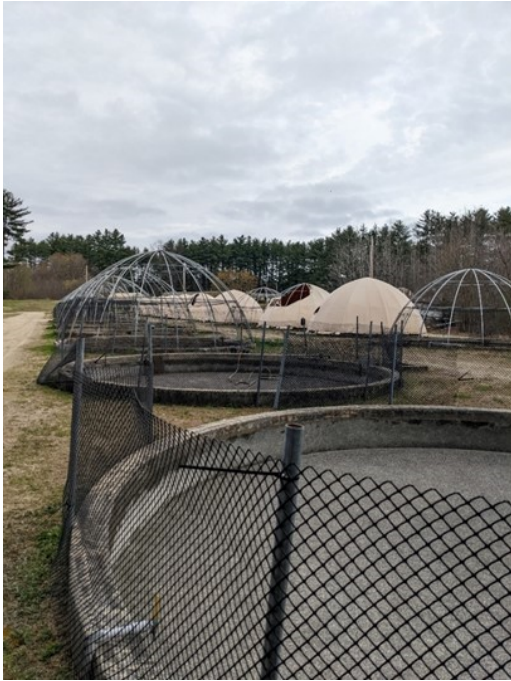
Figure 5-26: View of Lower Circular Tank Area

The campus has sixty (60) 25-foot diameter circular pools (circular units). The units provide 655 CF of rearing volume each (39,300 CF total) when operated at 1.5 feet water depth. The units are divided into two (2) areas (lower and upper, see Figure 5-26 and Figure 5-27, respectively) with thirty (30) pools in each area. Approximately thirty (30) of sixty (60) units have PVC metal frame dome covers, but many of the PVC covers have deteriorated to the point that they have been removed or are still in place but are torn and in tatters. The circular units are approximately fifty (50) years old and are constructed of concrete.

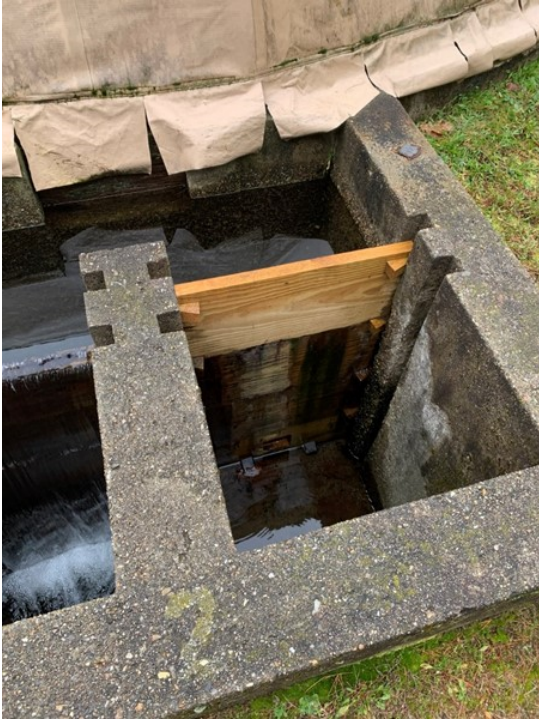
Figure 5-28: Upper Pool Side-Box with Separate Low Hand Gate Opening for Waste

The upper pools' side-boxes are wider than the lower pools' side boxes. The upper pool side-boxes have two sets of weir boards and a subdivision wall in the back half (Figure 5-28). One side has the hand pull gate (Figure 5-29) and leads to a drain/waste main leading to a small Settling Pond. The other side overflows to a serial reuse main down to the lower pools.

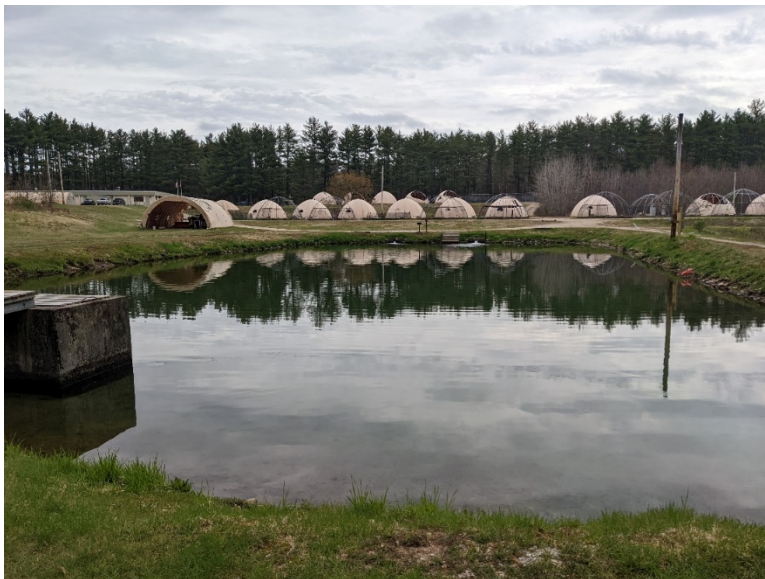
Figure 5-33: West Pond (production) Looking from its Outlet

Occasionally a contractor is hired to clean out the settling pond with a backhoe. The east pond and west pond were cleaned in 2011. Solids tend not to accumulate in the west pond for producing fish on overflow water.

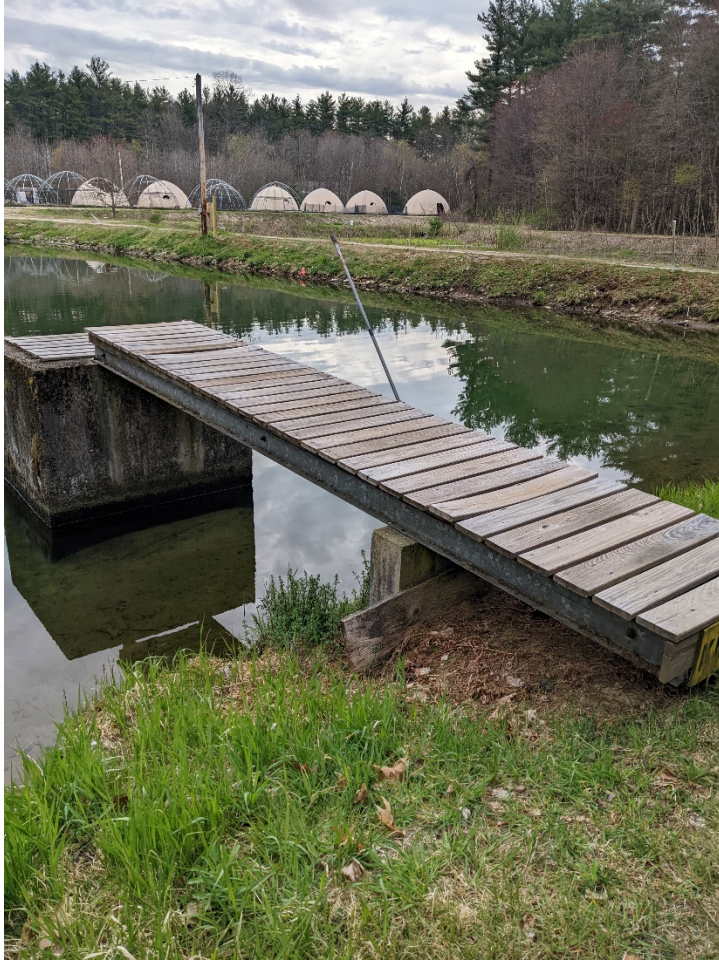
Figure 5-34: Access Walkway to West Pond Outlet Box; East Pond (treatment) in Background

The concrete outlet box at the West Pond is in fair to good condition. Its water entry has dual slots. The very front slots hold weir boards topped with a bar screen. The other slots were empty in May 2022. Access to the outlet box is via a wooden walkway that has no safety railing, it is recommended that these be added. The embankments of the ponds are in good shape. They are fully vegetated with no signs of erosion.

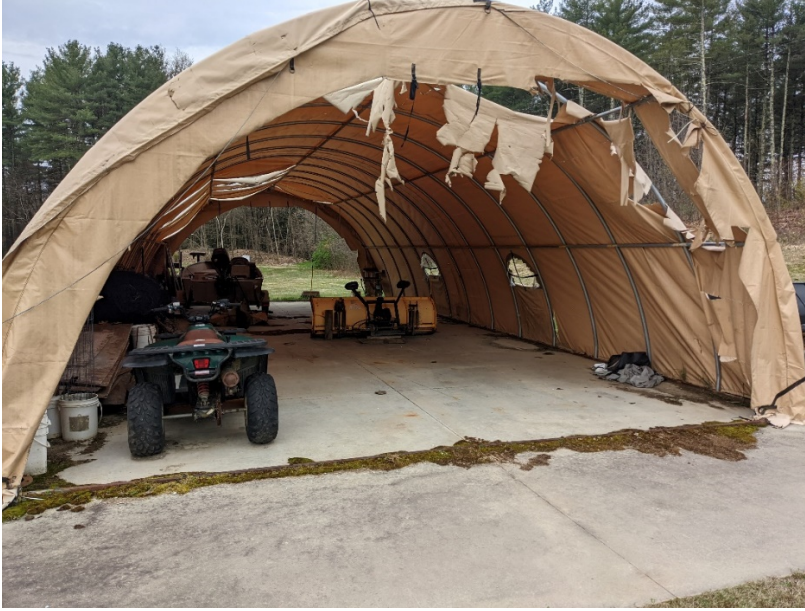
Figure 6-1: Vehicle Storage Building

The Vehicle Storage Shed is a single bay (22-ft x 45-ft) Quonset hut style shed (shown in Figure 6-1) with open ends that is used to store maintenance equipment. The structure consists of a concrete slab that is in good condition, wood curbing supports for metal framing, and a PVC cover over the framing. The metal framing is in good condition, as are the anchors of the frame to the storage building slab. The fabric covering is in poor condition and in need of replacement.

Staff noted that the open ends provide limited to no protection from wind, rain, snow and animals, which along with the drainage issues, limits what they are able to store in this building. Staff noted that the curved shape of the structure minimizes the height along the sides, which also limits the amount of equipment that can be stored here and indicated that simply fixing the cover would not meet their storage needs for this area, which includes the need for storage space for four (4) pickup trucks.

Hatchery personnel indicated their preference is to have a new storage building constructed on site for equipment and feed, potentially in a level area between the Upper and Lower Pools.

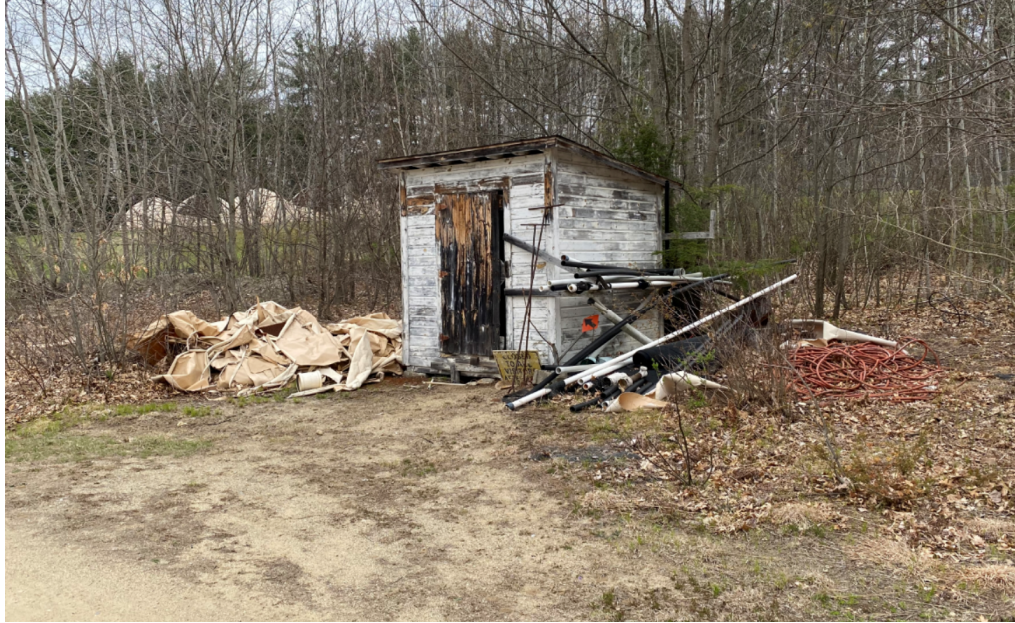
Figure 6-2: Storage Shed

There is an old storage shed located between the Upper and Lower Pools that is in poor condition, see Figure 6-2. This shed is wood construction and is rotting and falling apart. Staff noted that they are no longer able to store anything inside. This shed is a safety hazard and should be demolished as part of any renovation work.

Staff also noted that this shed was too small for their storage needs and noted that they need something closer to 20ft x 20ft that can be sealed off from animals and the elements would be preferred for their storage needs.
