Existing Conditions and Facility Evaluations – New Hampton

POWDER MILL FISH HATCHERY FEASIBILITY
STUDY

New Hampshire Fish and Game Department

May 25, 2023

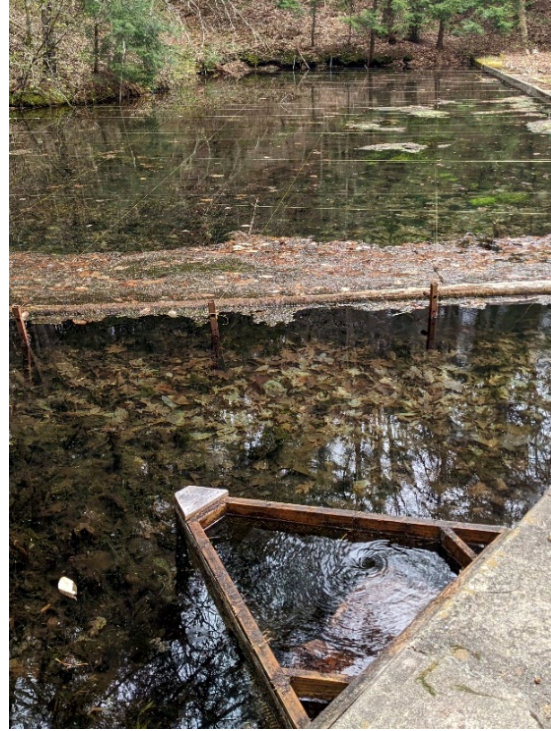
A low concrete gravity wall structure impounds the water of a Spring Pool (Figure 4-2), which has spring water rising up into it and has spring water flowing into it from an upgradient ravine. Broadly spaced wires are stretched across the pond to deter waterfowl. The pool has aquatic vegetation, a buildup of trapped sediment, and an outlet structure with a perforated plate screen and a corroded butterfly valve.

Figure 4-2: Spring Pool

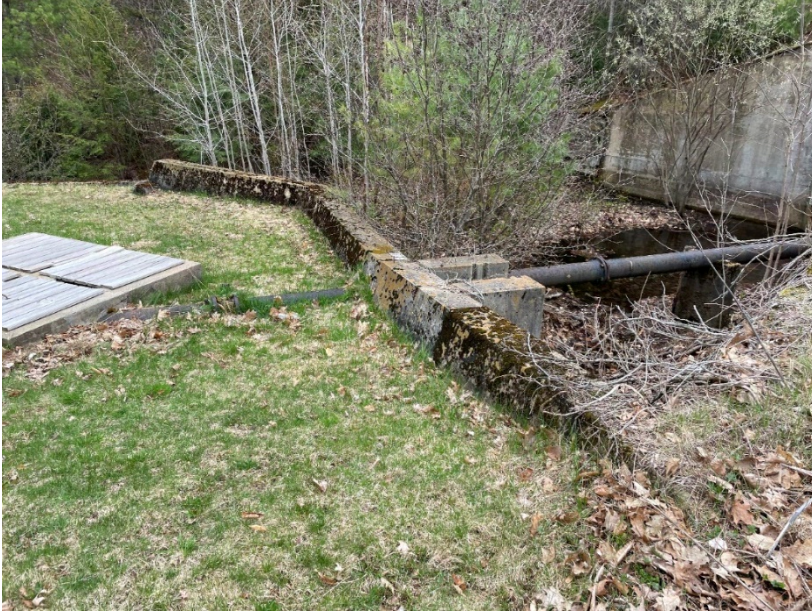
There is a minor source of spring water (shallow well points) across/south of RT 132 in another wooded ravine (Figure 4-4 through Figure 4-9). It is estimated there are seven shallow 2- to 3-inch diameter well points and three natural springs in the area. Hatchery staff have surged some well points with 8-foot of garden hose. A perforated plate screened, low concrete headbox diverts water from these springs into an 8-inch diameter ductile iron pipe (DIP), most of which is exposed, under the highway to a concrete distribution box with a buried butterfly valve on its inlet pipe. Year 2003 sewer drawings indicate 12-inch PVC from the distribution box to Raceway A-2 and the hatchery building. Some piping near the low headbox is reportedly clay. The minor springs can provide 100-200 gpm.

Figure 4-4: Minor Spring Concrete Distribution Box/Inlet Piping Below Crossing of RT 132

It is recommended that the minor springs be found, and their location, elevation, depth, diameter and material of construction be documented. They should be cleaned and surged by a well maintenance company and their flows measured and documented. The wooden bar screen in front of the intake box should be replaced with an aluminum or stainless steel profile bar screen. The wood framed and wood covered screen box over the pipe entrance should be replaced with one fabricated of longer life materials such as concrete, stainless steel or fiberglass or other composites. The wooden stop logs of the impoundment box should be replaced with composite stoplogs. Fallen and dying trees in an around the impounded spring water should be removed. The impounded water body seems small enough to feasibly cover at least partially with a structure with roof and screened walls to deter many animals and leaves and reduce direct sunlight that promotes detrimental algae growth and solar heating.

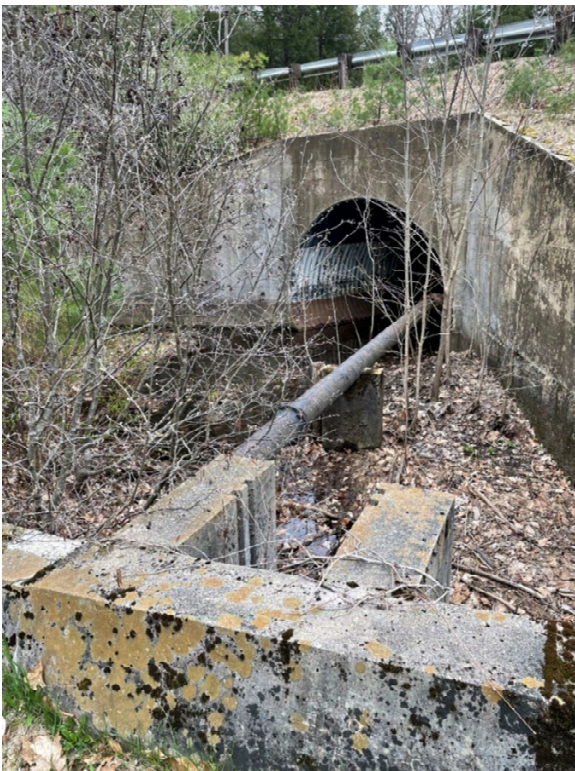
Figure 4-5: Pipe Support Across RT 132 from Minor Springs

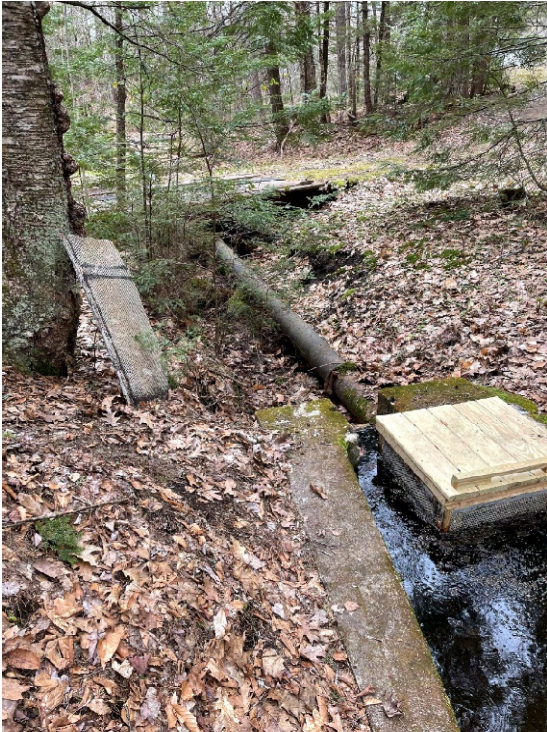
Figure 4-6: Minor Spring Concrete Headbox

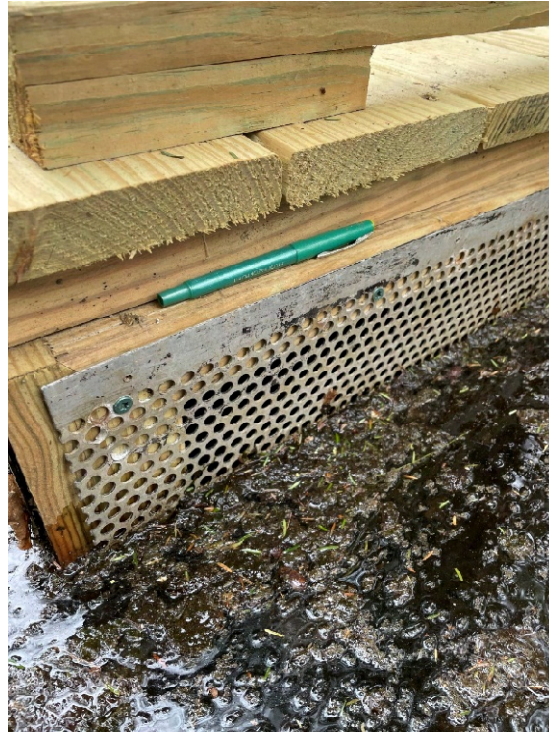
Figure 4-7: Wood Framed Inlet Screen at Minor Spring

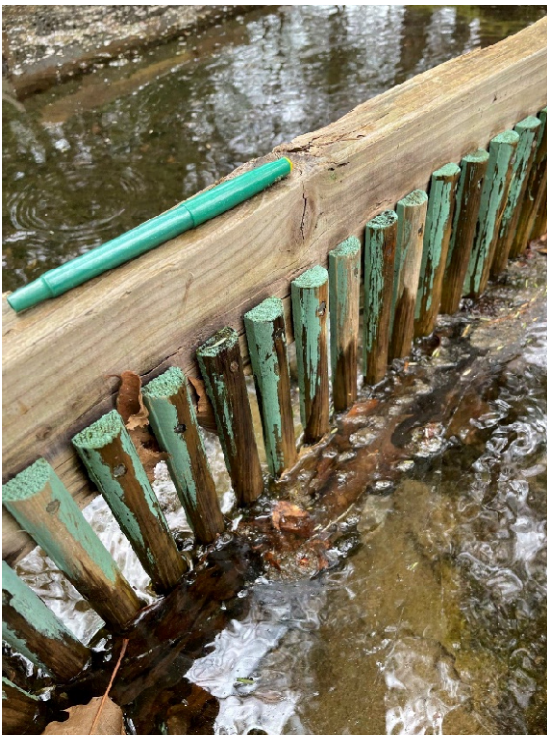
Figure 4-8: Wooden Stoplogs at Screen Upstream of Wood Framed Inlet at Minor Spring

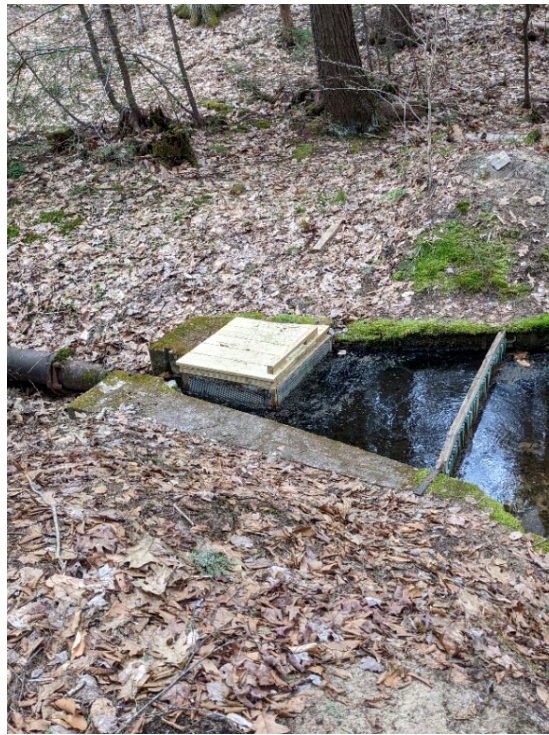
Figure 4-9: Head Box at Minor Water Source Across RT 132

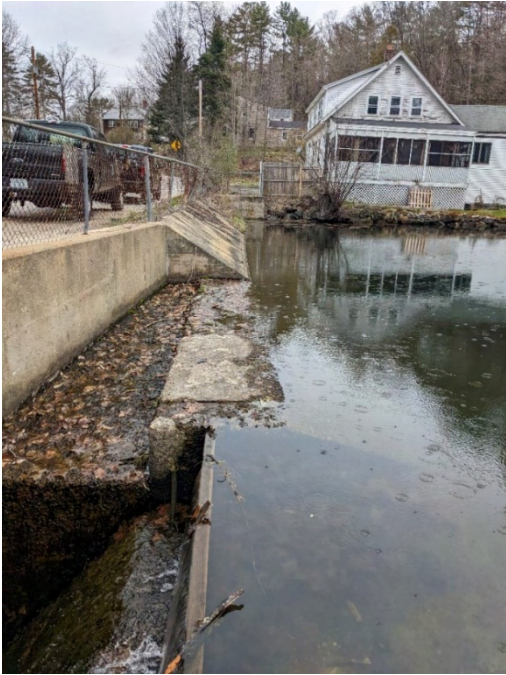
The total impounded area in Dickerman Pond is 5.0 acres with a 20-foot average working depth for a volume of 100 acre-feet (Figure 4-10). The “surface” nature of the pond water supply makes the system vulnerable to pathogens. The water supply piping from Dickerman Pond consists of a 6-inch DIP to B-Series and a 12-inch DIP to C-Series and the adjacent round tanks with a 2-inch branch to a lone round tank midway. These supply lines are fed from an inlet box in Dickerman Pond near the center of the dam and it is believed that the pipes were installed in 1995. The piping has never been cleaned but is fully drainable. Together these two supply lines can provide up to 1500 gpm. Inspection and condition assessment of Dickerman Pond was beyond the scope of this work. NHFGD notes that this dam is not owned by them, but by the state of NH and that both NHDOT and NHDES have both expressed concerns regarding the condition of this dam in the recent past. It is recommended that any improvements to this dam that are required be performed at the same time as any other significant hatchery upgrades are.

Figure 4-10: Dam at Dickerman Pond

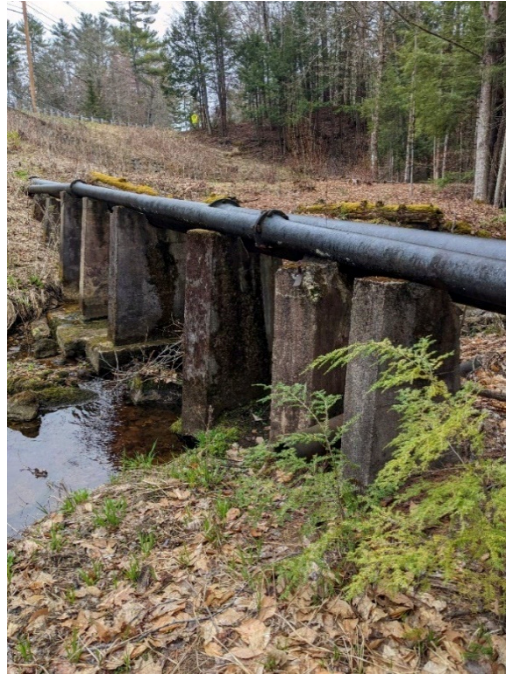
The 6-inch DIP (Figure 4-11 and Figure 4-12) crosses over Dickerman Creek twice between the dam and the raceway. At the upper crossing, the pipe is supported by concrete cradles. The pipe run has shifted over time so that it is no longer supported by the majority of the concrete cradles. This does not pose a short-term hazard, but as part of routine maintenance the situation should be investigated further to determine if the DIP should be shifted back to its original position with metal tiedown strapping or if the supports should be modified to help support the shifted piping. At the lower crossing of the creek the pipe is supported by concrete cradles and a steel beam. That crossing is in fair condition, with no short- or mid-range repairs required.

Figure 4-11: B-Series inlet piping shifted at support cradles at upper creek crossing

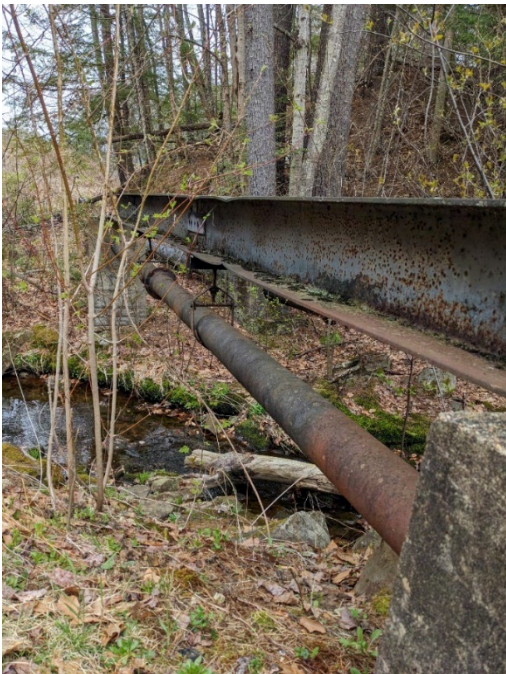
Figure 4-12: B-Series inlet piping at lower creek crossing

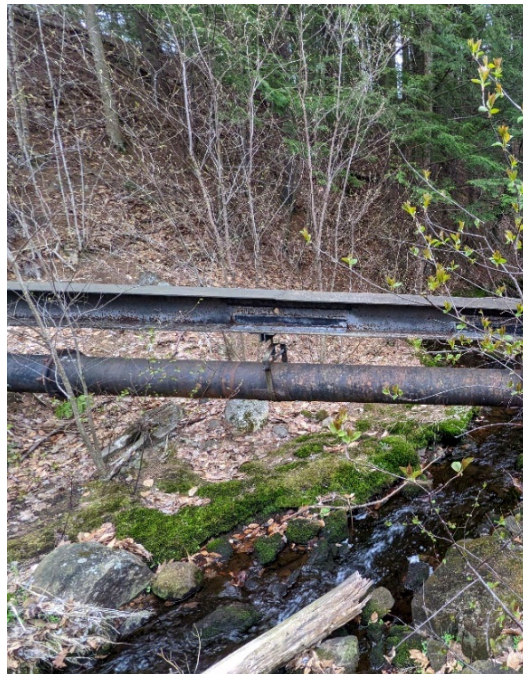
The 12-inch DIP supplying C-Series runs through the dam at Dickerman Pond and then overground down the slope to the B-Series area, before going underground. The pipe crosses over Dickerman Creek twice between the dam and the B-Series area. At the upper crossing the pipe is supported by concrete cradles (Figure 4-11). That crossing is in fair to good condition, with the pipe in contact with all but one of the cradles. At the lower crossing of the creek the pipe is supported by concrete cradles and a steel beam. That crossing is in fair condition with no need for repair at this time (Figure 4-13).

Figure 4-13: Lower crossing of Dickerman Creek for C-Series inlet pipe

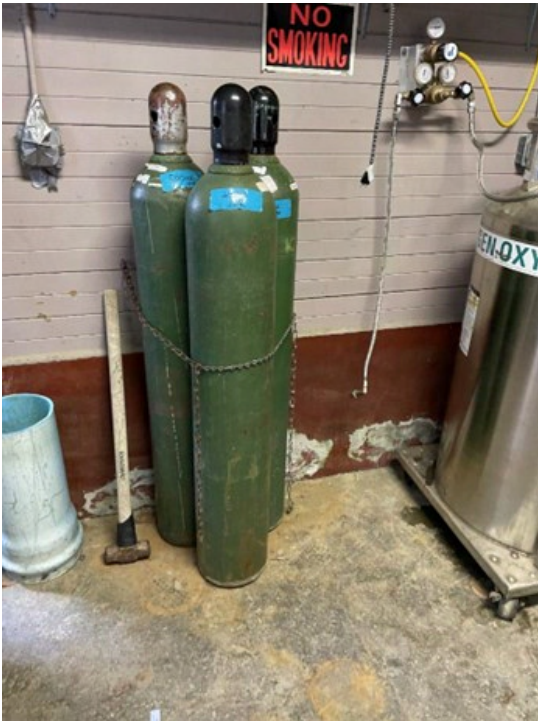
Most rearing units are equipped with oxygenation/degassing columns connected to a low-pressure air distribution system to provide for degassing and oxygenation of the spring water supply. A one horsepower (HP) Sweetwater blower acts as a vacuum line. The hatchery has a pressure swing adsorption (PSA) oxygen generator that is not working. Instead, a semi-portable liquid oxygen (LOX) tank is used. In May of 2022 there were three high pressure oxygen cylinders beside the LOX tank for manual backup, see Figure 5-4 and Figure 5-5 (these tanks are no longer in use).

Figure 5-4: High Pressure Oxygen Cylinders

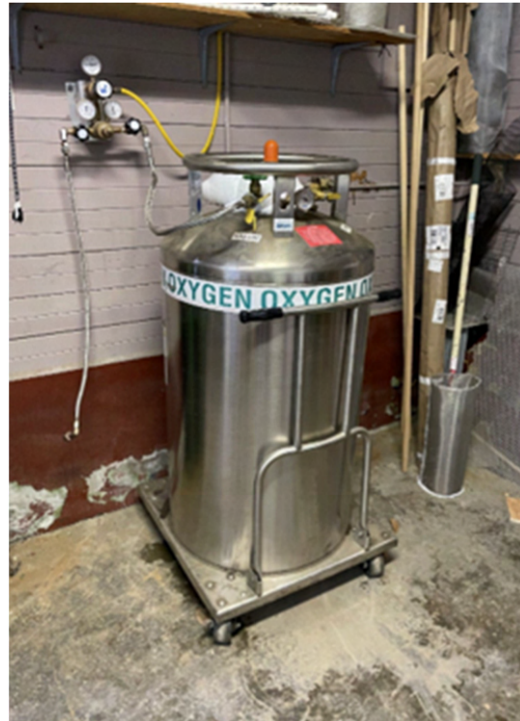
Figure 5-5: Liquid Oxygen (LOX) Tank

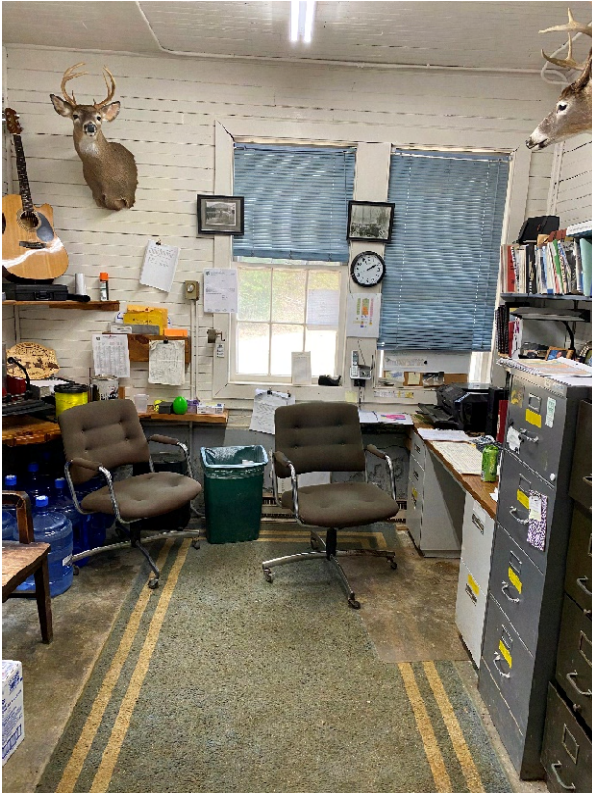
The office space is approximately 11-feet by 12-feet and laid out with a desk, filing cabinets, shelves, a water cooler, and a small closet under the stairs to the attic. Due to the step down and the narrow doorway, the office space is not accessible (Figure 5-13 and Figure 5-14).

Figure 5-13: Office

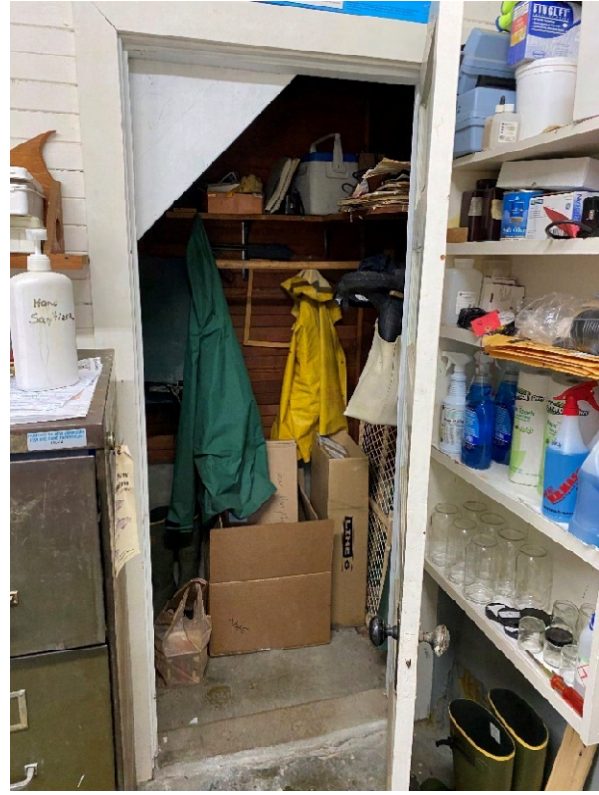
Figure 5-14: Office Closet Under Stairs

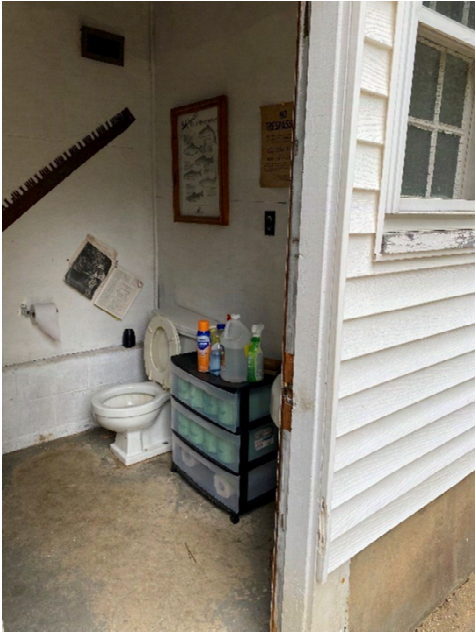
There are two bathrooms located on the south side of the building, which are accessed from the outside (Figure 5-15 and Figure 5-16). One of the bathrooms is currently being used as a storage space. Unlike the main floor, the floors of these bathrooms are level with the exterior grade so there is no step down as you enter the bathroom. Each bathroom is approximately 5-feet-6-inches wide by 5-foot 10-inches deep. Neither bathroom is currently set up to be ADA compliant, as they do not have ADA compliant fixtures, grab bars, and doors are less than the 32-inch minimum width.

Figure 5-15: Hatch House Bathroom

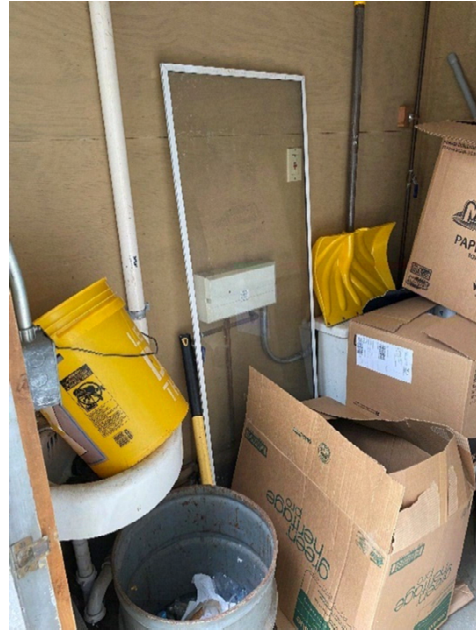
Figure 5-16: Bathroom used for storage

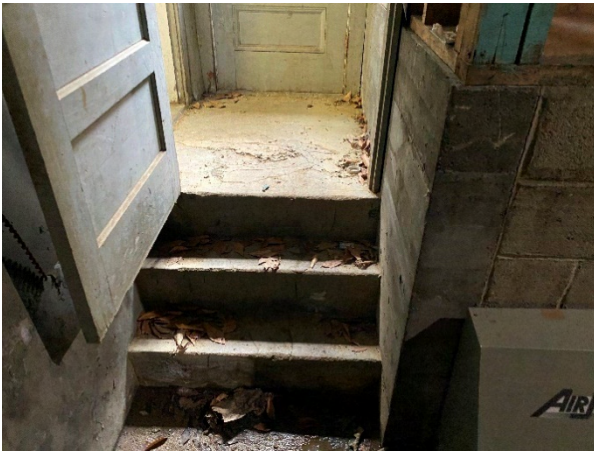
The mechanical room (15-feet by 7-feet 7-inches) is located between the bathrooms and the production area, and is accessed via the vestibule connected to the storage room, and a set of concrete steps (Figure 5-18 and Figure 5-19). The floor of the mechanical room is approximately 2-feet below the main floor. Two large metal screens in the wall between the mechanical room and production area allow airflow between the spaces. Standing water was observed on the floor in the mechanical room along with rusting of the bottom of the equipment and deterioration at the bottom of the concrete walls.

Figure 5-18: Stairs and Vestibule to Mechanical Room

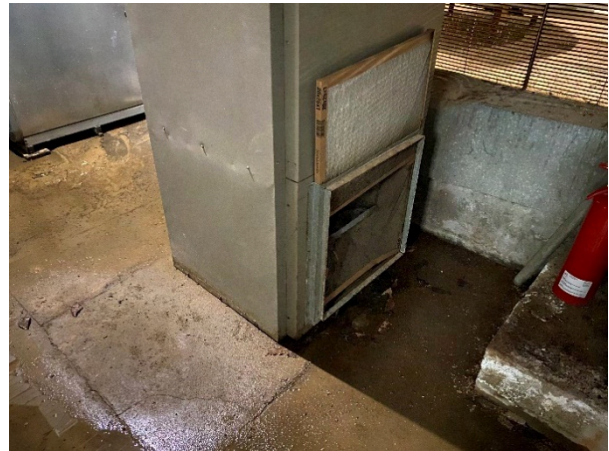
Figure 5-19: Mechanical Room Floor & Screens

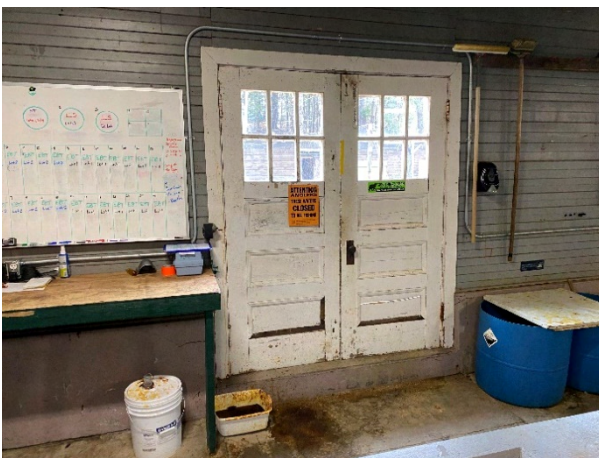
The main production rearing area is a large (85-feet by 45-feet) open room with concrete rearing tanks and walkways between the tanks and along the west wall. The interior finishes in this space are consistent with the finishes in other rooms. Refer to the structural writeup above for notes on the floor slab and drainage channels. Staff did note that this room is difficult to maintain consistent temperatures, especially during the winter, and during hot summer days. This is likely due to the amount of windows and doors, and lack of insulation in the walls (Figure 5-20 and Figure 5-21).

Figure 5-20: Double Doors on West Facade

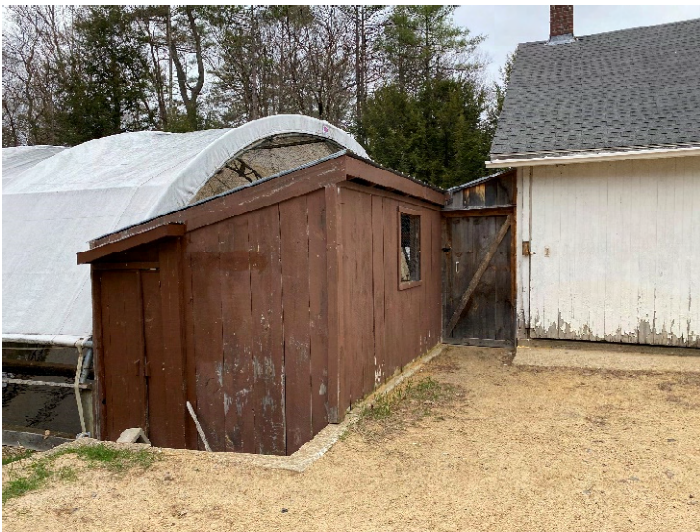
Figure 5-34: Raceway A-3 Covered Entrance Shed Structure

The covering over the raceways is open at the two ends. The west end is closed off with netting, while the east end is closed off with a wood shed structure connected to the adjacent historic garage. Access to the covered raceways is through the shed structure on the east side, through a door, and down a set of concrete steps, as the raceways are approximately 2-feet below adjacent grade at the entrance point. The wood shed structure appears to be in fair condition (Figure 5-34 and Figure 5-35).

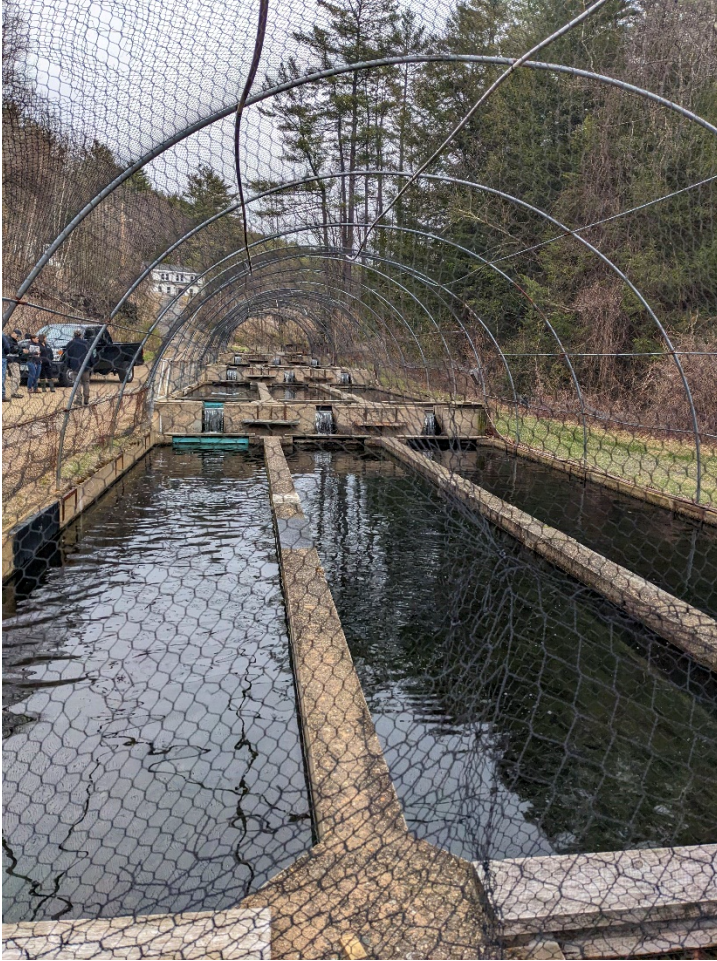
Figure 5-38: B-Series looking upstream

Water is supplied to B-Series by a 6-inch diameter cement-lined DIP from the intake above the dam at Dickerman Pond (Figure 5-38). B-Series contains four sets of three raceways, each approximately 7-feet by 50-feet, using serial water reuse of 404-gpm peak water flow. There is between 1.5- to 2.5-feet of head drop (i.e., fall) between each set of raceways. Water temperatures within this series fluctuate with a maximum of 58°F in the summer. They are protected from predation by metal-framed covers and netting.

The concrete of B-Series is in poor condition. There are vertical cracks, efflorescence and heavy spalling at approximately 20 percent of the wall top surfaces (Figure 5-39 and Figure 5-40). The raceway is oriented so water flows from east to west. The northmost exterior wall, adjacent to hatchery road, is in the worst shape with major spalling and cracking at the interface with the bottom of the wall and the floor of the raceways. During the inspection, leakage through the north outer wall was enough that water was flowing along the edge of the road. The concrete surfaces of the walls and floor below normal water line are eroded to an average depth of 1/8-inch. The spalling and cracking of the concrete is also more extensive at the baffles where water flows from one set of raceways to the next. The B-Series concrete has been patched in many locations as part of routine

The supports for the predatory netting system over the raceways was observed to be in poor condition, and unstable. Staff noted that during the winter, they have to take down the netting, because the netting and supports cannot take the load of snow on the netting. Increased predation control is recommended.

- Raceway A-5
 - Rehabilitation of the concrete to inject sealer into cracks and to re-line exposed concrete surfaces with epoxy concrete or similar.
- B-Series
 - Major structural rehabilitation is needed if they are to remain in service.
 - Increased predation control is recommended.
- C-Series
 - Severe concrete spalling of the C-Series raceways and leakage dictates replacement.
 - The transformer is deteriorated due to potential overloading and requires replacement.
- C-Series Circular Tanks
 - No recommendations currently.

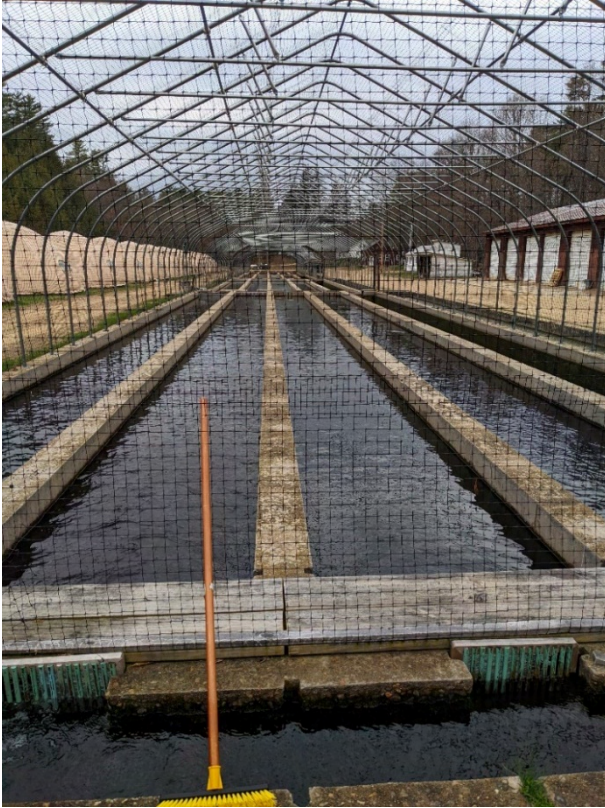
Figure 5-41: C-Series looking downstream

C-Series is comprised of five sets of linear six pass serial reuse raceways. The southerly five raceways were enclosed by metal-framed covers and netting at the time of the site visit, but have since collapsed. All of the C-Series raceways are unprotected. At the inspection, the four southerly raceways of the four upper sets were being used for rearing. The two northerly raceways of the four upper sets were being used for settling/treatment, as were all six of the westernmost (uncovered) set of raceways (Figure 5-41 to Figure 5-43).

Generally, pond water is used for B-Series and C-Series water supply. Fish feeding is accomplished by hand. The raceways are not equipped with electrical service. The raceways are swept and cleaned frequently and appear to have minimal sediment build-up. Many raceways have been kept dormant due to lack of water supply or inability to hold water. Many of the active raceways are severely deteriorated and require large amounts of water to maintain constant levels. Severe concrete spalling of C-Series and leakage dictates replacement.

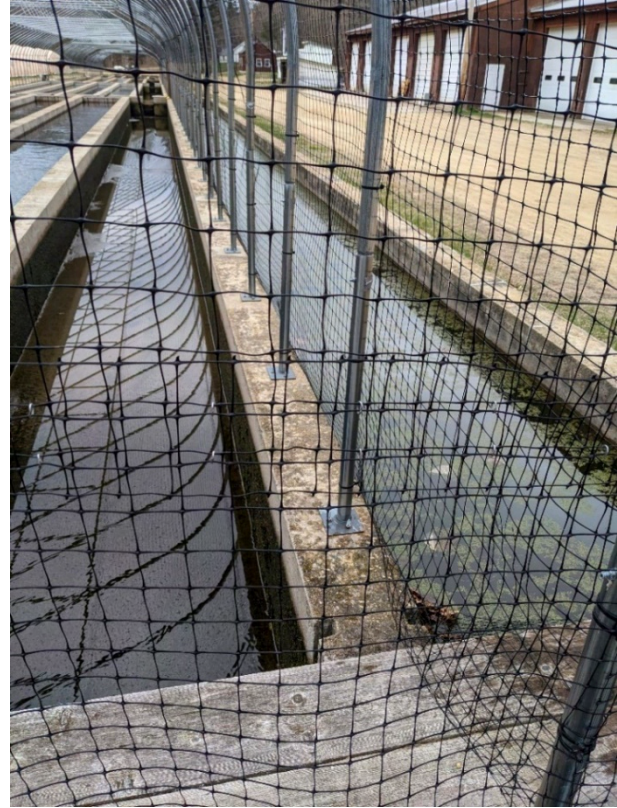
Figure 5-42: Northerly raceway at C-Series not protected by frame/netting (typical)

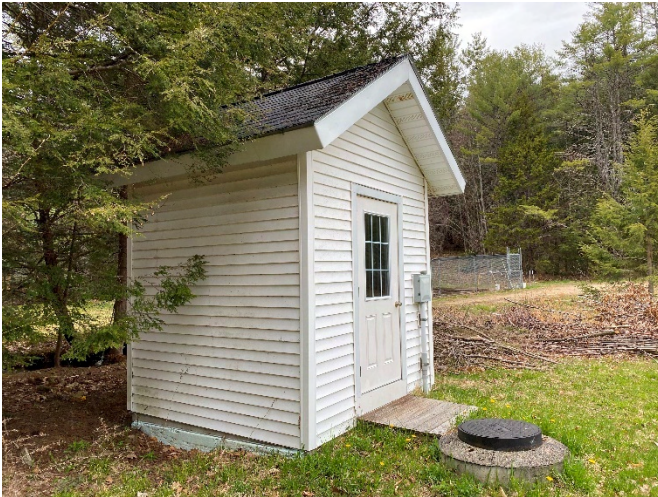
Figure 6-1: Sampling Shed at Raceway A-3

There are two sampling sheds in the A-Series area on either side of Dickerman Brook: one adjacent to Raceway A-3 is Outfall 001, which is the discharge from Raceway A-3, A-2 and the Hatchery Building (Figure 6-1) and the other adjacent to Raceway A-5 is Outfall 002, which is the discharge from Raceway A-5 and A-4 (Figure 6-2). The sampling shed at Raceway A-3 appears newer and in good condition. The sampling shed at Raceway A-5 is a little smaller and appears in fair to good condition, other than some minor damage to vinyl corner trim and fascia.

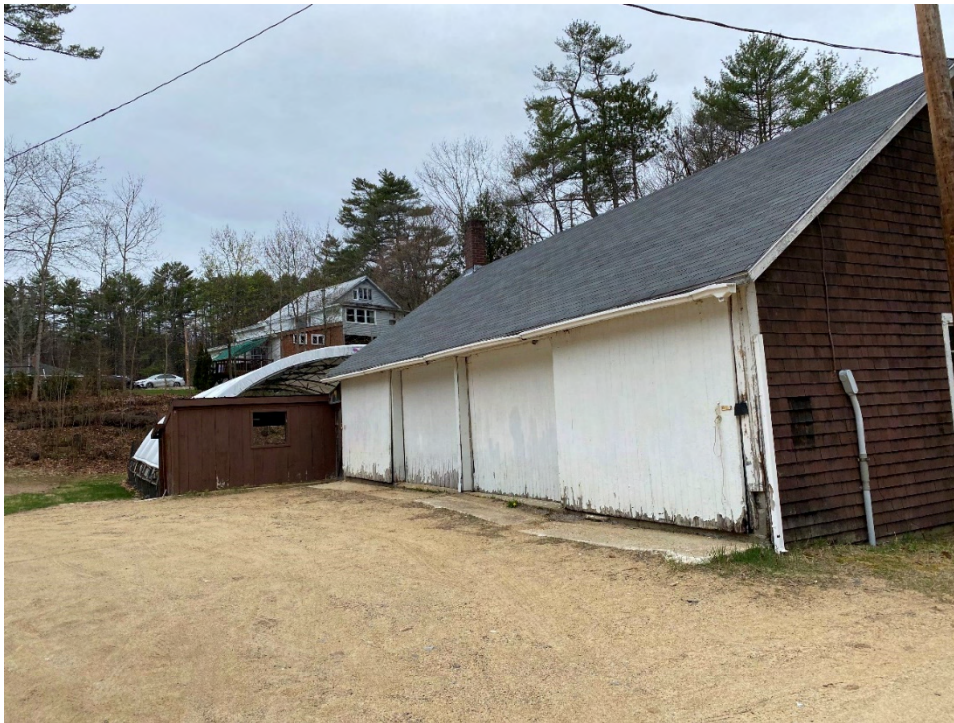
Figure 7-1: Upper Garage Front (South) Façade

The upper garage is located within the upper portion of A-Series area adjacent to Raceway A-3 (Figure 7-1). The exact age of the garage is unknown, however staff noted that this structure is historically registered. The upper garage serves as the primary feed storage area for A-Series area and is also used for the storage of other equipment such as tractors and nets. While the garage works well for the storage of netting and other miscellaneous equipment, it is not ideal for feed storage, since there is no means of maintaining temperature, and the barn doors have gaps at the bottom and provide no protection from rodents.

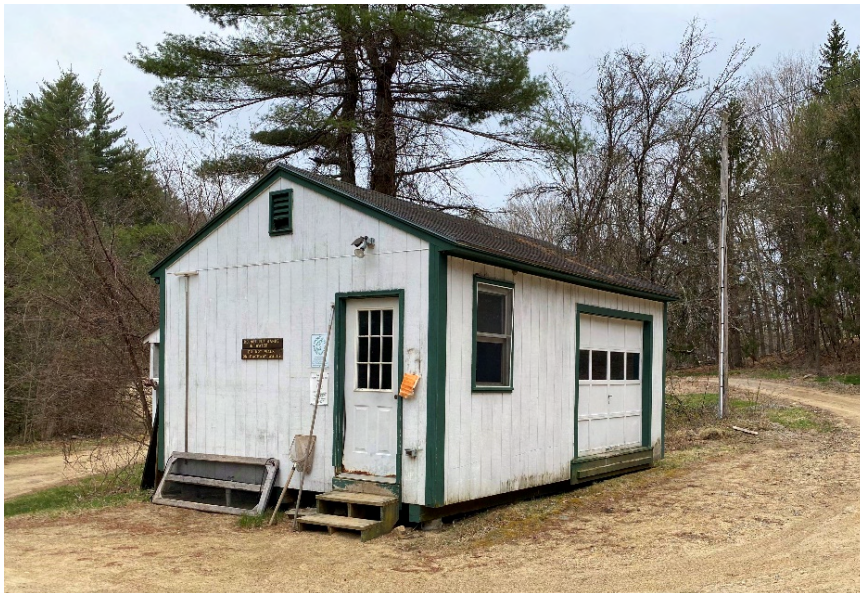
Figure 7-6: Feed Shop

The Feed Shop is a shed structure located adjacent to B-Series that was built in 1995 and is used primarily as a local feed storage area for B-Series along with some other miscellaneous storage (Figure 7-6). The shed consists of concrete sonotube foundations with wood girders supporting a simple wood structure shed, all of which appear to still be in good condition. The exterior walls are finished with vertical wood paneling which appears to be in good condition. The roof is a gable style roof with asphalt shingles and is still the original roof from 1995. The roof appears to be in fair condition, and no water leaking was reported, or observed. The interior has a plywood floor, with exposed studs and rafters.

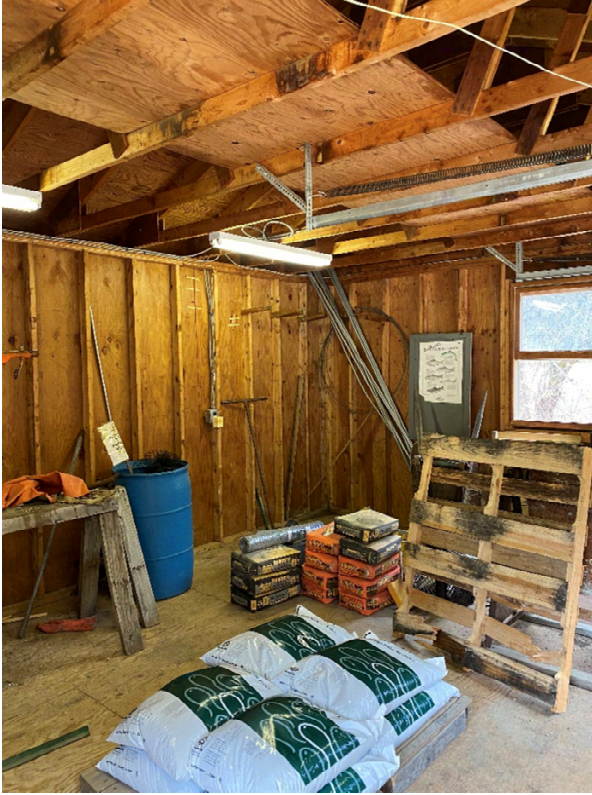
Figure 7-7: Interior View of Feed Shop

The Feed Shop is accessed via a man door with wood stairs on the east façade and an overhead garage door on the north façade. The doors are operable, however neither seals fully. The man door is rusted at the bottom and leaves gaps for weather and rodents, while the overhead door is not tight to the frame, leaving gaps between the door and wall. Due to rodent access and the inability to maintain consistent temperatures, similar to the Upper Garage, the Feed Shop does not function as an efficient feed storage structure (Figure 7-7 and Figure 7-8).

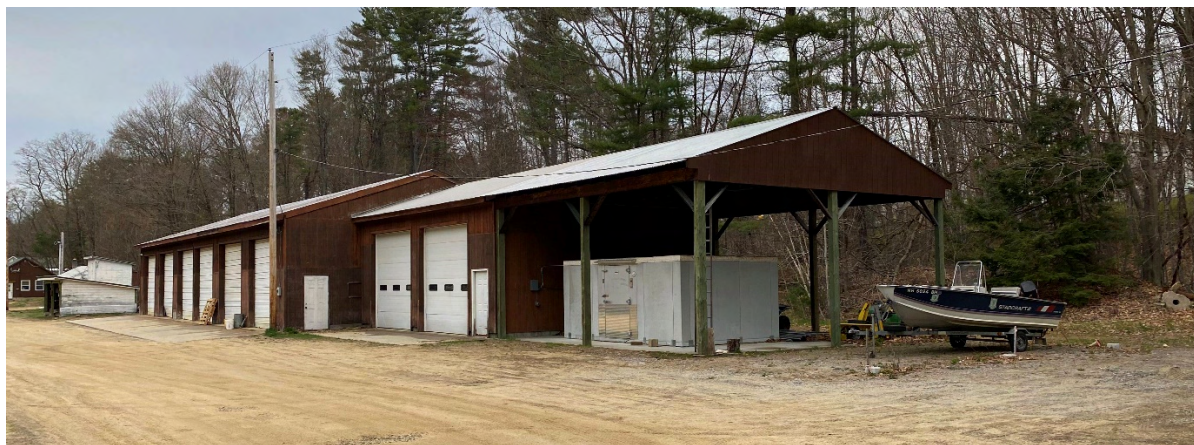
Figure 7-10: Garage - Overall View

There is a large multi-bay garage building that houses a boat bay with a workshop, wildlife bay, storage bay, feed storage bay, marine biology bay, state police bay, and an open covered area for a cold storage freezer (Figure 7-10). The Garage is constructed of a concrete slab foundation with wood framed walls and roof, which appear to be in good condition. The exterior is finished with vertical wood paneling, and the roof is a gable style metal roof. The roof appears to be in good condition; however, the roof soffit along the north side of the garage consists of screening material, which has been damaged, leaving openings for animals and insects to get into the garage. The vertical wood paneling is in good condition, except in some locations at the bottom of the of the paneling where it comes in contract with the ground. These locations show signs of the paneling rotting or warping and pulling away from the structure. This building is uninsulated and is not heated or cooled (Figure 7-11 and Figure 7-12).

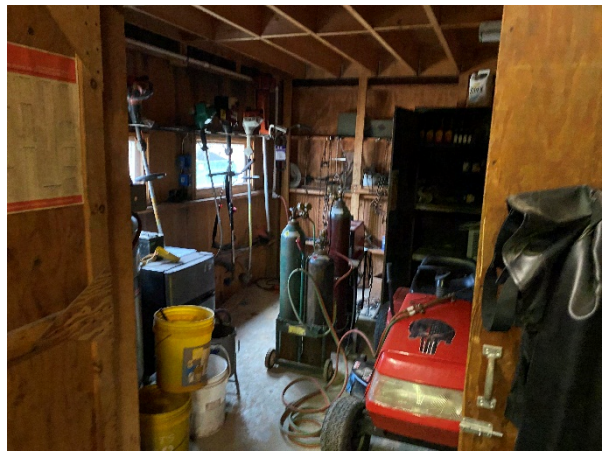
Figure 7-14: Auto Bay Workshop

The Auto Bay is the bay farthest west in the Garage. It is a single width bay, in which the back 12-feet are separated from the front for use as parts storage and a workshop space. This space is used for maintenance of vehicles. Staff noted that it is difficult to keep this space warm enough to work in the winter (Figure 7-13 and Figure 7-14).

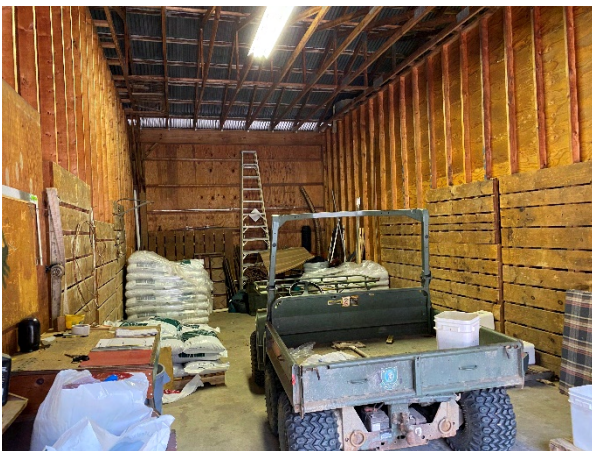
Figure 7-17: Feed Bay

Beside the Wildlife Bay, is the Feed Bay, which serves as the feed storage area for C-Series area (Figure 7-17). Staff noted that similar to the other feed storage areas, this space does not provide protection from rodents, and is difficult to maintain the temperature. As noted above, the roof soffits are compromised, and since the walls separating the bays are not fully closed up to the roof, and the doors between bays are often left open, rodents have several possible ways of getting into this bay.

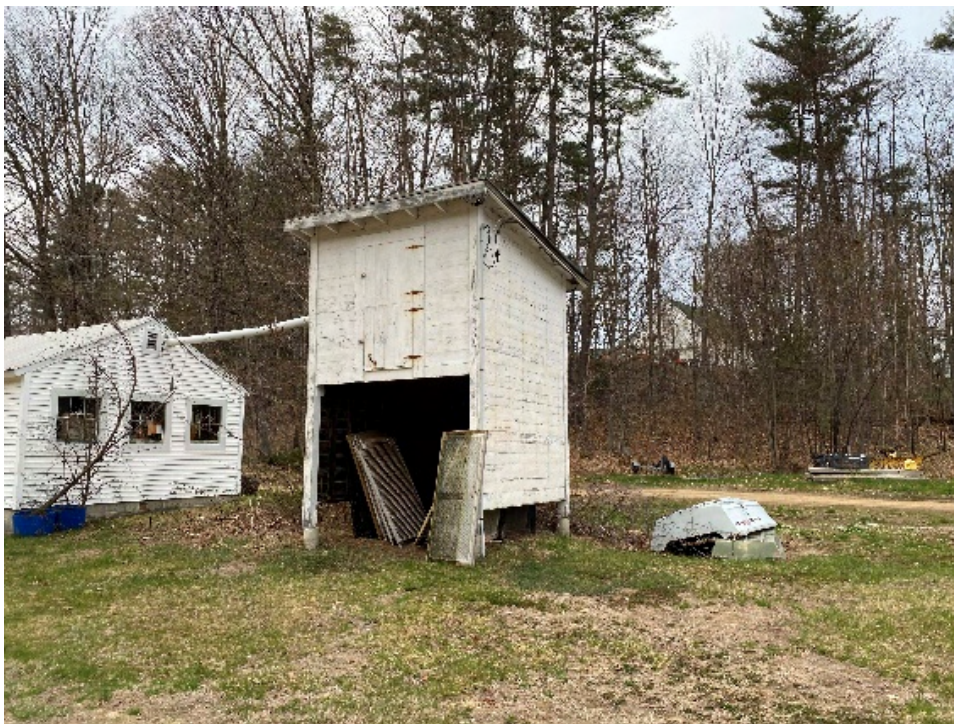
Figure 7-19: Shaving Shed

The Shaving Shed is an elevated wood structure for the use of collecting and storing sawdust generated from the Woodworking Shed next door (Figure 7-19). The upper sawdust storage area is connected to the Woodworking Shed via a PVC duct. Staff noted that this structure is no longer used for storing sawdust, however, the lower section of the structure is still used for miscellaneous storage. The age of this structure is unknown. It is recommended that this structure be demolished before it collapses and causes further issues.

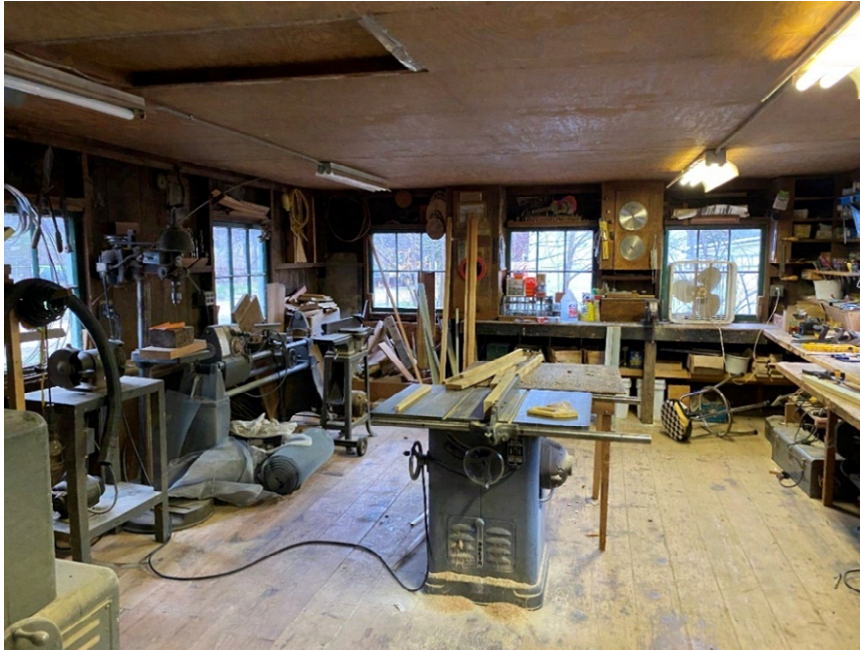
Figure 7-21: Woodworking Shed Interior View

The walls of the shop space are not insulated, and the windows appear to be the original single pane windows. The windows are not operable, but are designed to be able to be removed to allow for ventilation. However, due to the lack of insulation, blocks have been installed around the windows making it difficult to remove them, and some of the windows have been covered with plastic to provide additional insulation. Staff noted that it is difficult to get adequate ventilation in the space. During the winter, this shop is rarely used since it is hard to keep warm (Figure 7-21).

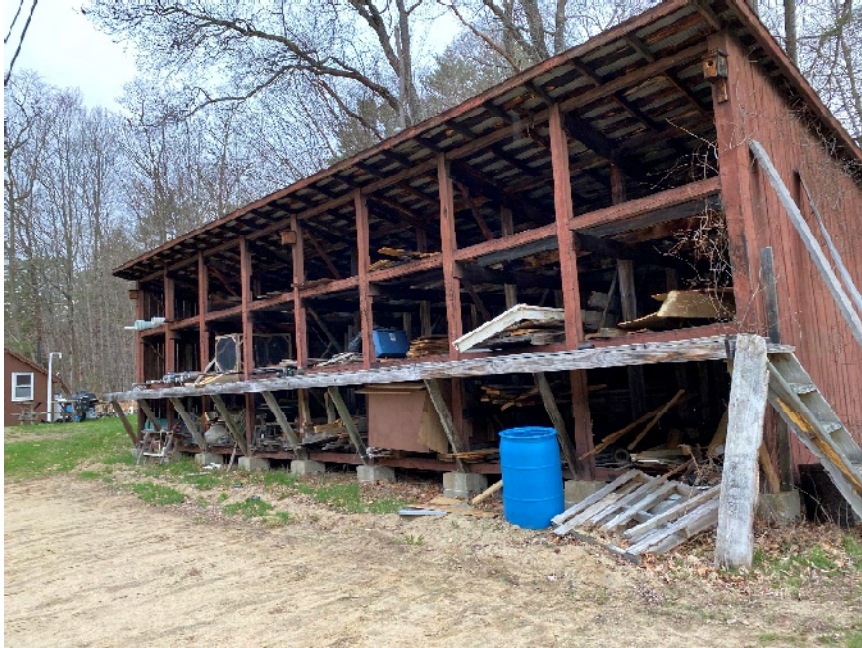
Figure 7-22: Timber Shed

The Timber Shed is 3-sided wood frame storage structure with a metal roof, used for the storage of miscellaneous materials, located adjacent to the Woodworking Shed (Figure 7-22). The wood framing appears to be in fair condition, and concrete blocks appear to still be in fairly good condition. There is a makeshift wood deck along the front of the structure to allow for easy access to the storage bays. The wood deck does not appear to be properly supported as it is visually sagging and leaning away from the structure.

Staff noted the Timber Shed was originally designed to hold the wood for the wood signs fabricated in the Woodworking Shed, which were used by all of the hatcheries and other state facilities. However, they no longer make all of the wood signs, so they no longer need to store nearly as much wood as when this was originally built. The staff noted the Timber Shed should be removed.

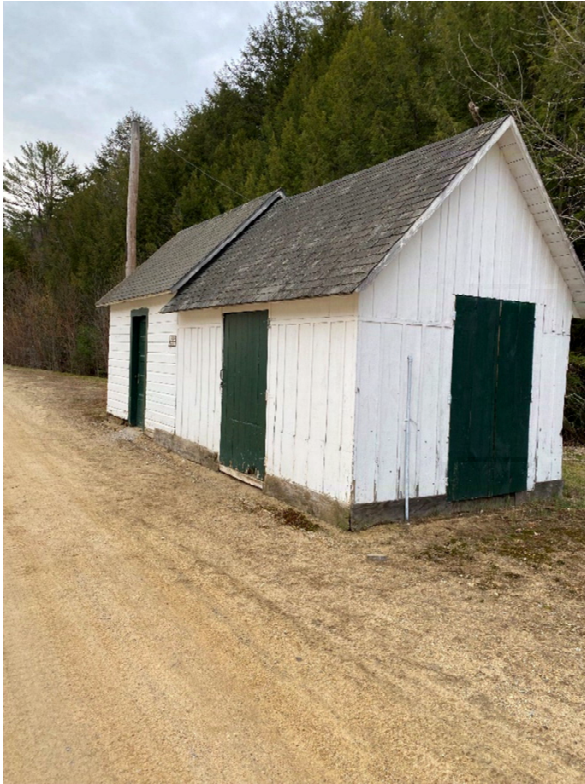
Figure 7-23: Tool Shed (Front)

The Tool Shed is a wood frame structure on the south side of the C-Series circular tanks (Figure 7-23 and Figure 7-24). It is currently still being used for storage of netting and other similar items used locally at C-Series. This structure is in overall poor condition and is not suitable for use. The wood paneling at the back is pulling away from the framing, and the roof has multiple holes in the south side. Water damage to the wood slat finishes on the interior is evident and the wood is showing signs of rotting. It is recommended this structure be removed as part of any renovation work performed at this facility.

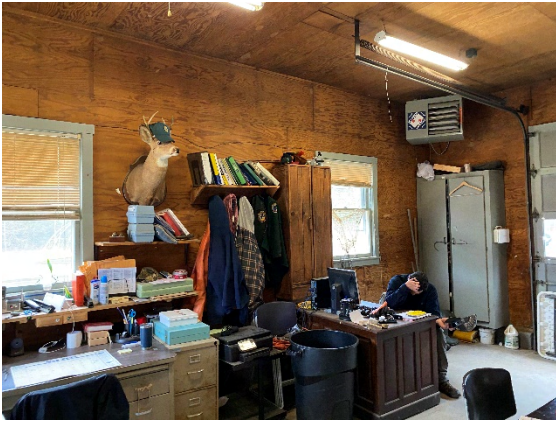
Figure 7-27: Utility Shed Interior 1

This building is heated with a gas-fired wall-mounted unit heater and has an old wood burning stove to provide supplemental heating. This building does not have air conditioning. Domestic hot water for the utility sink is provided by an electric instantaneous water heater. Equipment appears to be in good condition (Figure 7-27 and Figure 7-28).
