# Existing Conditions and Facility Evaluations – Twin Mountain

POWDER MILL FISH HATCHERY FEASIBILITY  
STUDY

New Hampshire Fish and Game Department

May 25, 2023

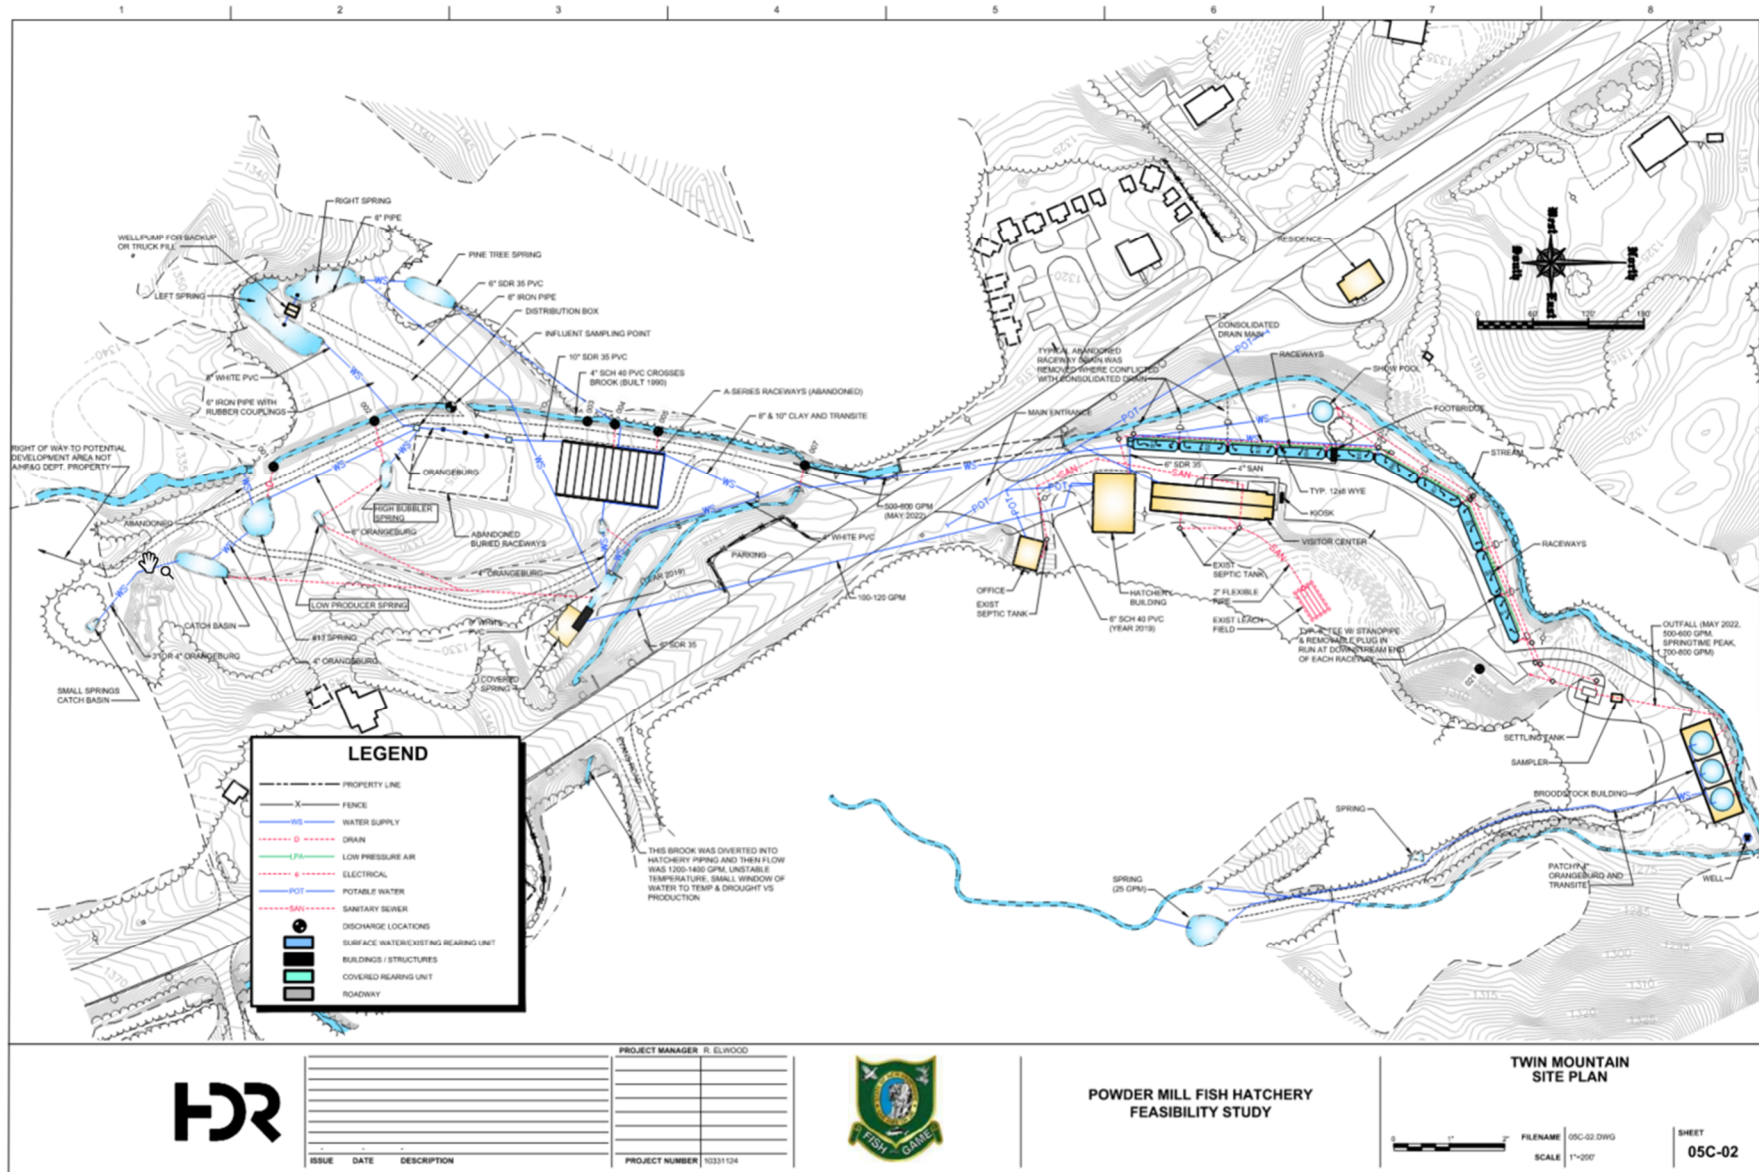
Figure 1-1: Existing Site Plan

The existing Site Plan (Figure 1-1) illustrates the hatchery boundary, approximate topographical information and general hatchery infrastructure. The study drawing was developed using digitized (i.e., traced) Computer Aided Drafting (CAD) techniques and map overlay technology. The drawing is believed to be reasonable, to-scale representations of hatchery resources for planning purposes. The drawing is not intended to be used for construction phase engineering.

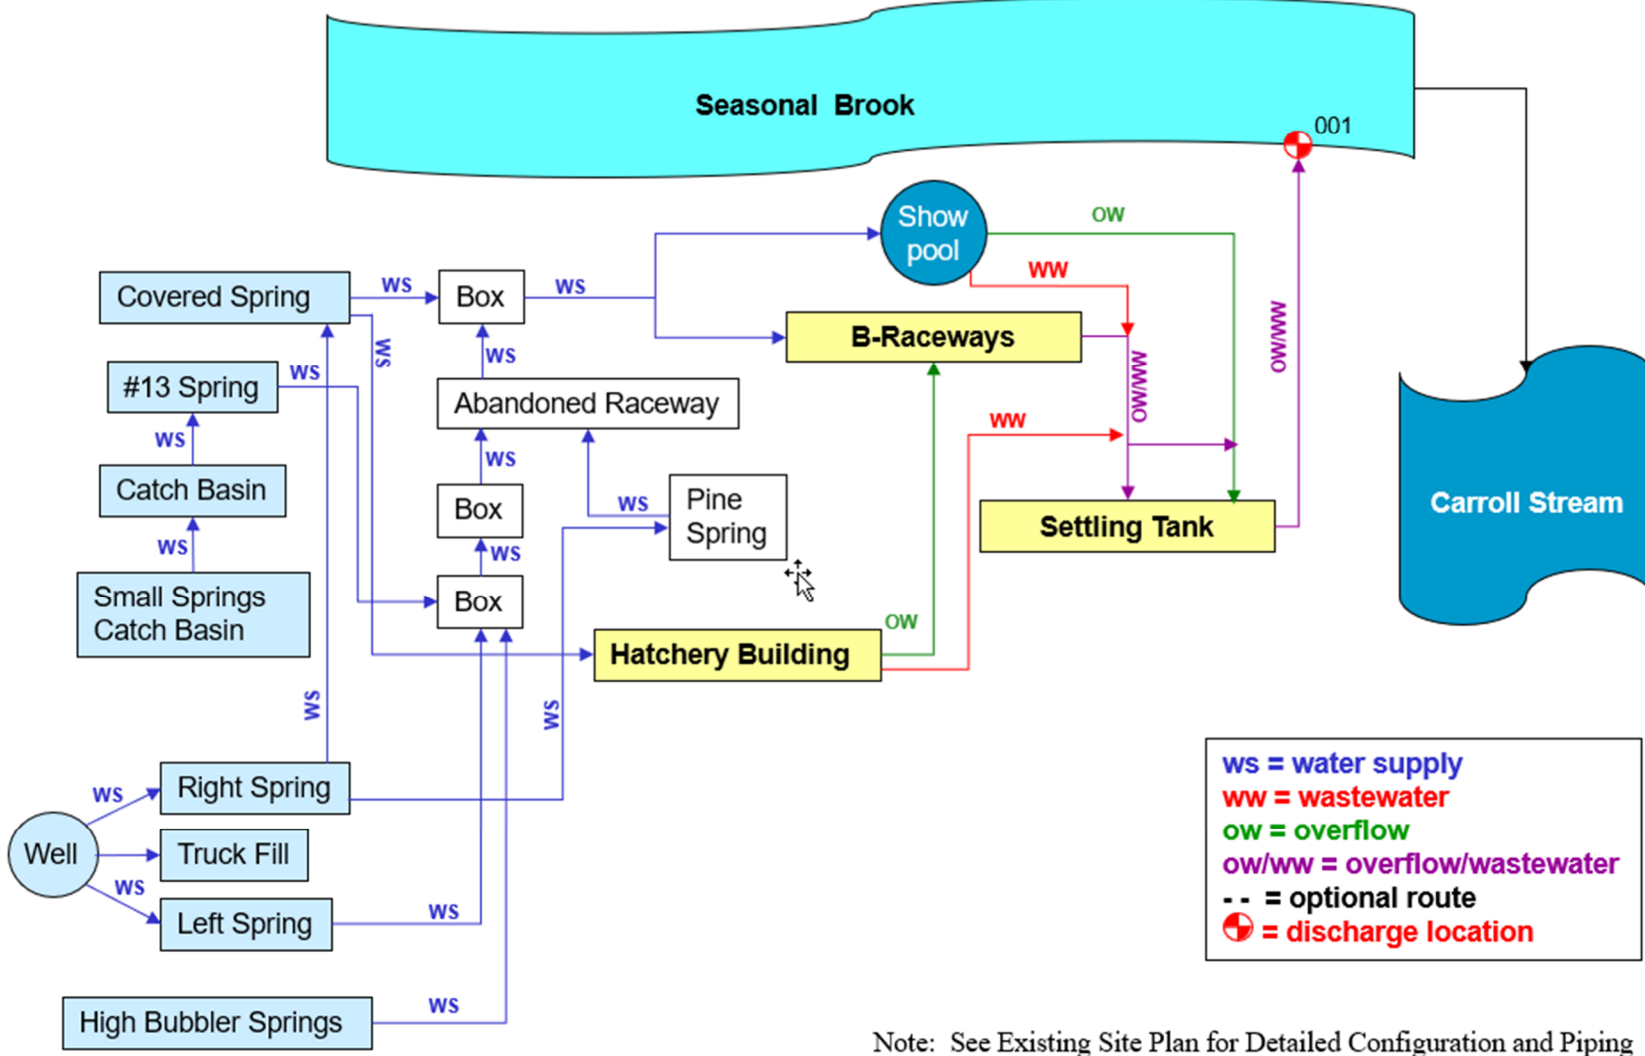
Figure 1-2: Process Flow Diagram

NPDES has authorized Twin Mountain State Fish Hatchery to discharge its effluent through outfall 001 into the Unnamed Tributary to Carroll Stream. In 2021 the Region 1 Final Aquaculture General Permit (AQUAGP) was released (NHG130000), which superseded Twin Mountains individual permit issued in 2012 (NH000074). A flow diagram of the facility is shown in Figure 1-2.

A general flow schematic has been generated for the site, which depicts the water sources and discharge locations (see Figure 1-2). Water flow measurements have been obtained using the sharp crested weir method or calculated using a known volume container and timed fill. There is an effluent water flow meter for total flow leaving the active parts of the hatchery.

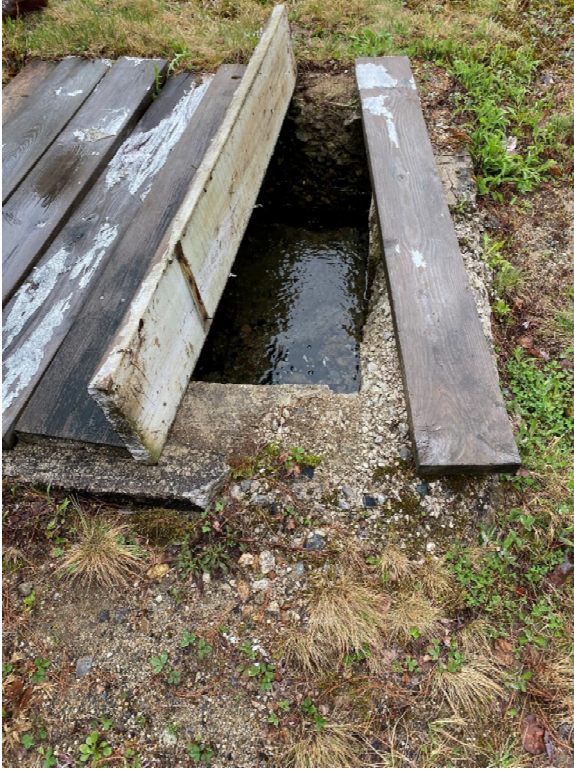
**Figure 4-6 Low Producer Spring Headbox**

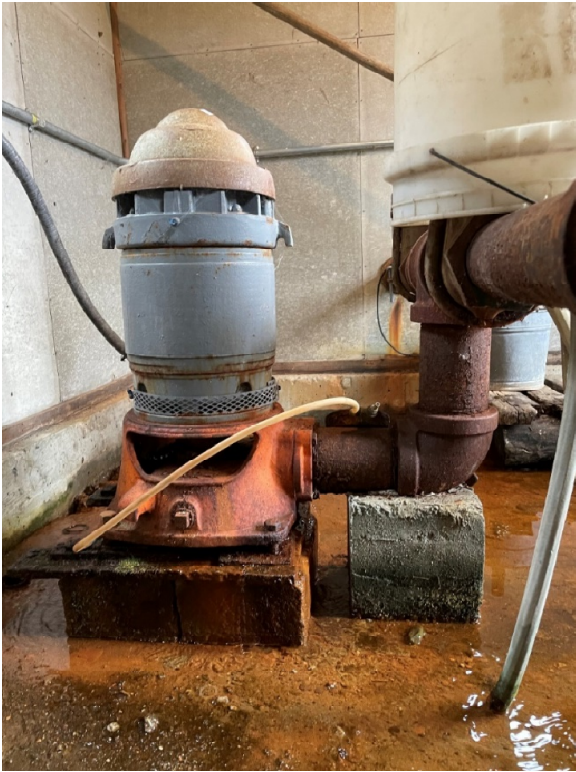
**Figure 4-7: Production Well Pump Discharge Head**

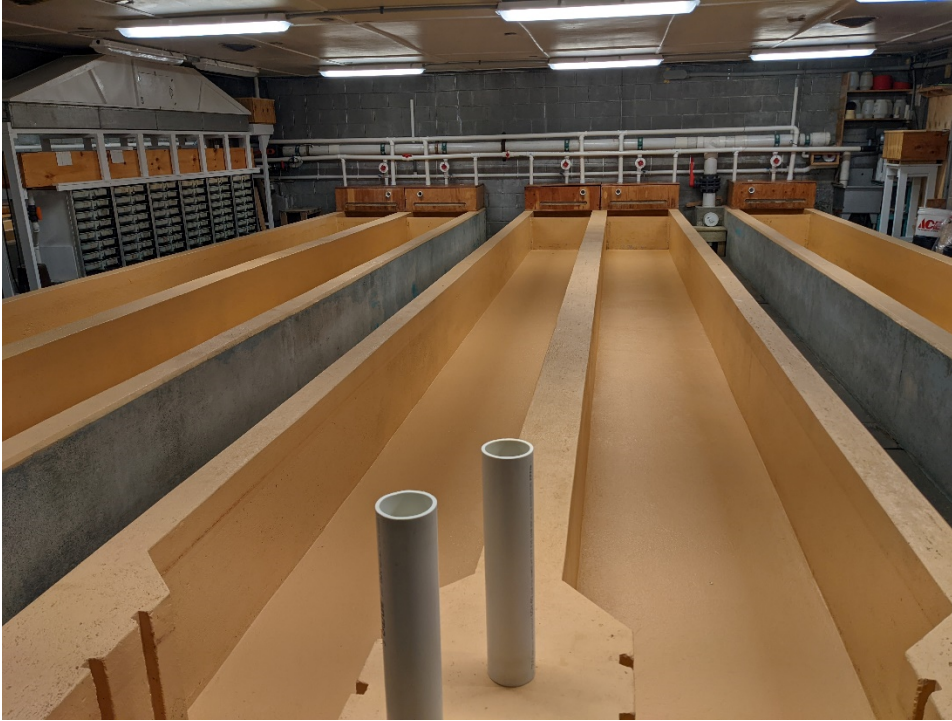
**Figure 5-1: Indoor Raceways 1-5 and Incubation Area**

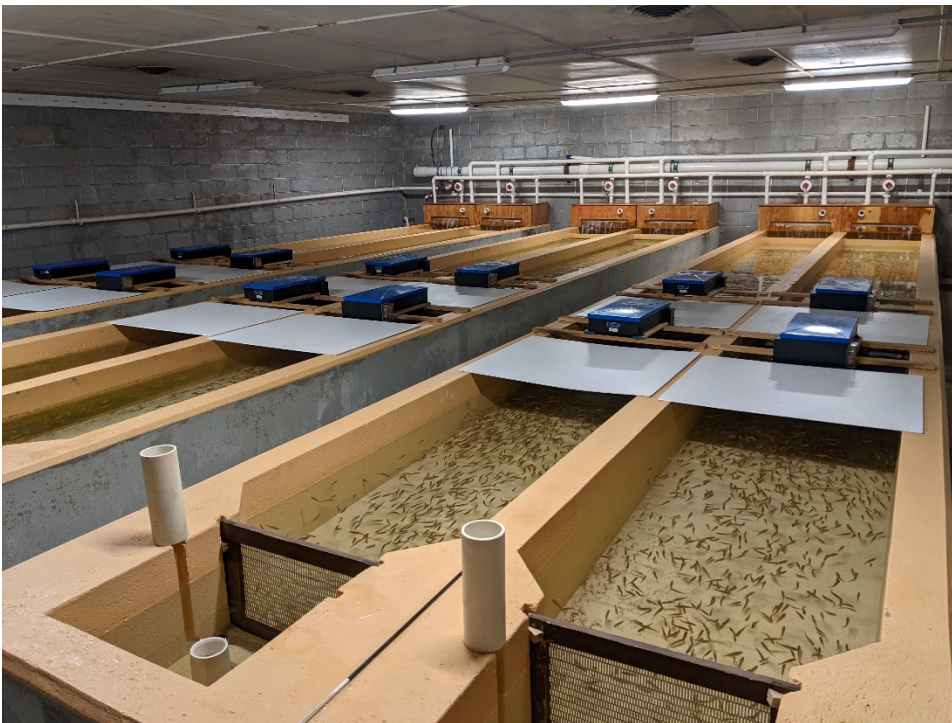
**Figure 5-2: Indoor Raceways 6-11 with Fish Feeders (blue belt feeders)**

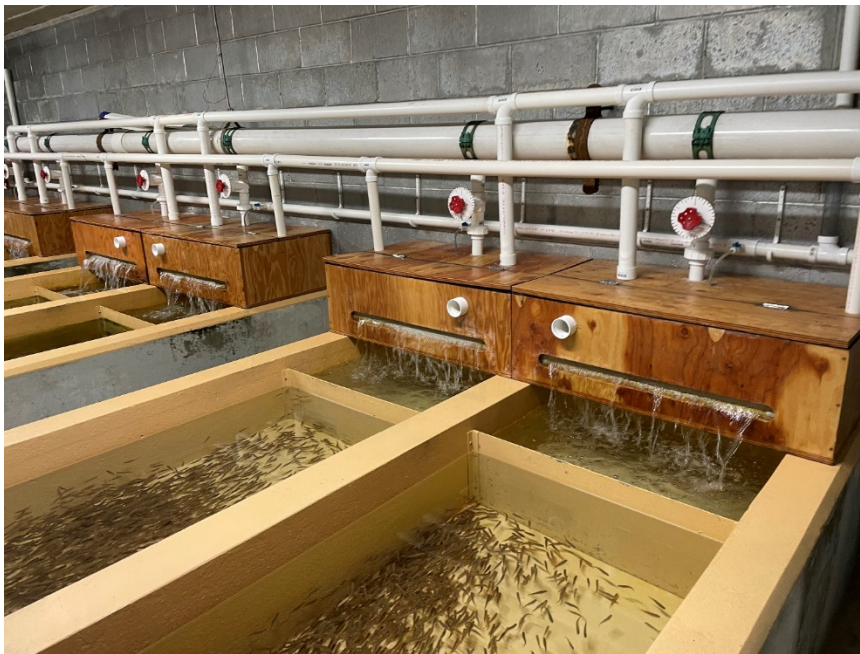
Production water within the indoor rearing units is raw, first-use spring water. Gas stripping systems made by the hatchery manager aerate and reduce detrimental dissolved nitrogen and carbon dioxide (CO<sub>2</sub>) in the water supply (Figure 5-3). The primary goal is CO<sub>2</sub> reduction. Automatic belt feeders are used to administer food to the indoor raceways. Hatchery personnel report that the indoor raceways are brushed and cleaned daily. The south room has an egg picking table with two seats designed for two incubator trays.

**Figure 5-3: Degas/Aeration Boxes**

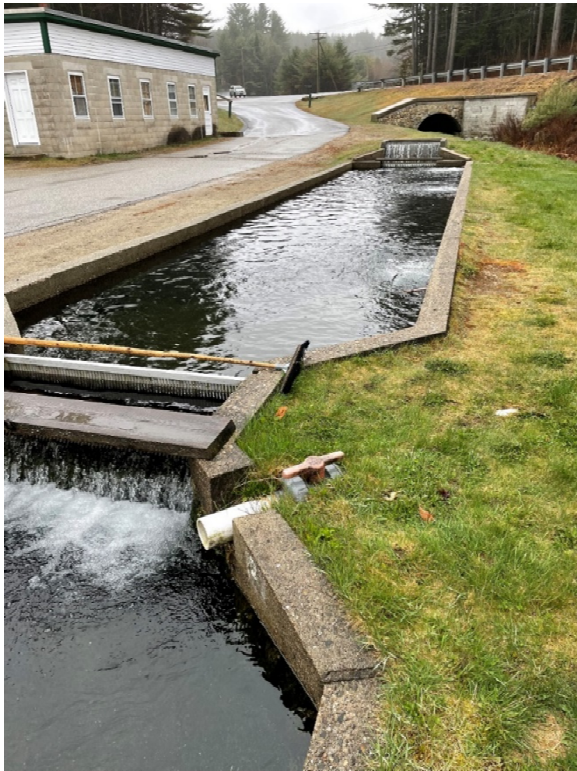
The B-Series raceways (50-ft long by 10-ft wide by 1.75-ft water depth) consist of ten (10) raceways located on the east side of Route 3 that operate under ten-pass serial reuse. Hatchery personnel report the raceway flow rates vary from 281 to 481 gpm. Water supply arrives at a header box at the first raceway and also fills an adjacent filler box. An 8-inch or 12-inch main leaves the filler box and has valved 4-inch branches to Raceways B-2 through B-5, and B-6 has a 6-inch white PVC inlet pipe with a threaded plug (Figure 5-11).

B-Series raceway concrete is in fair condition. Approximately 10% of the raceway wall top surfaces are spalled or have been recently been rehabilitated. There are spalls at the inlet/outlet control structures between adjacent raceways. All loose and deteriorated concrete should be removed from spalled areas and it should be replaced with new concrete.

**Figure 5-11: Raceway B-2 Supply Valve**

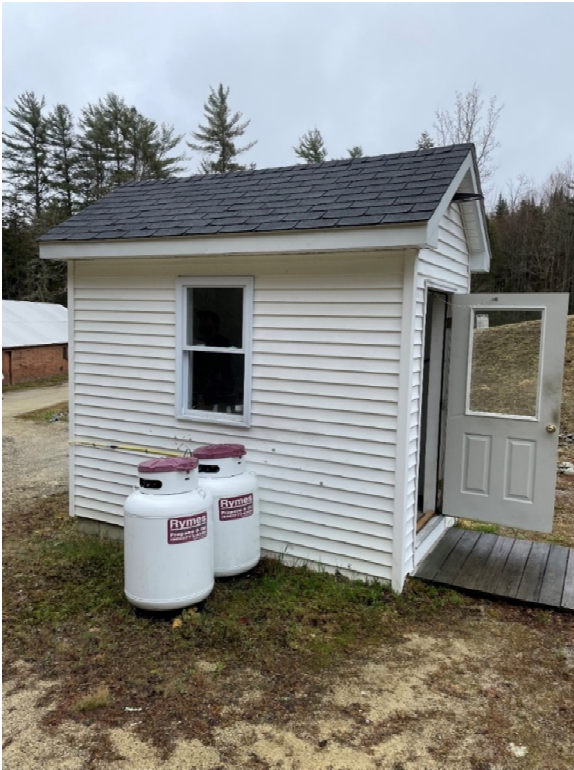
Figure 5-13: Sampler Shed

Draft pipeline consolidation drawings dated 03/27/09 indicate a sampling vault on a 12-inch PVC outfall pipe. The vault is topped with a shed (Figure 5-13) with refrigerated automatic sampler and transit time water flow meter. Peak springtime flow is 700-800 gpm. On May 4, 2022, the meter displayed 692 gpm.

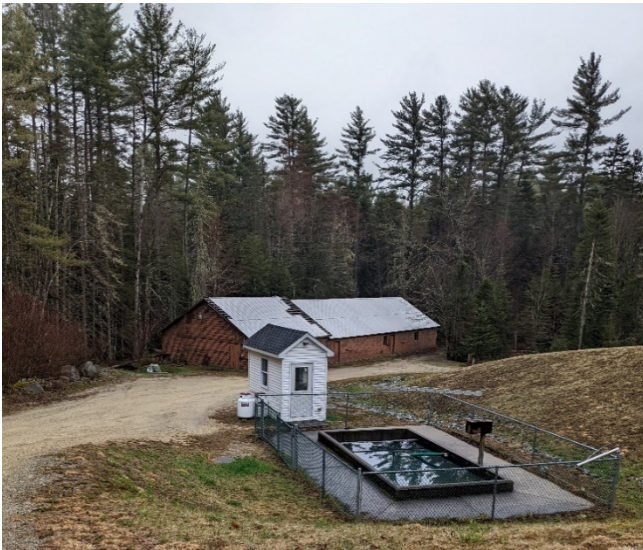
The water source for the Broodstock Building has been abandoned but is discussed in Section 4.5. Draft 2009 drawings indicate 4-inch PVC pipe into the building with supply branches to each of the three 25-foot diameter painted concrete tanks inside and 6-inch plastic drains from each tank to the receiving stream. Hatchery staff noted that the Broodstock Building was abandoned due to failure of the past regime to concern themselves with future use. They made a decision to not connect the current line into discharge 001 (Figure 6-1). Initial visual inspection of the existing infrastructure appeared to indicate the building could be put back into use with replacement of the roof and minor rehabilitation of some of the wooden structure (Figure 6-2). Water supply sources would require further evaluation to determine if water supply was sufficient to supply water to a brood. Hatchery staff noted that in the past, water quality was good for this purpose.

**Figure 6-1: Broodstock Building (Abandoned) with Settling Tank and Sampler Shed in Foreground**

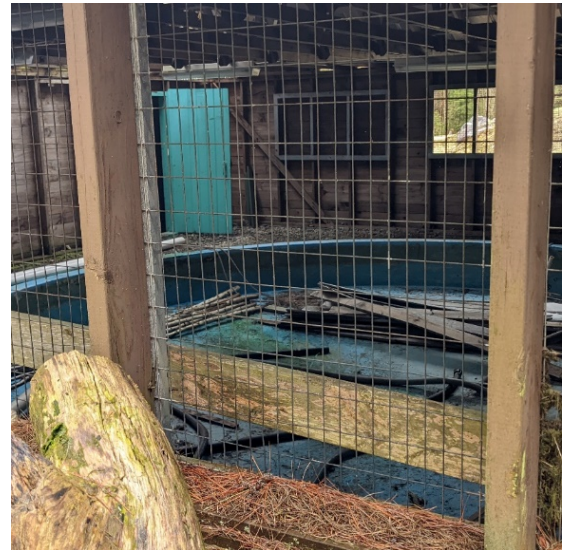
**Figure 6-2: Typical Interior Tank in Broodstock Building (Abandoned)**

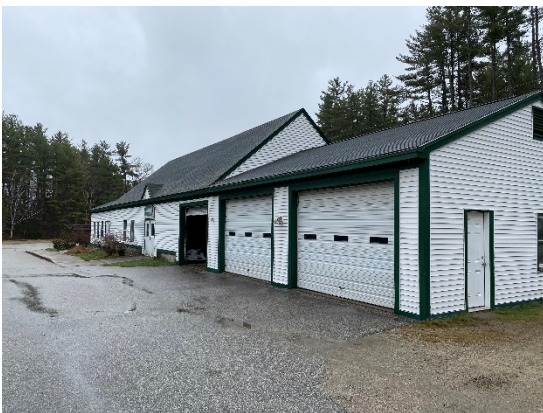
Figure 7-1: Visitor's Center Garages Front View

The roof consists of a taller section over the first bay and the Visitor's Center and a lower section over the other two garage bays. Both sections are asphalt shingle and were observed to be fair to poor condition and is recommended to be replaced.

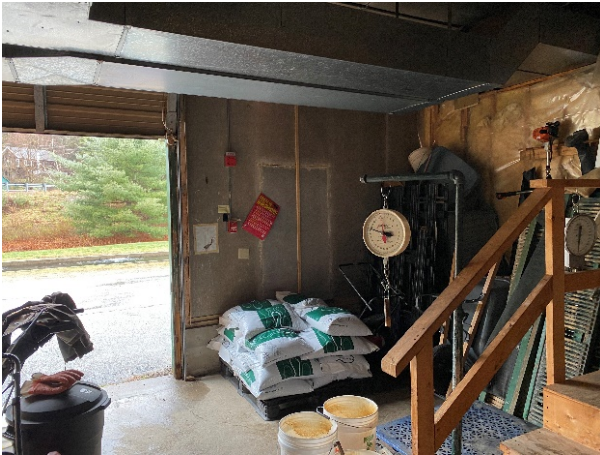
**Figure 7-3: Feed Storage Bay Interior View**

Staff noted that feed is delivered from Berlin Hatchery and must be unloaded and stacked by hand. The feed storage area similar to other facilities does not provide temperature control in the summer, and provides little protection from rodents, as the door to this bay is left open for long durations throughout the day. The double bay garage area (Figure 7-8) does allow for the storage / maintenance of smaller vehicles, but there is no place to store or perform maintenance work on larger vehicles either as part of this building, or anywhere else on-site.

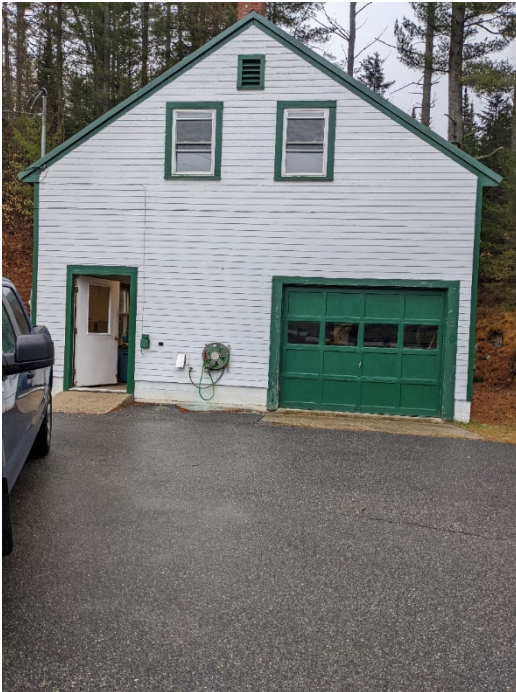
The Office Building is a two-story building at the main entrance to the site, that was converted into an office from its original intended use of a garage and maintenance shop (Figure 7-9). The lower level consists of a narrow garage on one side, and main entrance, utility closet, open workspace, small bathroom, and storage area on the other side (Figure 7-10 and Figure 7-11). The upper level is an open area that is set up as an office with file storage.

**Figure 7-9: Garage/Office Building**

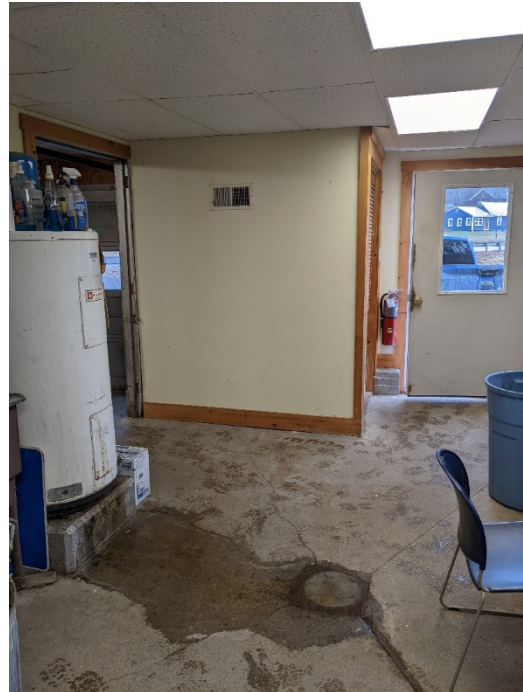
**Figure 7-10: First Level of Garage/Office Building**

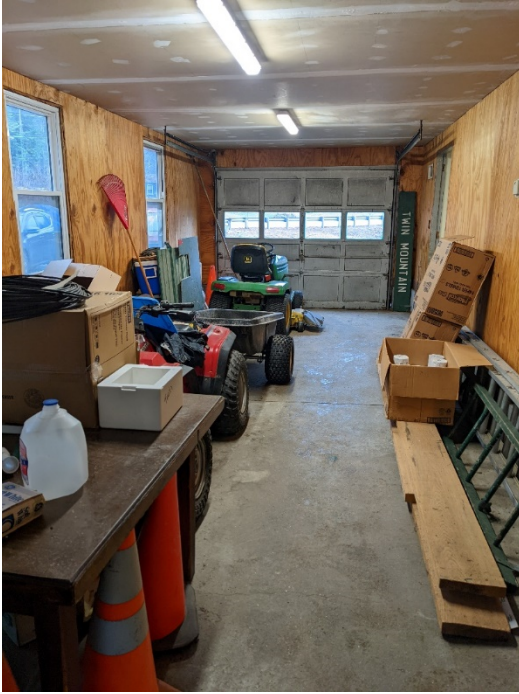
**Figure 7-11: Vehicle Storage/Rollup Door in Garage/Office Building**

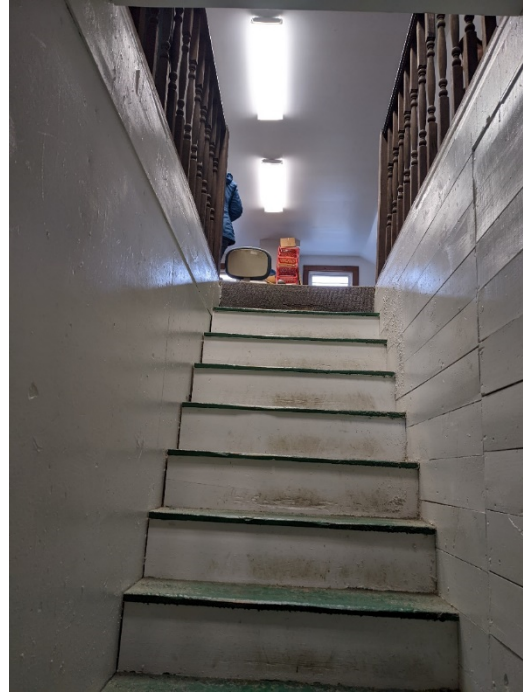
The stairs to the second floor are only 35-inches wide, which is less than the 44-inches minimum allowed per code. The stairs also have 8-inch risers with a 9-inch top riser, which are greater than the 7-inch riser maximum allowed per code. The stairs do not have any handrails. See Figure 7-12.

**Figure 7-12: Stairway to Upper Level of Garage/Office Building**

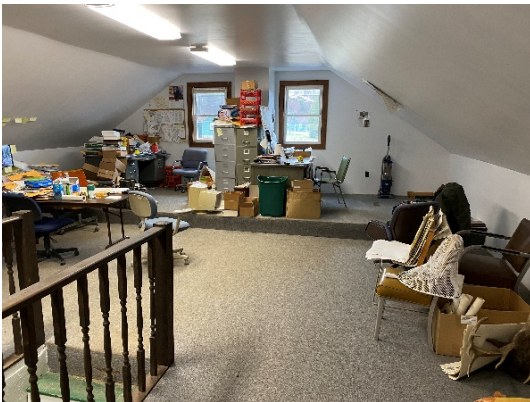
On the second floor, the walls at the sides are only 42-inches high, which again is well below the 6'-8" minimum height allowed per code (Figure 7-13).

**Figure 7-13: Upper-Level Office Space**
