# Existing Conditions and Facility Evaluations - Warren

POWDER MILL FISH HATCHERY FEASIBILITY  
STUDY

New Hampshire Fish and Game Department

May 25, 2023

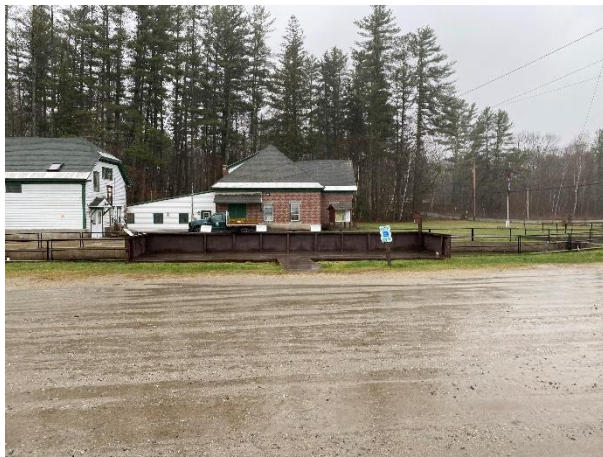
**Figure 3-1: Show Pond, Accessible Viewing Area and Accessible Parking Space**

Facility personnel estimate that 30,000 people visit the facility annually. Visitor's amenities include a visitor's center, display area and viewing station at the Hatchery Building, public restrooms (ADA compliant), show pond with accessible viewing platform (Figure 3-1), public parking (including dedicated accessible parking), pavilion, and picnic tables (Figure 3-2). The Visitor's Center is currently closed due to fire separation issues between the Visitor's Center area and the residence / office above it. See Section 6.5 for more information on the Visitor's Center. The visitor's area in the Hatch House has also currently closed, due to the fact that the area has no accessible path from the parking areas to the entrance. See section 5.1 below for more information on the visitor's area and

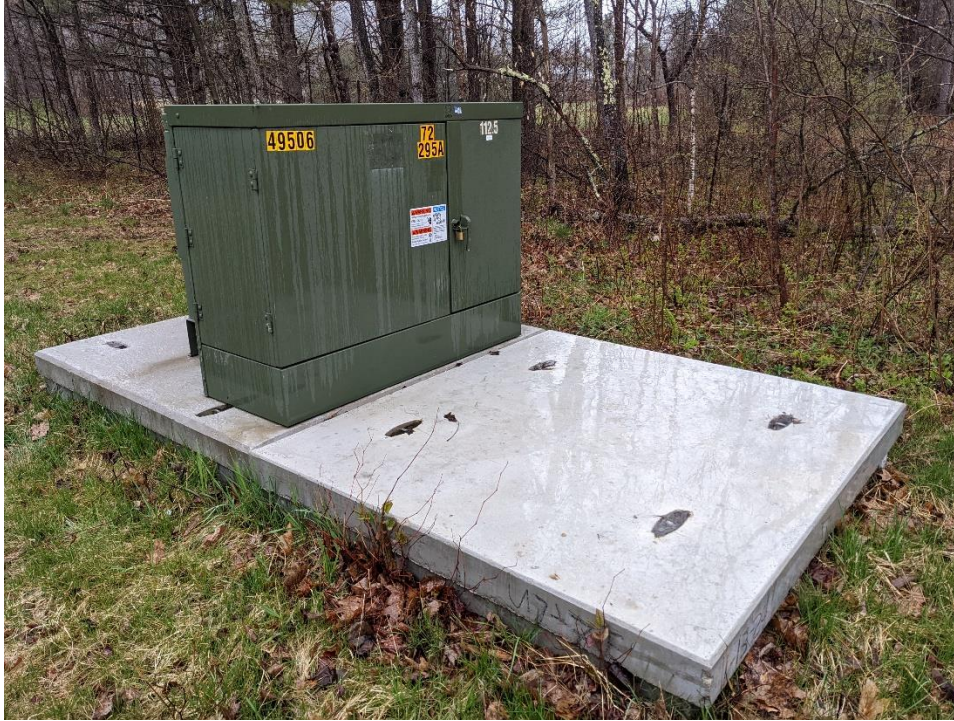
**Figure 4-3: Transformer and Foundation at Well/Pump House #2**

Primary power to Well #2 pump house is provided from a new 112kVA, 208V utility pad-mount transformer, see Figure 4-3. Primary power to the transformer is routed underground from a nearby distribution line. Power is routed underground from the transformer to the meter located on the well house. A 208V panelboard in the well house provides power to Well #1, #2, and #3, as well as the monitoring/alarm system and ancillary lighting/receptacles.

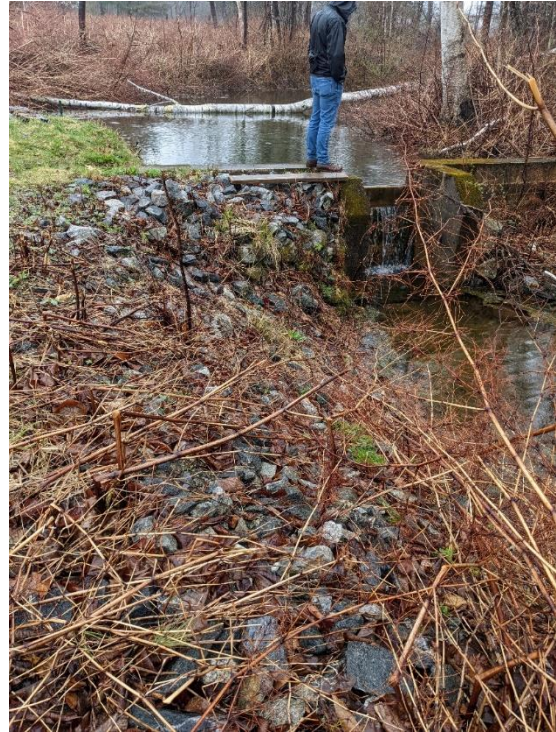
Figure 4-9: Dam/Impoundment of Pump 3 Reservoir (Screen Box in left background)

A concrete control structure/dam impounds water in Pump 3 Reservoir (Figure 4-8) that is collected from the Main Springs Area as well as Well #3. Impoundment height is controlled with weir boards. Riprap has been recently added downstream of the impoundment (Figure 4-9). Impounded water depth is 2-3 feet. The concrete of this control structure is in fair to good condition, with minor surface cracking and some vegetation growth on exposed surfaces. There is no recommended maintenance at this structure at this time.

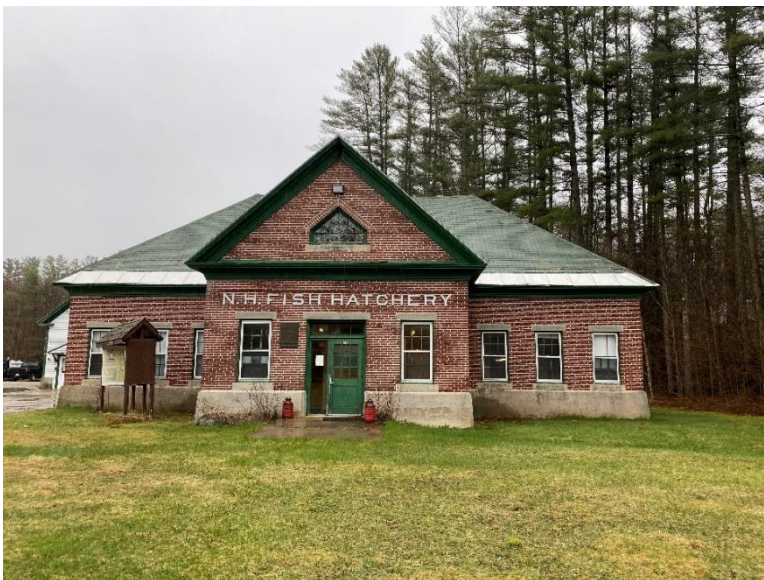
Figure 5-1: Hatch House Front (West) Facade

The Hatch House consists of the original hatchery building (Figure 5-1), which was constructed in 1915, along with an addition that was constructed on the back (east) façade to create an office space and additional linear tanks (Figure 5-2 and Figure 5-3). The exact date of the addition is unknown. This building is believed to be historically registered.

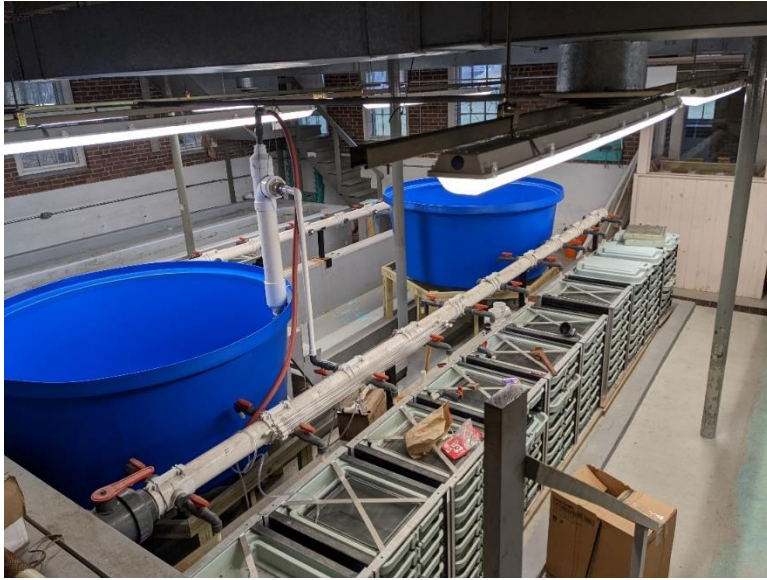
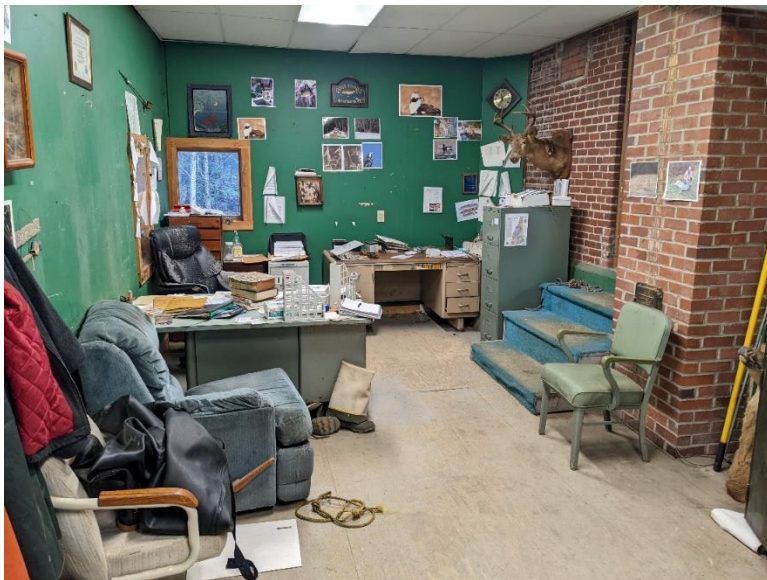
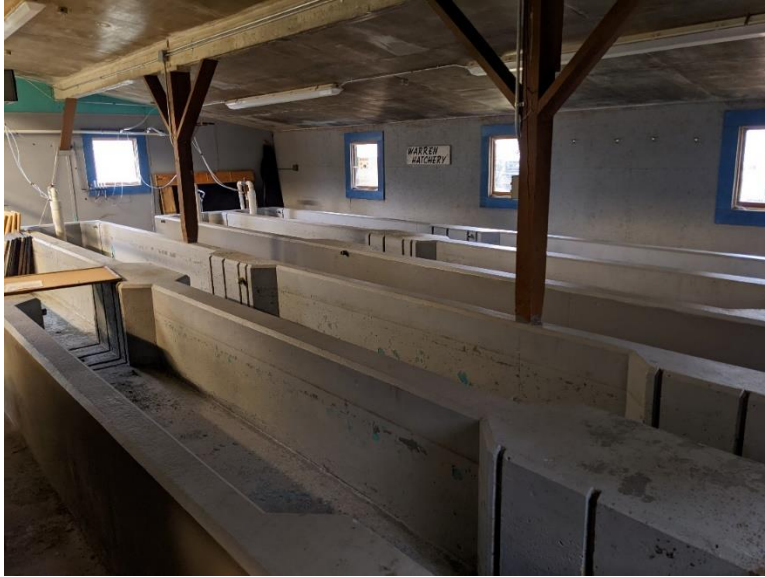
concrete walls of the linear tanks. The structure of the rear addition appears to be in good condition (Figure 5-9 to Figure 5-11).

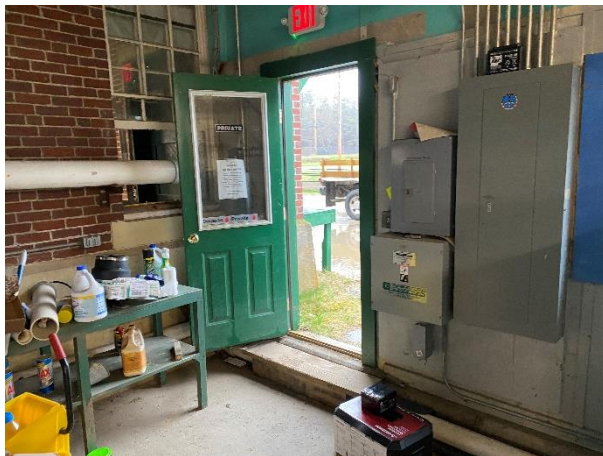
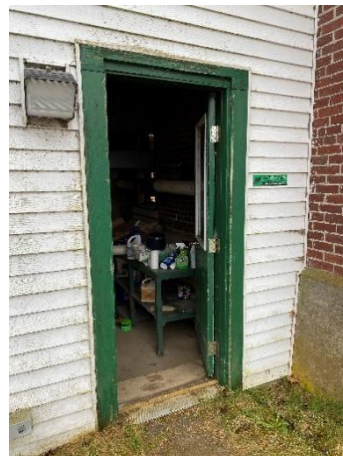
At the rear addition, there is a single 30-inch wide man door on the north façade that provides access into the rear tank room from the exterior. This door is a composite wood door with a vision panel and an aluminum threshold on a concrete sill. The door is operable and appears to be in good condition. The aluminum threshold does not appear to be sized correctly for the door, as it stops in front of the door, and a piece of wood has been placed behind the threshold to close off the underside of the door. The door sill is approximately 7-inches above the interior floor level of the rear addition, and there is a wood step inside the door (Figure 5-16 and Figure 5-17).

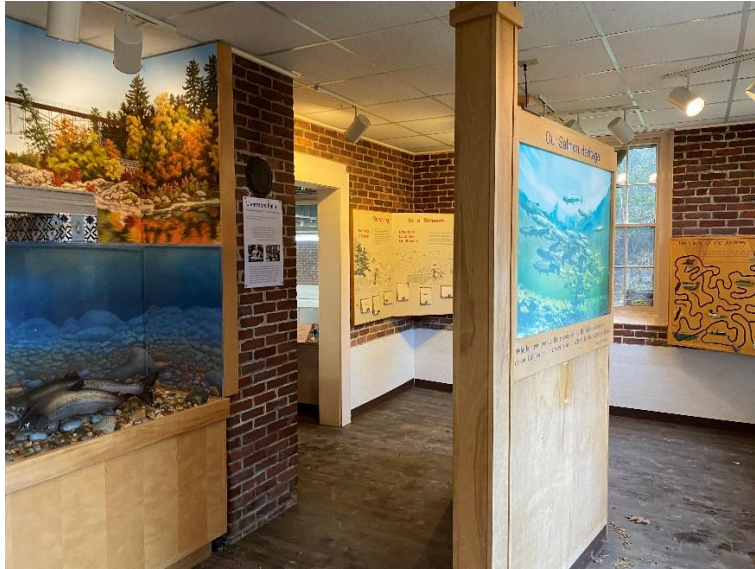
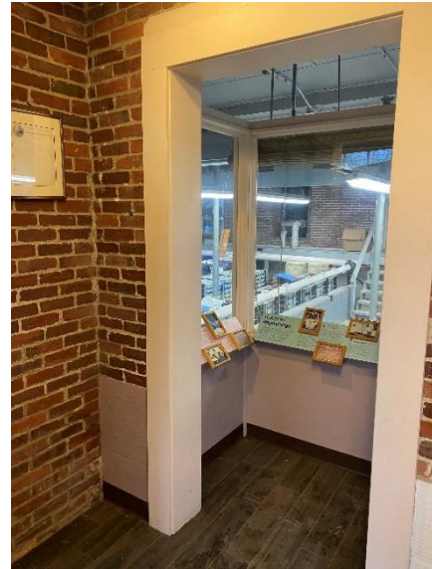
The visitor's area is located at the front of the Hatch House and is intended to be used as a public space for information and education displays, (Figure 5-18) as well as a viewing outlook into the main hatchery floor (Figure 5-19). Currently this area is closed, due to accessibility issues noted earlier. This space is accessed through the front door on the west side of the building. The interior finishes consist of a composite wood floor, exposed brick walls on painted concrete knee walls, and

acoustic drop ceiling. This room appears to be in good condition with no major deficiencies, other than the doors and windows noted previously.

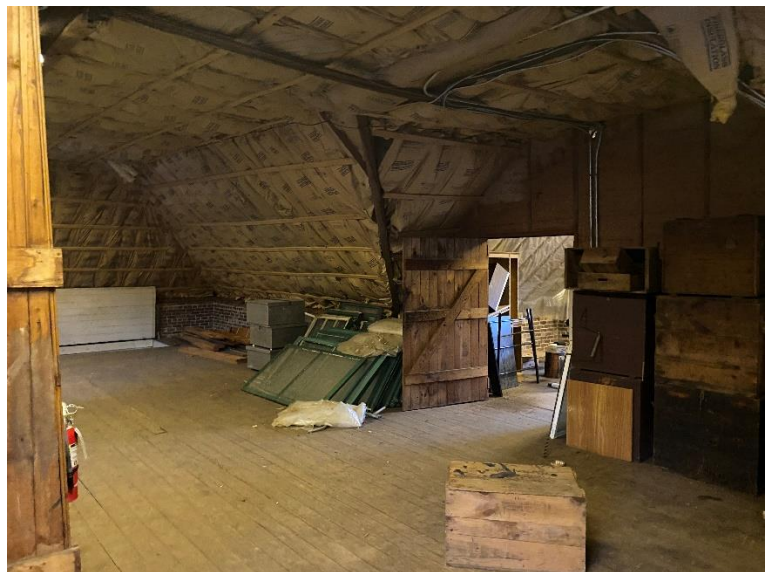
**Figure 5-23: Attic Space**

The attic space above the main tank room is used for miscellaneous storage, but was mostly empty at the time of the site visit (see Figure 5-23). The attic space consists of wood plank flooring, exposed brick exterior walls, and exposed roof rafters with fiberglass insulation. There are two smaller spaces that are separated from the main area of the attic by wood framed walls. The attic space appeared to be fairly clean and well maintained for an underutilized storage space.

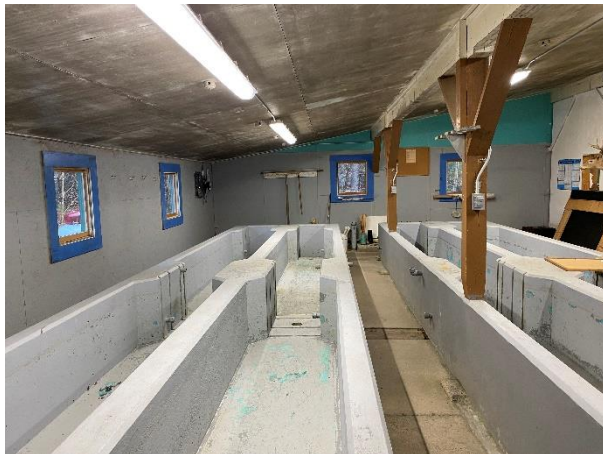
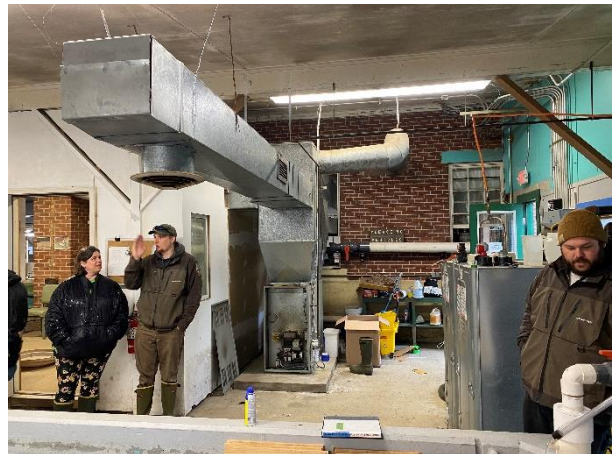
The rear tank room consists of a 37-foot by 24-foot space with two sets of linear tanks, and a 12-foot by 12-foot area between the office and the entry door that houses mechanical and electrical equipment for the entire hatch house (Figure 5-26 and Figure 5-27). This space was not in use at the time of the visit due to issues with lack of ventilation / air circulation and mold. Both of the linear tanks were empty. The floor is an unfinished concrete floor. The walls and ceiling are asbestos paneling on wood framing. The floor, walls, and ceiling appear to be in fair to good condition.

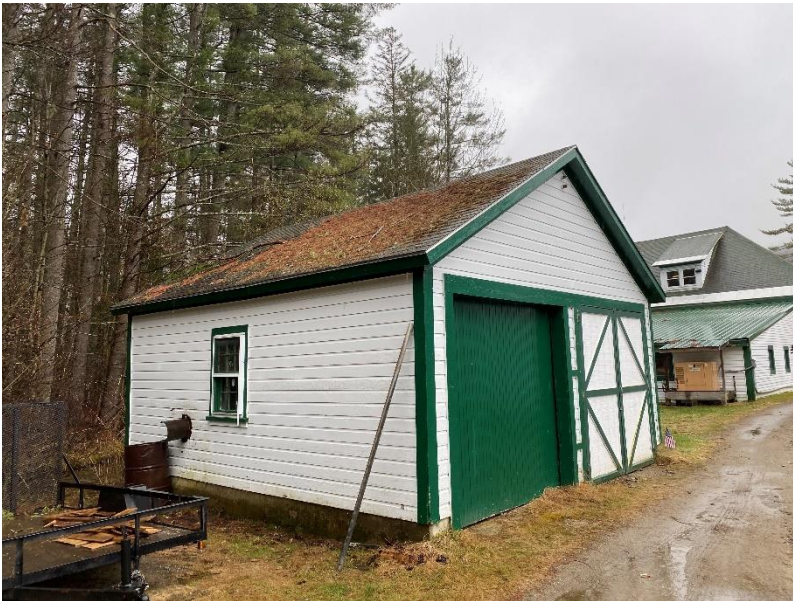
**Figure 6-1: Garage**

The Garage is adjacent to the Visitor Center and Assistant Residence behind the Hatch House, see Figure 6-1. It is a 19-foot by 19-foot wood structure that is used for the storage of miscellaneous vehicles, equipment, and storage, consisting of two garage bays and a storage loft above the eastern bay. The structure consists of a concrete foundation and floor slab with timber framed walls, roof, and two wood columns that support a central wood beam for the storage loft. The wood framing appears to be in good condition, but the concrete slab was observed to have significant cracking, most notably along the column line in the middle of the garage (see Figure 6-2).

The roof is an asphalt shingle roof, and it appears to be in good condition other than a buildup of moss and pine needles on the eastern side of the roof that should be cleaned off to prevent future damage. The walls are constructed with wood siding exteriors and plywood or OBS panels on the interior and appear to be in good condition.

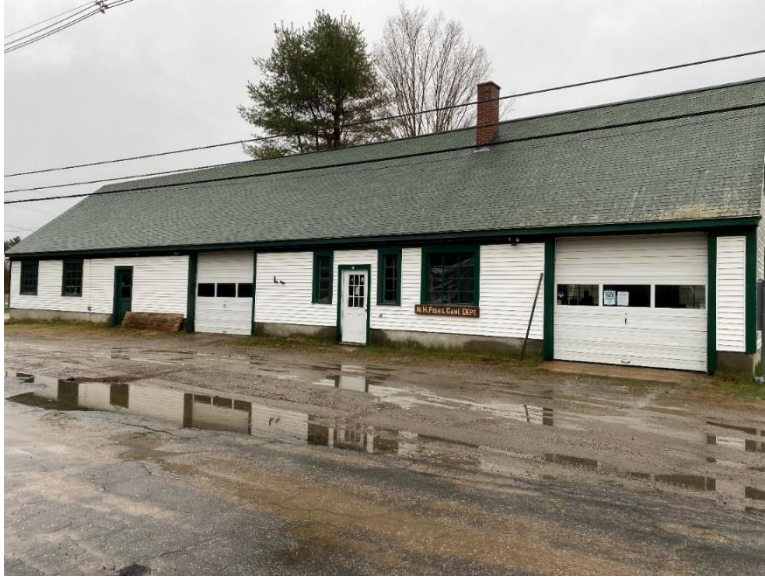
**Figure 6-4: Warehouse Building Front Facade**

The exterior walls consist of wood plank sheathing with vinyl siding exterior finish. The exterior walls are not insulated. The vinyl siding appears to be in good condition other than a few locations with minor cracking or chips.

The windows are all the original wood framed awning style windows with single pane glass. These windows offer little insulation, and in the workshop area, plastic sheeting has been installed over the windows to help provide insulation, but that prevents the windows from being operable which mitigates their use for ventilation and air circulation. It is recommended that all windows be replaced with new insulated double pane glass windows with thermal breaks.

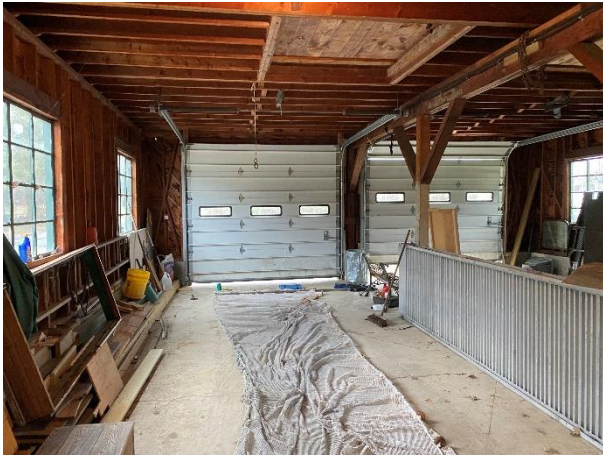
The Warehouse Building has two single man doors and four overhead garage doors (see Figure 6-5). The man doors at the main entrance appears to have been replaced within the past few years with a newer insulated exterior door with insulated glass. The other man door to the garage bay appears to be the original door. The overhead doors appear to be in good to fair condition, however all of these doors appear to leave gaps around the door, especially at the bottom. It is recommended that any doors to spaces that are to be heated be replaced with insulated garage doors that provide a proper seal when closed.

**Figure 6-5: Garage Bay Overhead Doors**

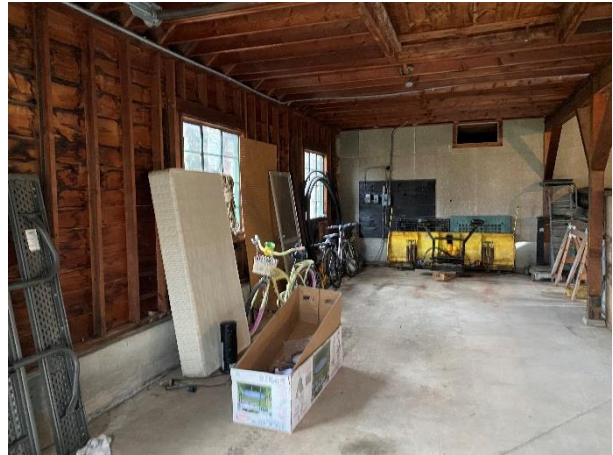
The Warehouse Building is broken into four bays (garage bay, feed storage bay, entrance bay, and workshop bay) with a storage attic that runs above all four bays for the length of the building. The garage bay is located at the north end of the Warehouse Building and consists of two 36-foot by 14-foot bays that are accessed by overhead garage doors on the north façade of the building. The garage bay consists of a concrete floor slab with exposed studs and ceiling joists. This space is not insulated or heated. The south wall of this space is wood stud framing with asbestos panel finish (Figure 6-6).

**Figure 6-6: Garage Bay Rear Wall**

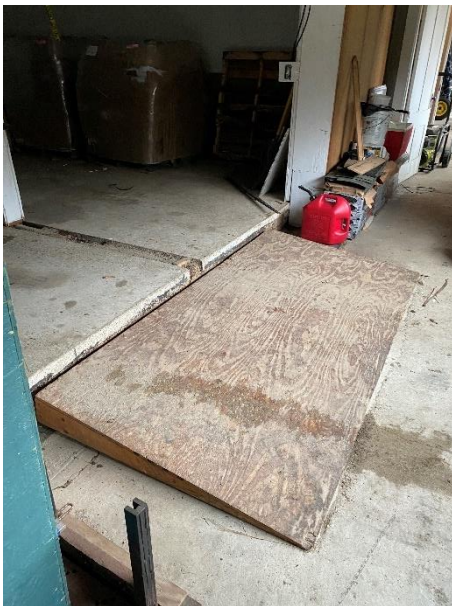
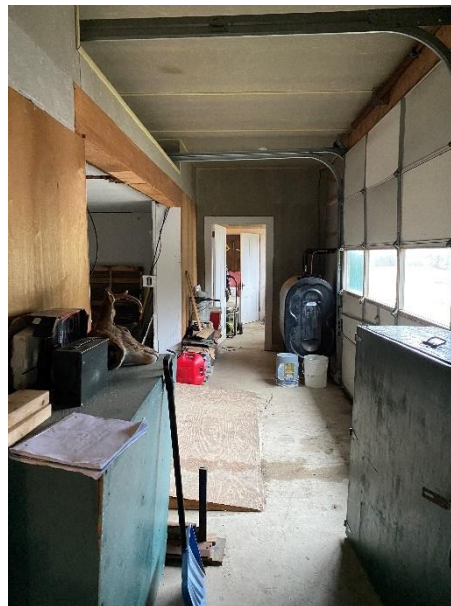
The feed storage bay is located between the garage bay and entrance bay and is approximately 24-foot-wide. The bay is accessed directly from the exterior via an overhead garage door, or from the garage or entrance bay via man doors. The front section of the bay is a seven-foot-deep open area with level slab, while the rear 18-foot section of the of the bay was previous used for cold storage with cork insulated floor, walls and ceilings. The door between the insulated and uninsulated sections of this bay has been removed and a wood ramp has been placed at the opening to allow for easy movement of feed pallets and for storage of a tractor. Similar to other feed storage areas at other facilities, the feed storage area does not provide a means for temperature control, nor does it provide a secure area to protect the feed from rodents (see Figure 6-7 and Figure 6-8).

**Figure 6-7: Feed Storage Wood Ramp**

**Figure 6-8: Feed Storage Front Access**

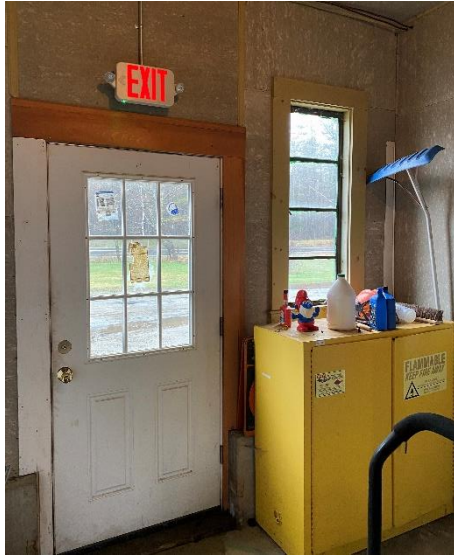
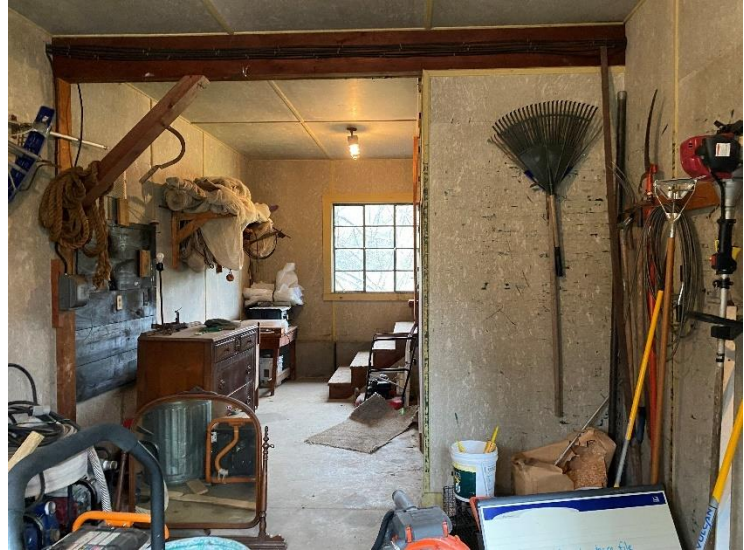
The entrance bay is approximately 12-feet wide and serves as the main entrance into the Warehouse Building, miscellaneous storage, and access to the attic storage via a set of wood stairs. The stairs to the attic do not have any railings or handrails. The interior walls and ceiling are finished with asbestos panels. It is recommended that OSHA compliant railings and handrails be installed along the open edge of the stairs (see Figure 6-9 and Figure 6-10).

**Figure 6-9: Entrance Bay Main Entrance Door**

**Figure 6-10: Entrance Bay Storage and Stairs to Attic**

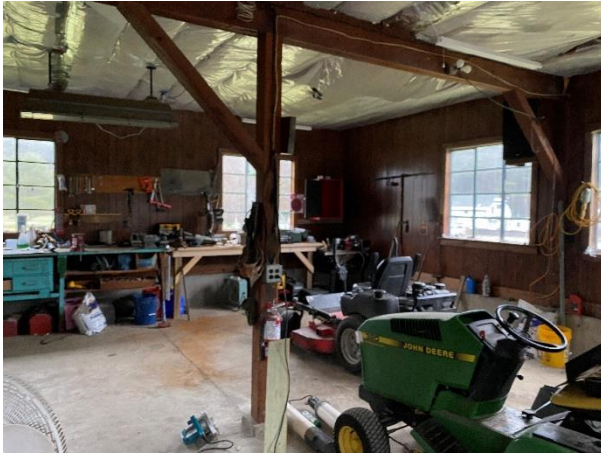
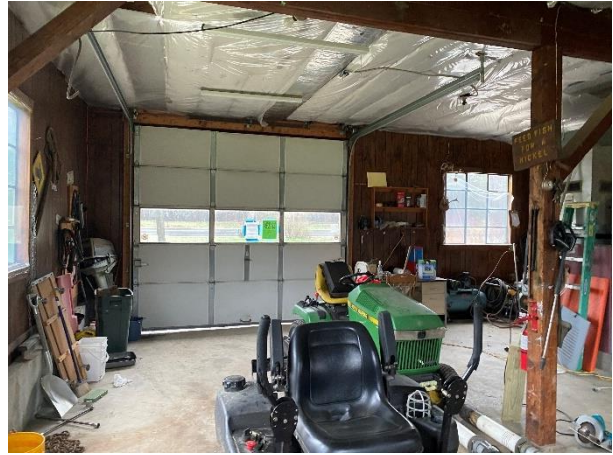
The workshop (24-feet by 28-feet) is the southernmost bay in the warehouse, and it is used for miscellaneous maintenance repairs on smaller equipment. This bay has direct access to the exterior via an overhead garage door or can be accessed from the entrance bay via a man door. This space has a concrete floor slab, wood panel interior finish on the walls, and open joist ceiling. Plastic sheeting has been fastened to the ceiling joists to provide some insulation from the attic space. The exterior walls are not believed to be insulated. Staff noted that this space is hard to keep warm during the winter and does not provide adequate ventilation when the windows are covered with plastic. It is recommended that this space be gutted to expose the studs and joists, and new insulation and wall and ceiling finishes be installed along with new insulated operable windows and insulated garage door (see Figure 6-11 and Figure 6-12).

**Figure 6-11: Workshop Bay**

**Figure 6-12: Workshop Overhead Door**

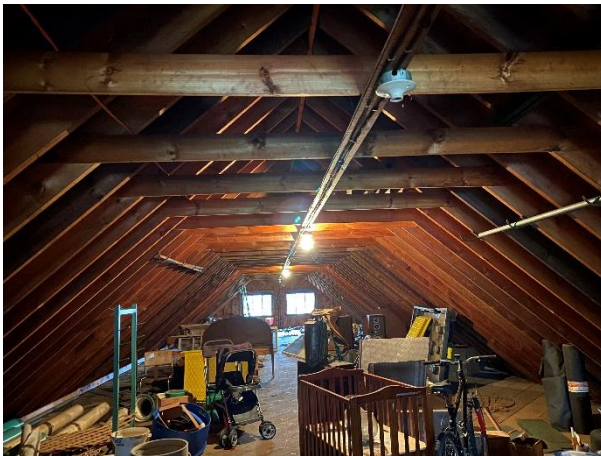
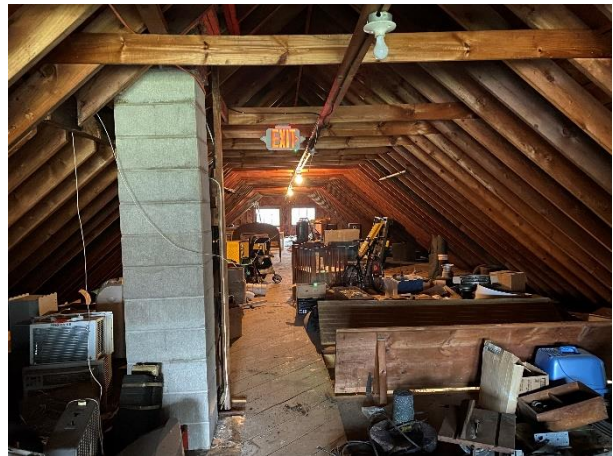
The attic space runs the length of the building above all four bays and is used for miscellaneous storage. The attic space consists of wood plank flooring with exposed roof rafters. There is no insulation in the attic. The attic is accessible from the entrance bay via a wood stair case and there is a wood access door in the floor. No evidence of water damage or leaking from the roof were observed (see Figure 6-13 and Figure 6-14).

**Figure 6-13: Attic Space Storage Area**

**Figure 6-14: Attic Space Access Doors**

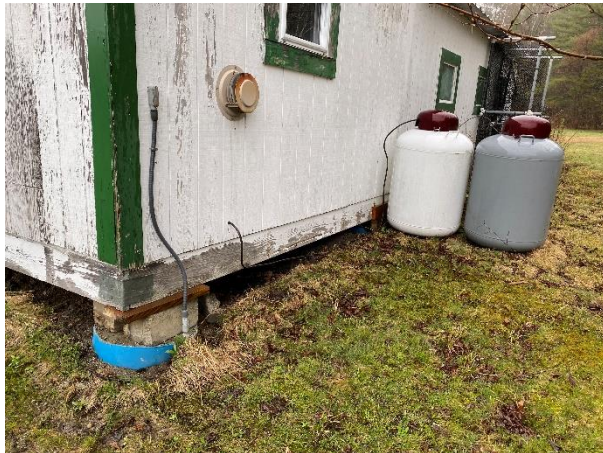
storage area is comprised of a wood frame roof supported by wood posts sitting on individual concrete footings. At the southeast corner of the feed storage, there is a metal bracket to hold the wood base together and the base is shimmed up on top of the concrete blocks, which were observed to be deteriorated.

**Figure 6-18: Southeast Corner of Feed Storage and Pole Shed**

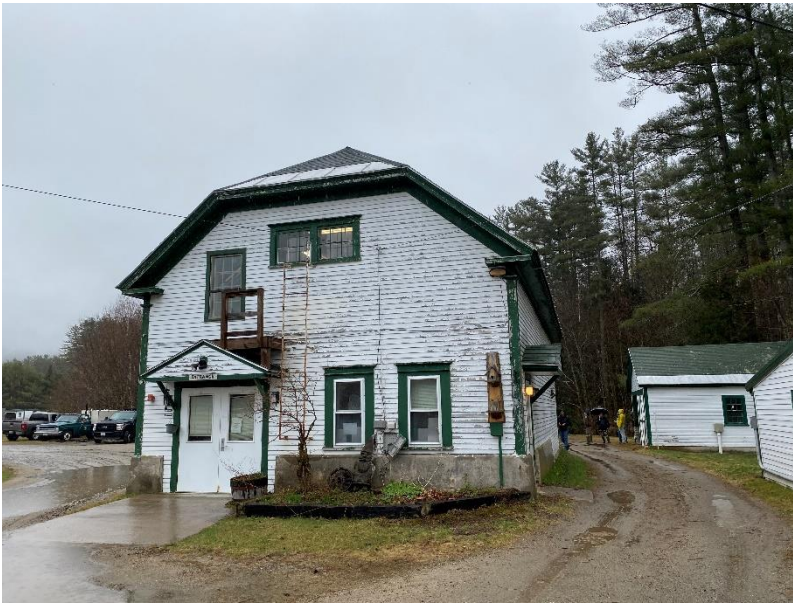
**Figure 6-19: Front Facade of Visitor Center and Residence**

The exterior walls are wood framed walls with wood siding exterior finish. The level of insulation in the walls is unknown, but it is believed that there is insulation within the walls. The walls appear to be in good condition other than cosmetic paint peeling from the wood siding and trim (see Figure 6-19). It is recommended that the exterior be repainted, especially if this building will continue to serve as the visitor's center.
